WEST-END FLOODING INVESTIGATION 24 JULY 2009 RAINSTORM EVENT

CONSOLIDATED REPORT AND ACTION PLAN

MARCH 2011

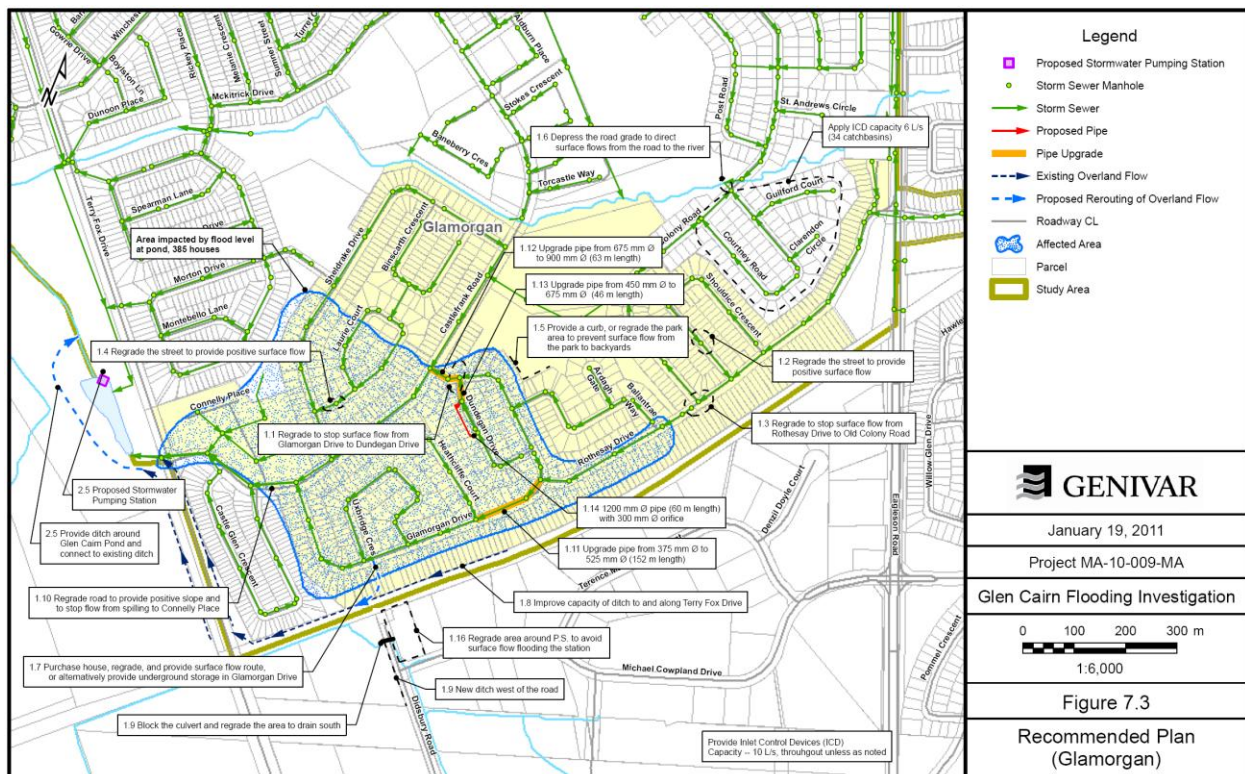
Figure 2 – Summary of Improvements for the Glamorgan Cluster

1. *Overtaxed storm sewers and deficient overland drainage system:*

The July 24, 2009 rainfall event exceeded the design capacity of the storm drainage system. This led to water entering basements through window wells, improperly sealed BWVs or cleanouts and floor joints around foundations. Water in basements evacuated through basement floor drains contributing high extraneous flows to the sanitary sewer system. This was a particular issue in Stittsville and Kanata South.

For Glen Cairn, more significant changes are required to address overland drainage. The Glen Cairn overland flow system was studied in great detail as part of the Glen Cairn EA (Appendix 4). Several overland flow modifications are recommended to alleviate ponding and flooding issues, including:

- modifying some parks to provide surface storage (i.e. Dog Bone Park),
- potentially acquiring a property in the Glamorgan area to improve an outlet for overland drainage,
- modifying roadway and pathway grading to improve drainage, and
- storing excess water in underground pipes.

Figure 2 provides an overview of the improvements identified for the Glamorgan cluster. Similar figures are provided in Appendix 4 for the other clusters in Glen Cairn.

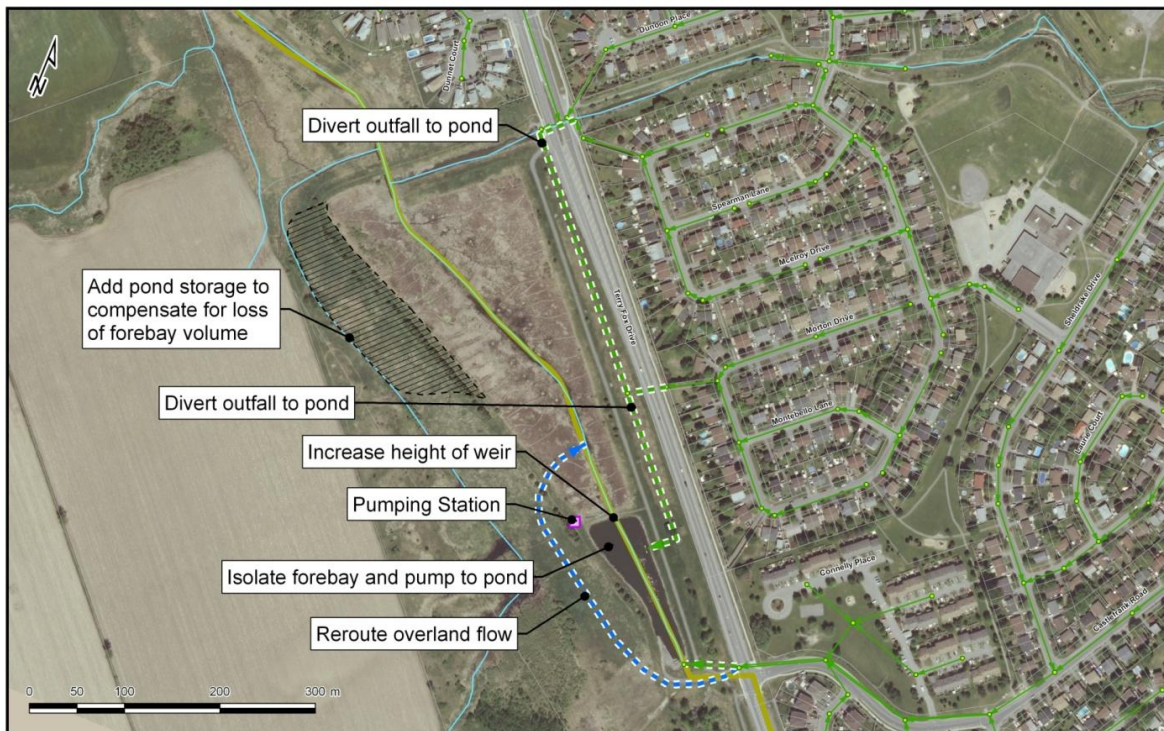
Figure 3 – Stormwater Pumping Station

2. High water level in Glen Cairn Stormwater Pond and Carp River:

Since the pond and the Carp River serve as the outlet for the storm sewers, the capacity of the storm sewers are impacted by the outlet levels during large/infrequent rainfall events. This exacerbated the overtaxing of the storm sewers.

As part of the Glen Cairn EA, different alternative solutions were considered, such as channelizing the Carp River to improve the outlet, modifying the pond to increase its capacity and providing a storm water pumping station at the wet pond to lower the water level during significant rainfall events. The objective of these alternatives was to improve foundation drainage for homes in parts of the Glen Cairn community by providing a more efficient outlet for the storm sewer system. The preferred solution for the purpose of flood protection is the construction of a storm water pumping station in the water quality portion of the Glen Cairn pond. The water quality portion of the pond will then be isolated from the remainder of the pond so that during extreme events, the pumping station will maintain lower water levels in the water quality pond, thereby maintaining a free outlet for the storm system (a significant portion of the Glen Cairn storm sewer system outlets to the water quality pond). High levels in the river and remainder of the pond will therefore have no effect on the sewer system. Figure 3 shows the proposed conceptual solution. Further details are available in Appendix 4.

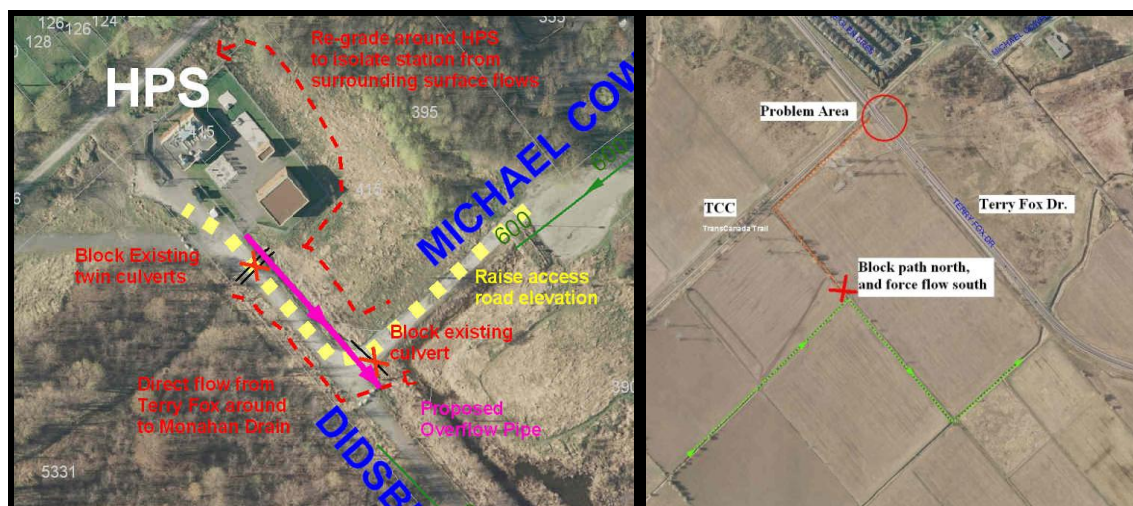
Figure 5 – Overland Flow Modifications Along Monahan Drain and TCT.

There is a culvert immediately south of the TCT where the Monahan Drain crosses Terry Fox Drive. This culvert is designed to convey flow from a relatively small area. During the July 24, 2009 rainfall event, a large pool of water accumulated on the west side of Terry Fox Drive. This was the result of the significant rainfall that overwhelmed the

Monahan Municipal Drain system and some flows were directed north towards the TCT instead of outleting to the south as intended under normal conditions.

As noted, the TCT is the dividing boundary between the Carp and the Monahan systems, but there is a culvert located just east of the Hazeldean pumping station. This culvert is intended to drain rear yards from homes along Rothesay and the eastern portion of Glamorgan to the Monahan Drain. This culvert permitted flows from the Monahan Drain to reverse and move northward into the rear yards of the homes along Glamorgan and Castleglen and contributed flows to the Glen Cairn pond.

Grading and culvert modifications will be undertaken along the Monahan Drain, near the TCT and the Hazeldean Pumping Station to minimize the risk of this situation reoccurring in the future. Figure 5 shows the proposed modifications.

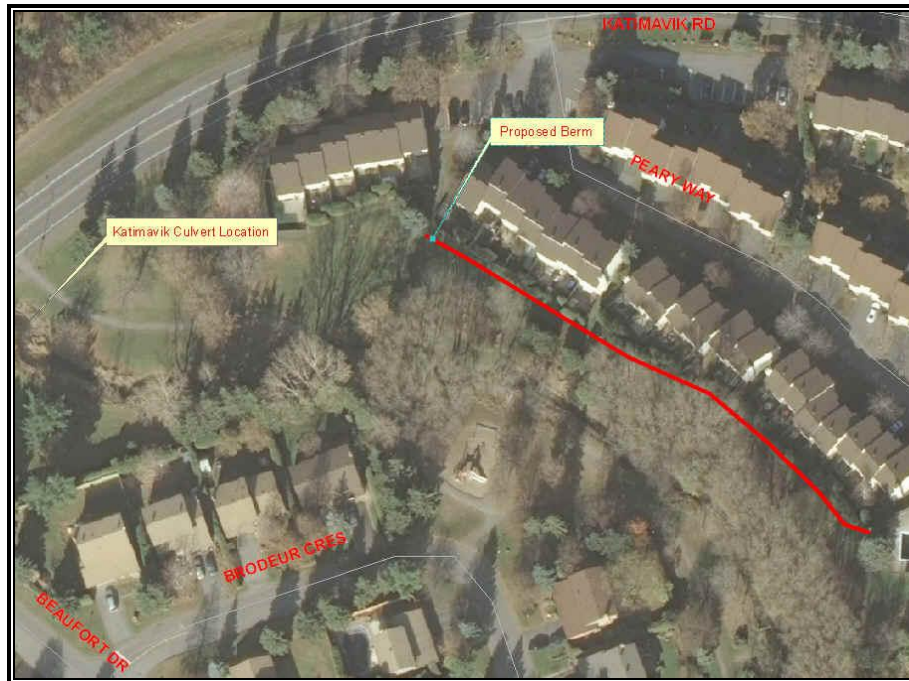
Figure 6 – Proposed Berm Behind Homes on Peary Way

On July 24 2009, high water levels were reported in Cattail Creek at Katimavik Drive. Debris, transported as a result of the storm, partially clogged the grate of the culvert crossing Katimavik Road causing water to back into the yards of properties along Peary Way and enter basements through window wells and joints around basement floors.

A hydraulic assessment was carried out to determine the capacity of the culverts and resulting water levels in Cattail Creek during large infrequent rainfall events. It was found that with the culverts entrance free of debris, the existing culverts have sufficient capacity, although water levels do approach backyards. Creating a berm in the backyards along

Cattail Creek, south of Katimavik, is recommended. During detailed design of the berm, the need for grating at the Katimavik culvert inlet will be reassessed. Figure 6 depicts the recommended solution and further information can be found in Appendix 3.

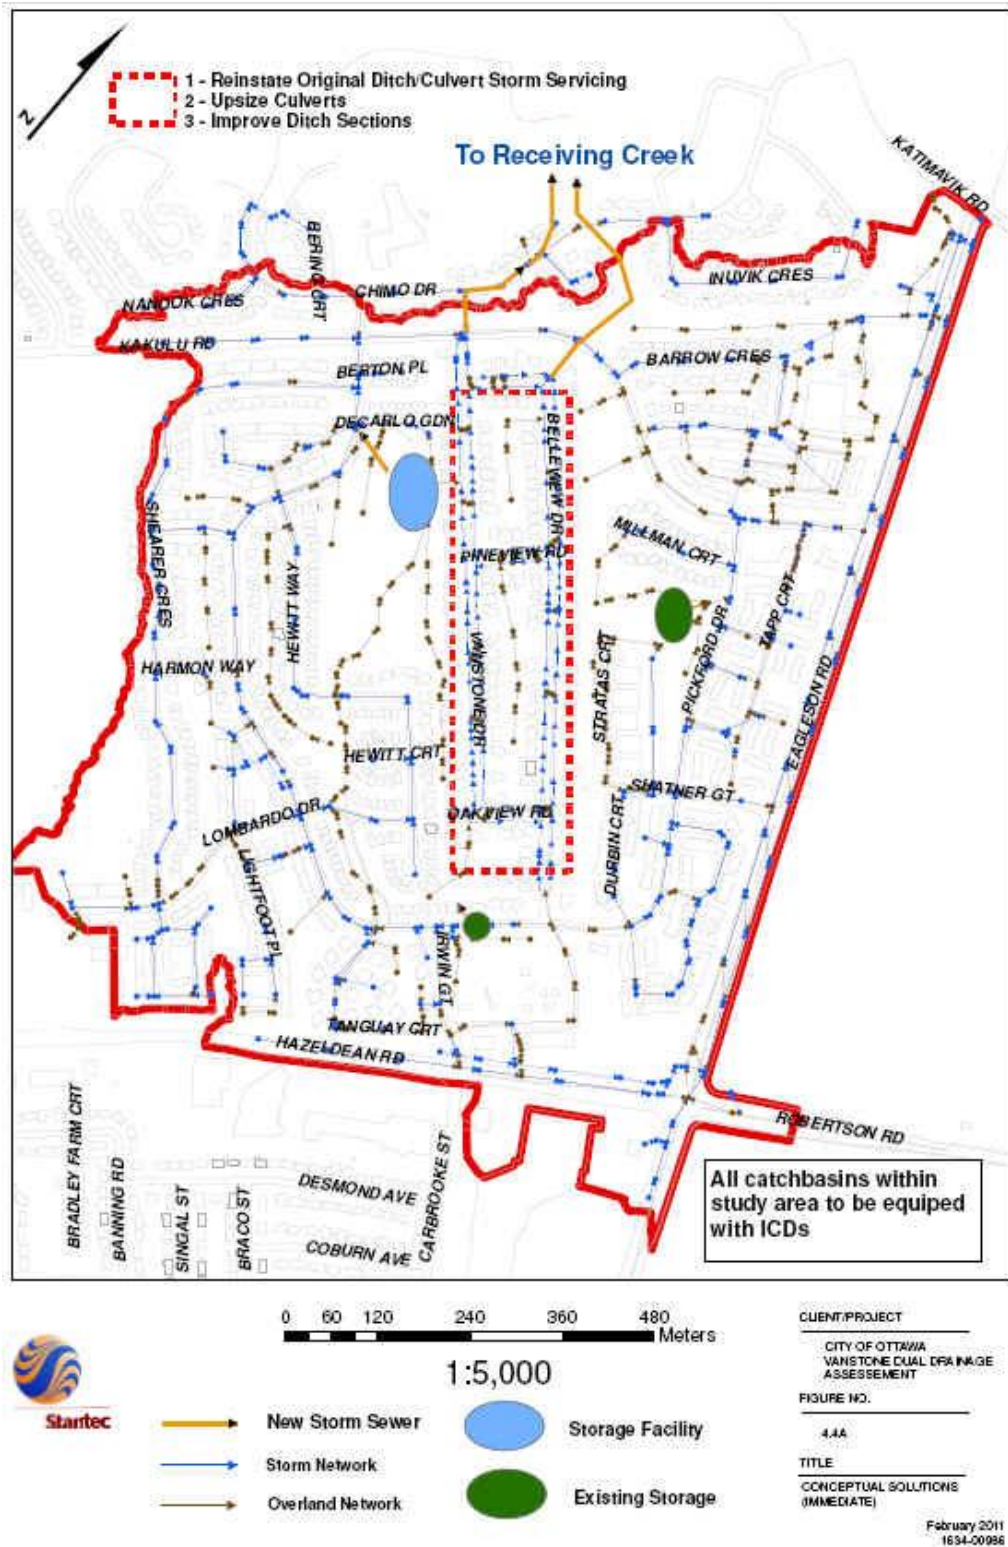
Figure 7 – Vanstone Area Drainage Improvements

For the Vanstone area, there have been alterations to the roadside ditches that have reduced the ability for the drainage system to handle large events. These alterations have impacted overland drainage causing surface flooding and may have encouraged some residents to connect their sump pumps to the sanitary system (some homes at the end of Vanstone and Belleview flooded due to high flows in the sanitary system). There are also eaves troughs that outlet at or near building foundations and this can contribute to basement flooding and to extraneous flow into the sanitary system.

For the Vanstone area, the intent is to reinstate roadside ditches along Vanstone Drive and Belleview Drive to improve the overall performance of the drainage system. New outlet sewers at the extremities of Vanstone and Belleview will also be constructed to convey the ditch flow to Cattail Creek. Stormwater storage is also proposed in Hewitt Park. Figure 7 shows the proposed improvements for the Vanstone area and further information is provided in Appendix 3.

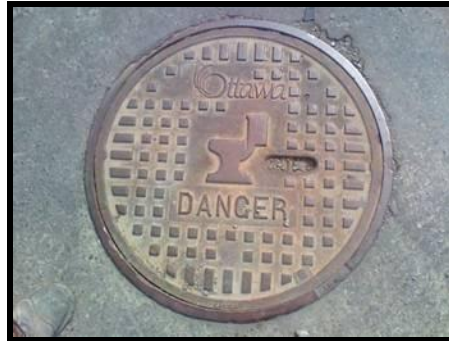
Figure 8 – Maintenance Hole Cover Replacement

Sanitary sewers experienced a significant amount of extraneous flow, which lead to many occurrences of sewer backups in basements across all west-end areas affected by flooding. These high extraneous flows were caused mostly by basements that were flooded by storm water (these basements then drained into the sanitary system via floor drains) and by stormwater entering through holes in maintenance covers that would have been submerged during the large rainfall event.

Fog testing was undertaken in Glen Cairn, Katimavik and Beaverbrook to confirm the presence of cross-connections or other unwanted sources of storm water inflow into the sanitary sewer system. The fog testing identified one catch basin connected to the sanitary sewer system in the Beaverbrook area (this has already been corrected) and a number of other locations where storm water could enter the sanitary sewer system. It was also evident during the fog testing that there is potential for storm water to enter sanitary sewers through vent openings in the maintenance hole covers.

The second element is the replacement of maintenance hole covers with solid covers. Approximately 1,400 covers are currently being replaced in all areas impacted in the Stittsville, Kanata South and Kanata North areas. Figure 8 depicts a new sanitary maintenance hole cover.

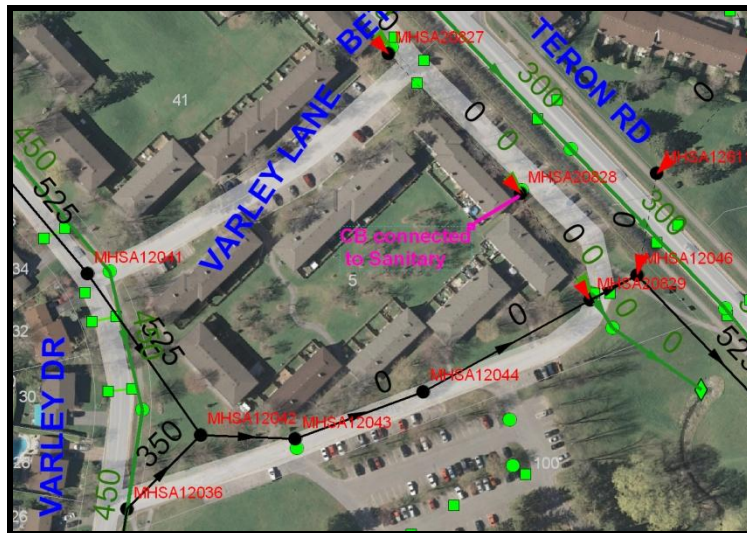
Figure 9 – Beaverbrook/Varley Cross Connection.

The third element is to seal sanitary sewers and maintenance hole structures at locations identified by the fog testing to eliminate inflow sources. This was the case in the Beaverbrook/Varley area where a storm catch basin was connected to the sanitary system (See figure 9). This has since been corrected.

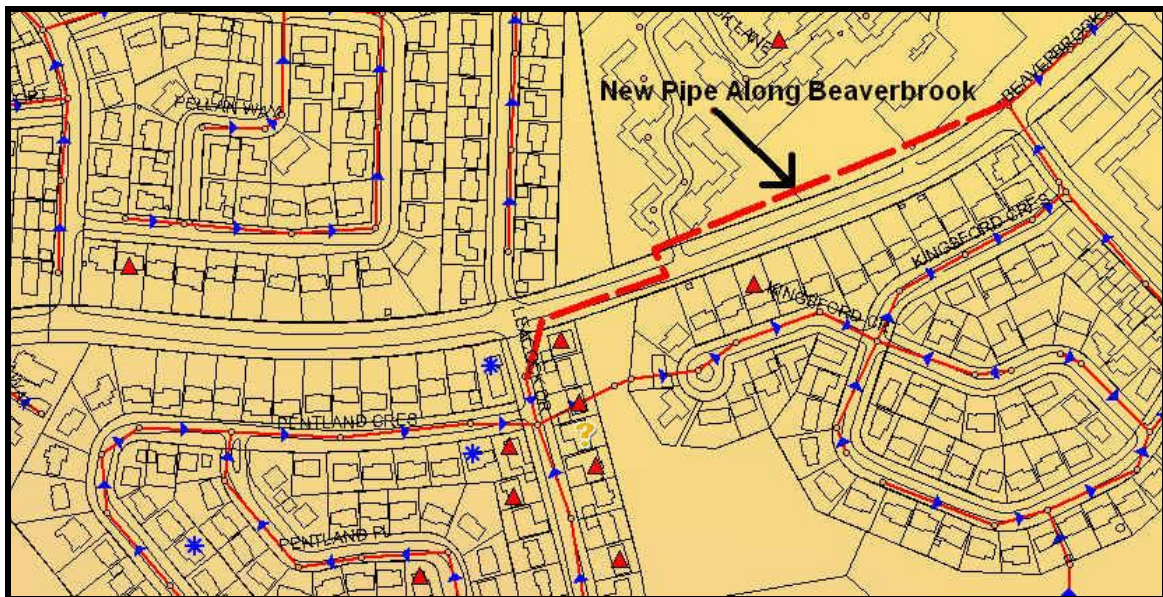
Figure 10 – Leacock Sanitary Sewer Improvement

Some sections of the sanitary sewer system exhibit poor hydraulic conveyance due to the lack of adequate pipe slope. In most instances, frequent cleaning of these segments can resolve the problem, but in limited instances the frequent cleaning is not enough and sedimentation and grease accumulation become a chronic problem. This was the case in the Leacock area where a combination of extraneous flows and sediment accumulation contributed to the flooding.

The extraneous flow portion of the problem will be addressed with the solution noted the previous item. A new sanitary pipe is proposed to bypass the existing pipe that experiences sedimentation problems. The existing pipe on Leacock will also be replaced to improve sewer hydraulics by increasing the slope and diameter of the pipe. Figure 10 shows the proposed sanitary sewer improvements for the Leacock area.

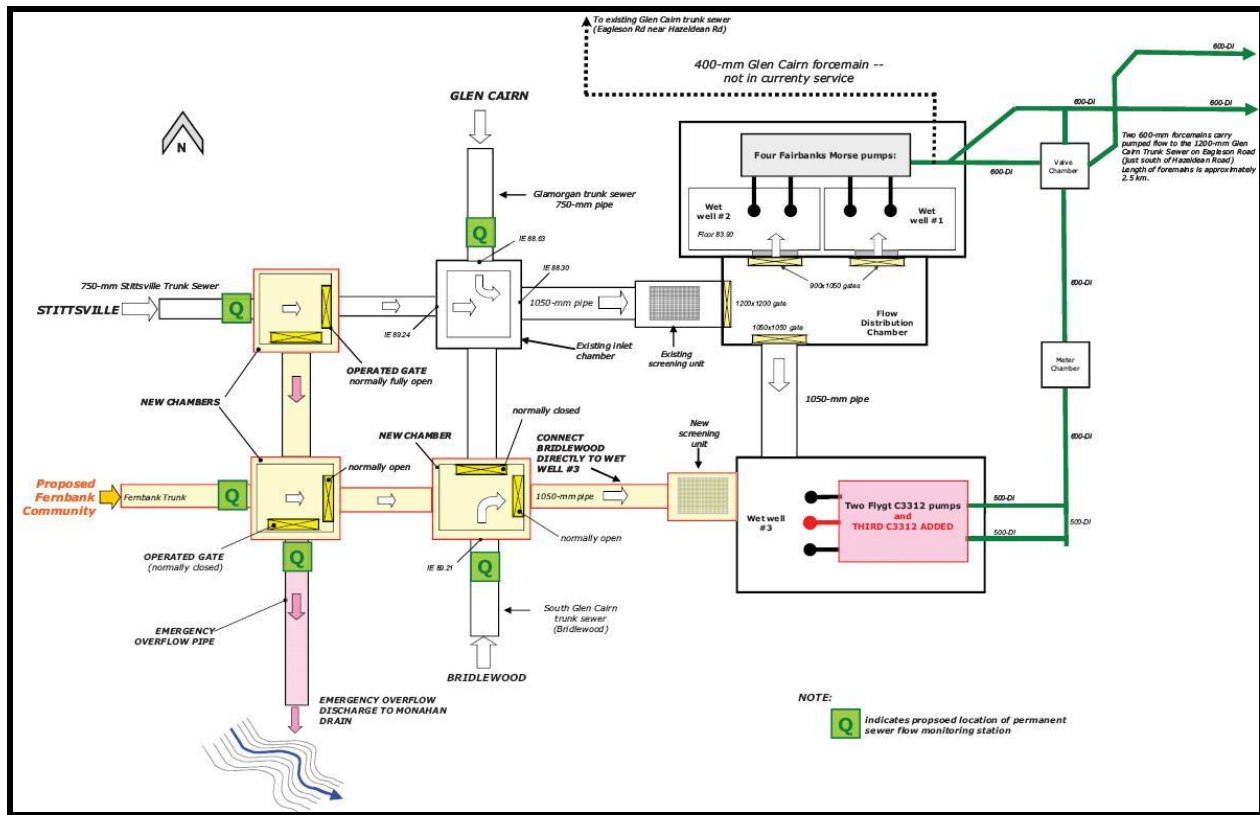
Figure 11 – Hazeldean Pumping Station Solutions

Elevated wet well levels at the Hazeldean Pumping Station, caused by excessive extraneous flows in the incoming sanitary trunk sewers, contributed to basement flooding in the Glamorgan area.

Implementing the measures to remove the extraneous flows from the sanitary sewer system will reduce the risk of the Hazeldean Pumping Station being overwhelmed. Additional measures at the Hazeldean station include improving the station inlet configuration, providing a more effective emergency overflow, and increasing pumping capacity to provide a buffer between current demands and those expected from new developments as well as high extraneous flows experienced during severe rain storms. Figure 11 shows a schematic of the proposed solutions at the Hazeldean Pumping station and further technical details are provided in Appendix 4.
