MORRISON HERSHFIELD

BUILDING CONDITION AUDIT and STRUCTURAL
ASSESSMENT

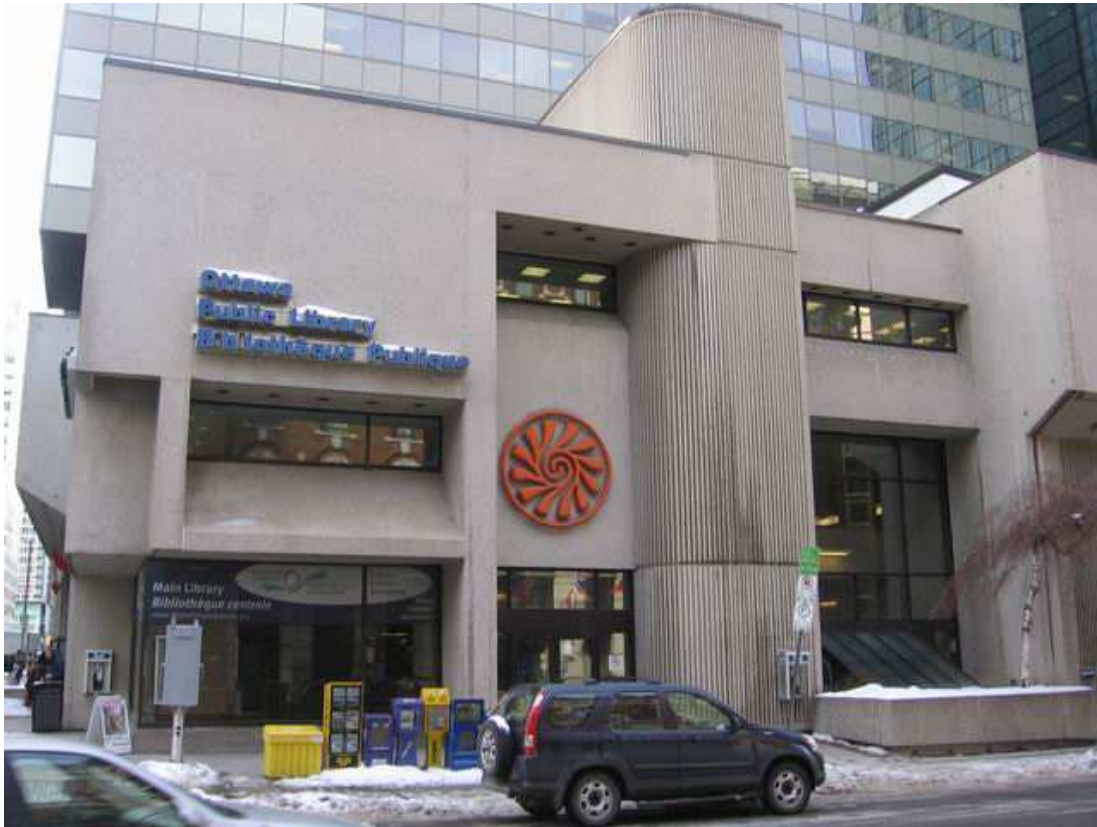
Photograph 1 - Metcalfe Street elevation

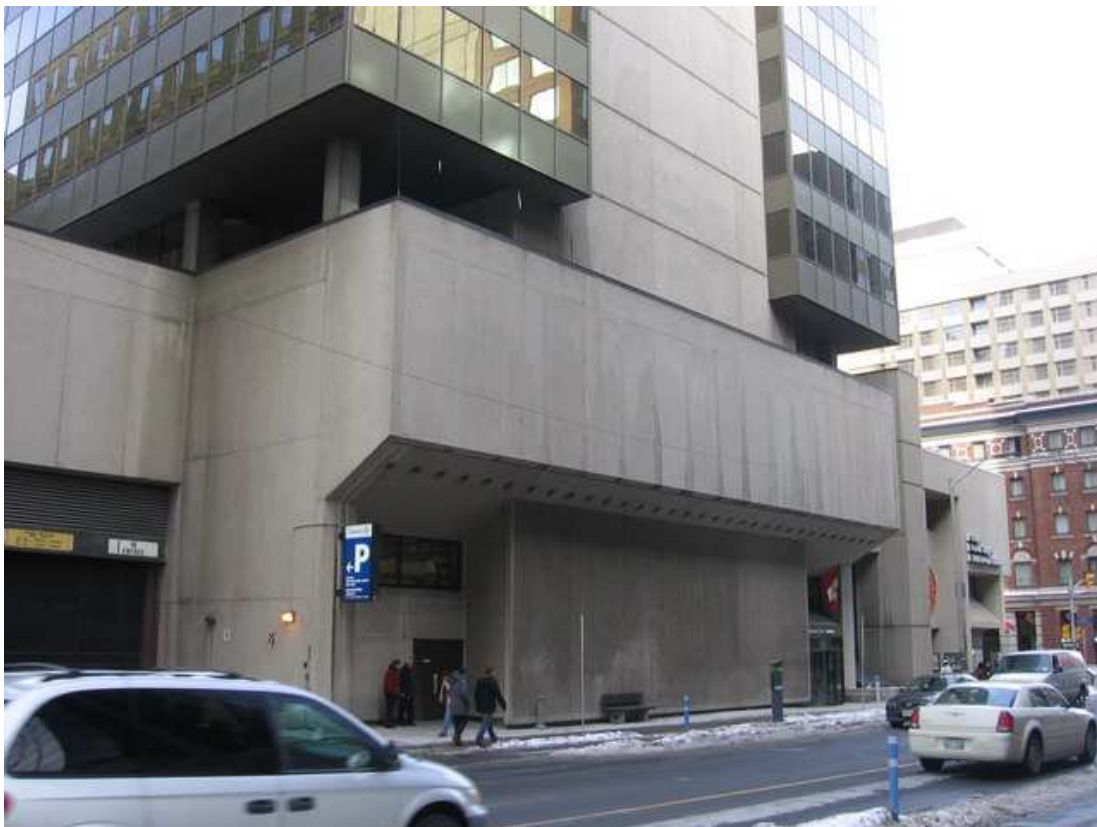
Photograph 2 - Laurier Avenue Elevation

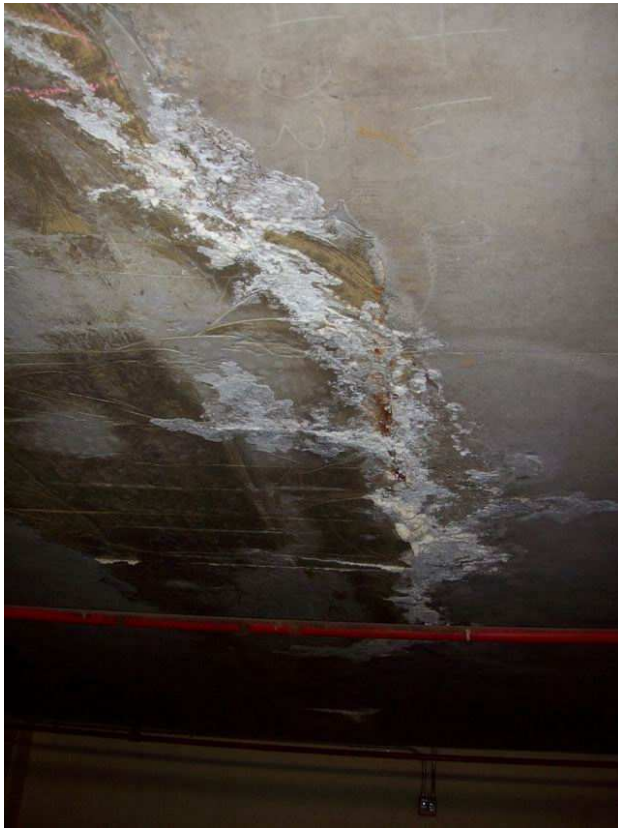
Photograph 3 - Soffit cracking with efflorescence and corrosion staining

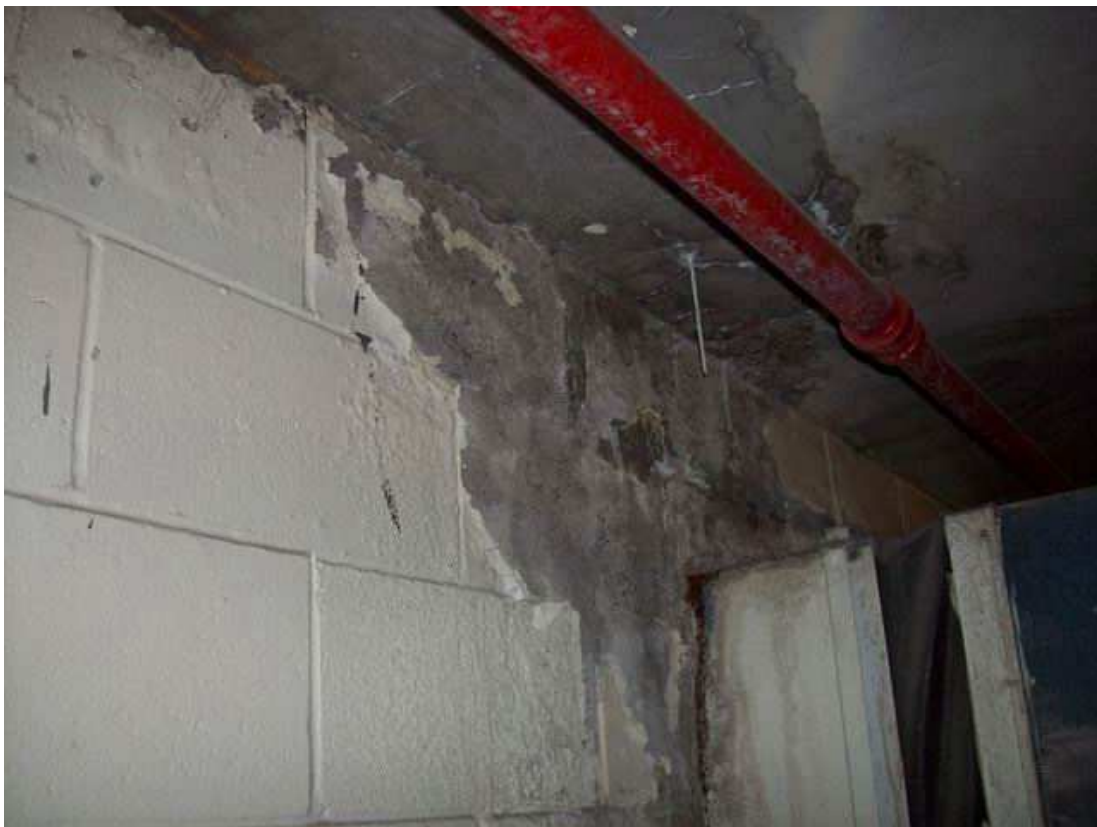
Photograph 4 - Concrete wall damage

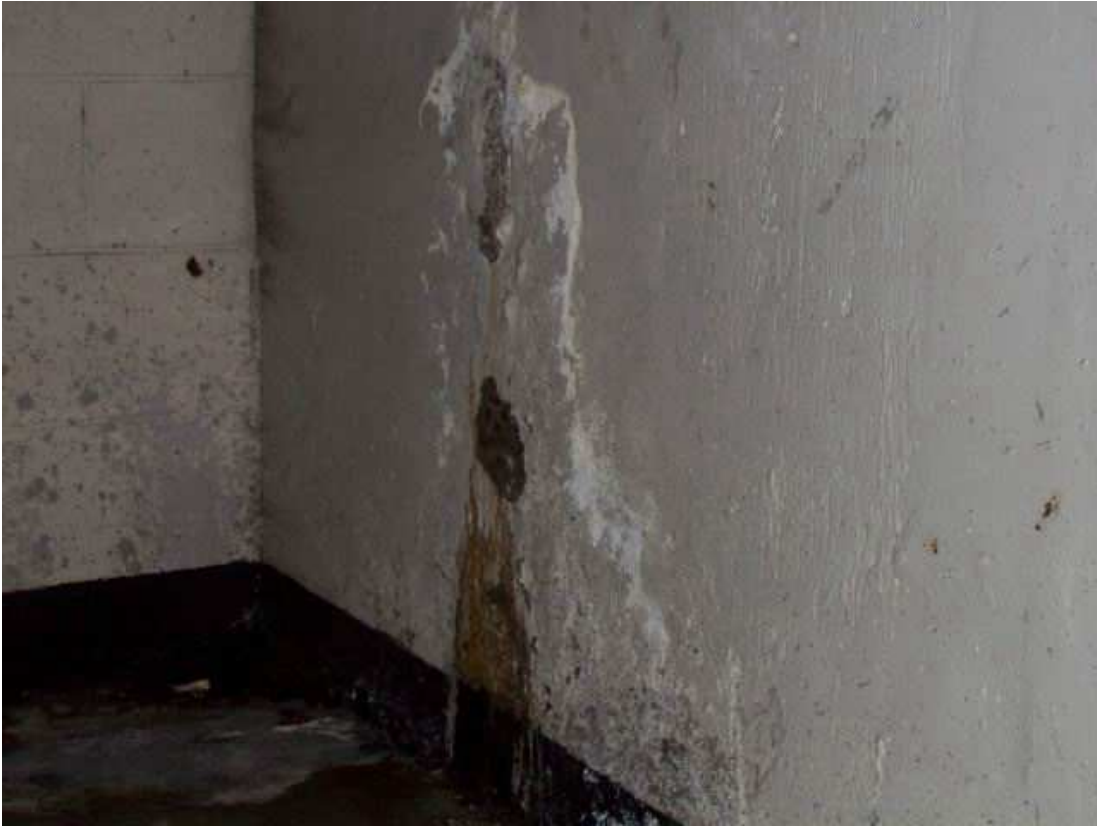
Photograph 5 - Wall cracking with corrosion staining

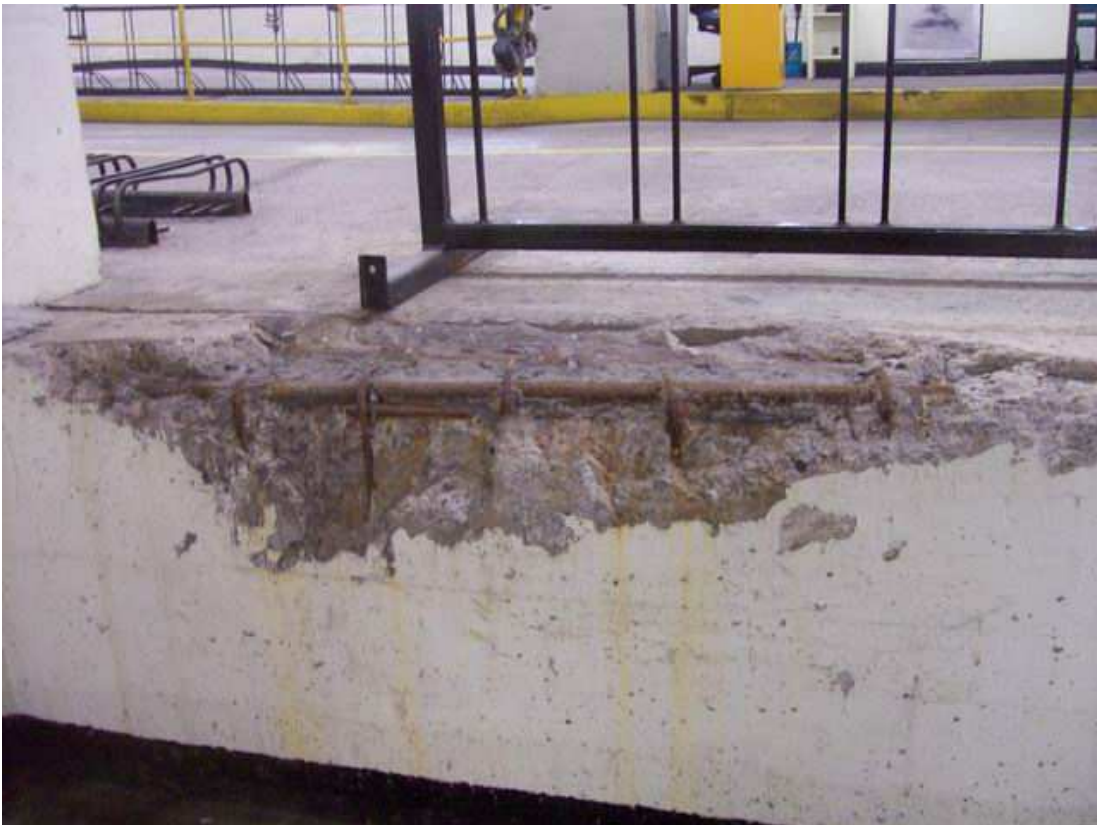
Photograph 6 - Spalled concrete at half wall

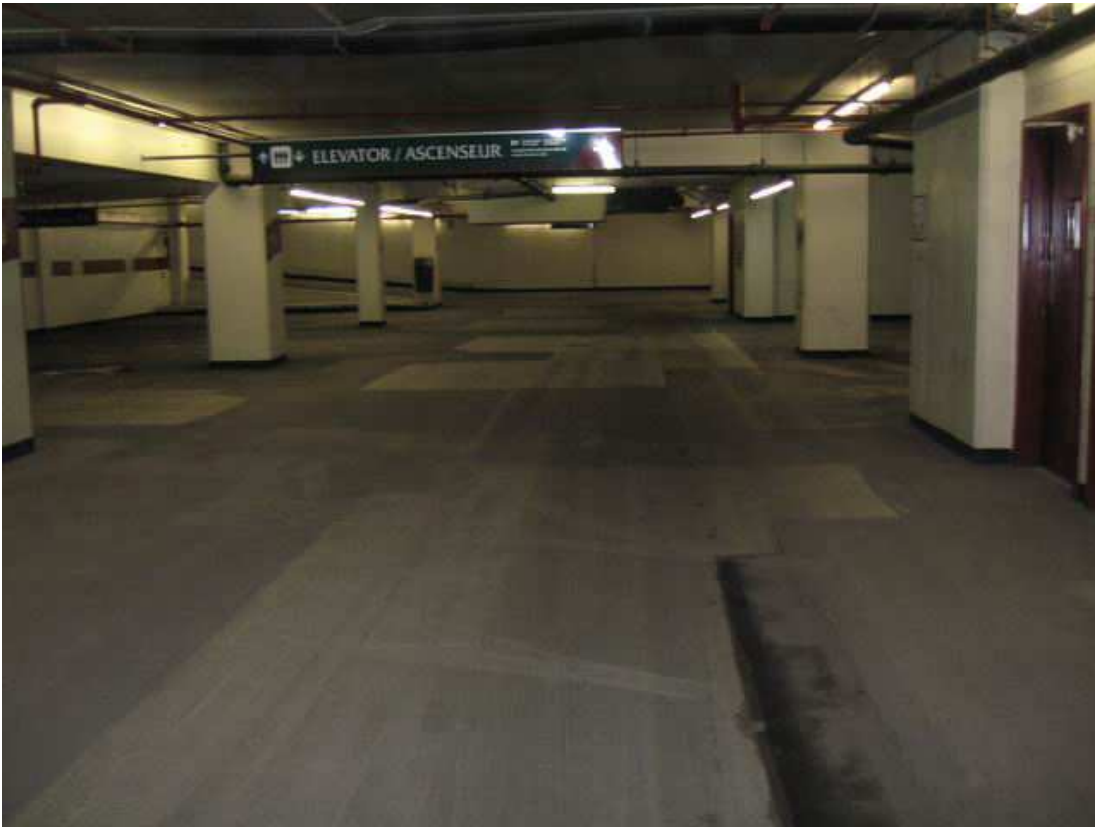
Photograph 7 - Membrane patch repairs

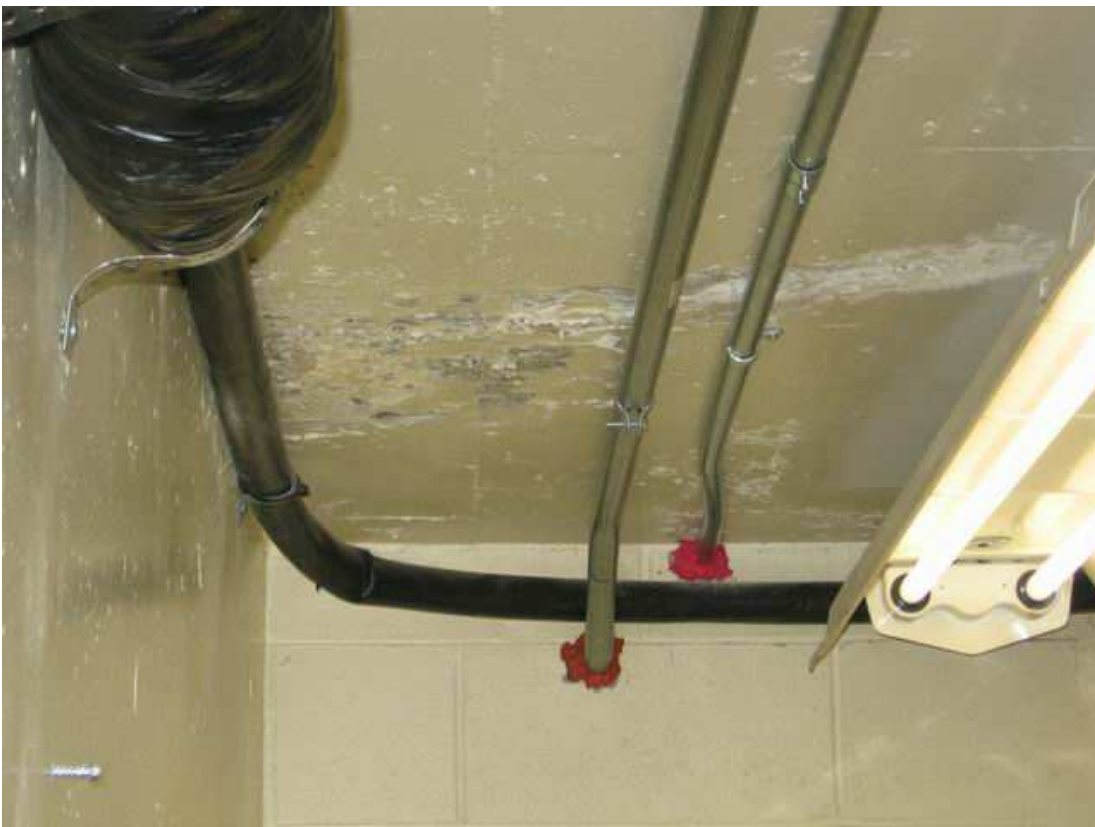
Photograph 8 - Water damage in server room

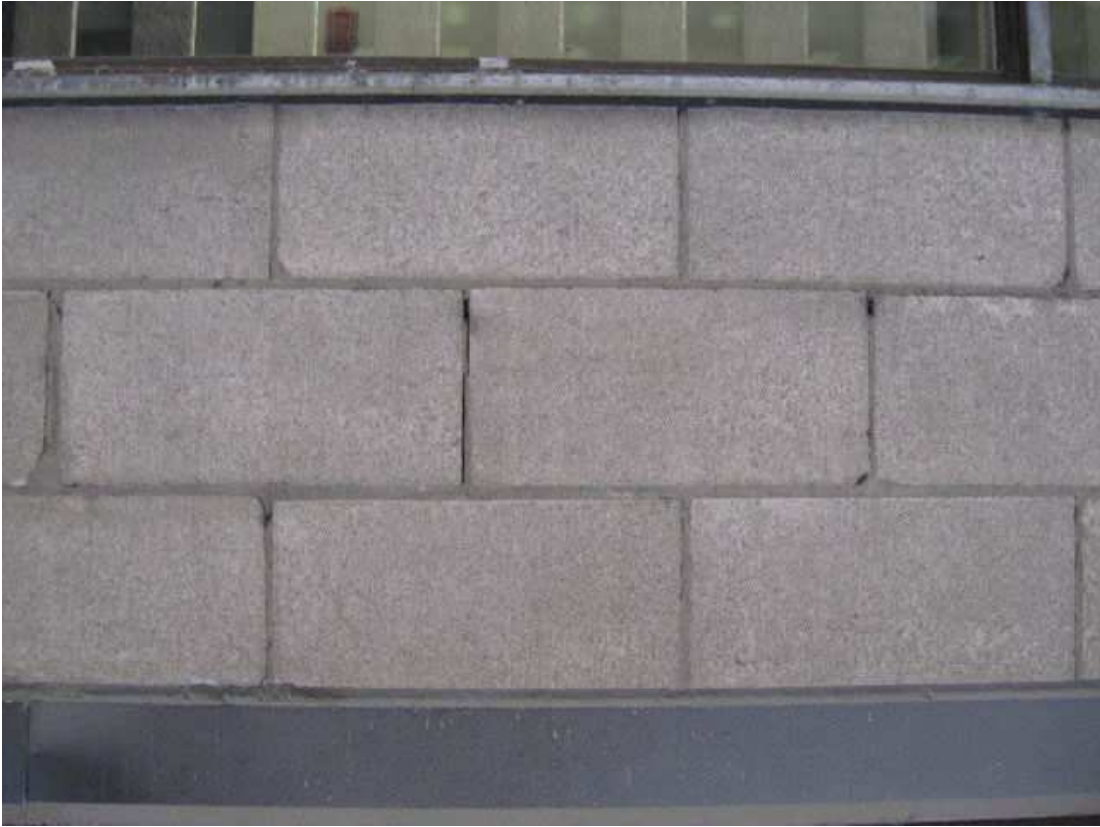
Photograph 9 - Deteriorated mortar at exterior block wall

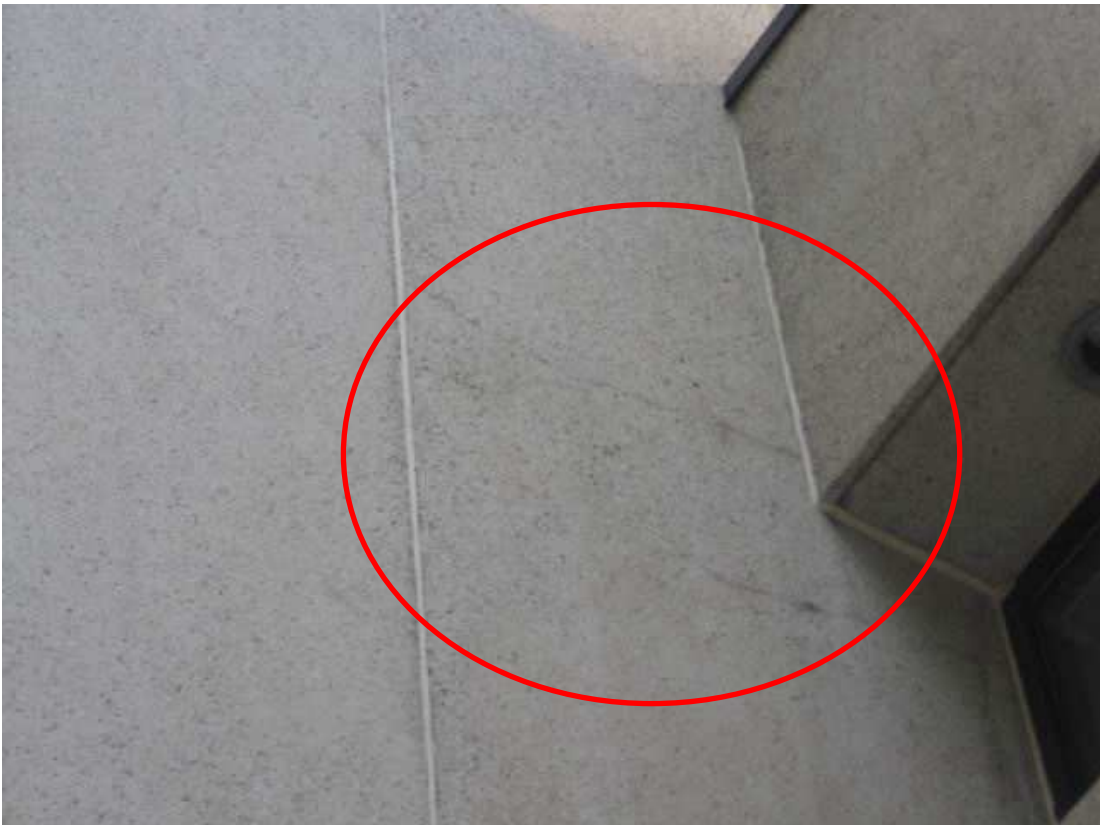
Photograph 10 - Cracking of precast panel

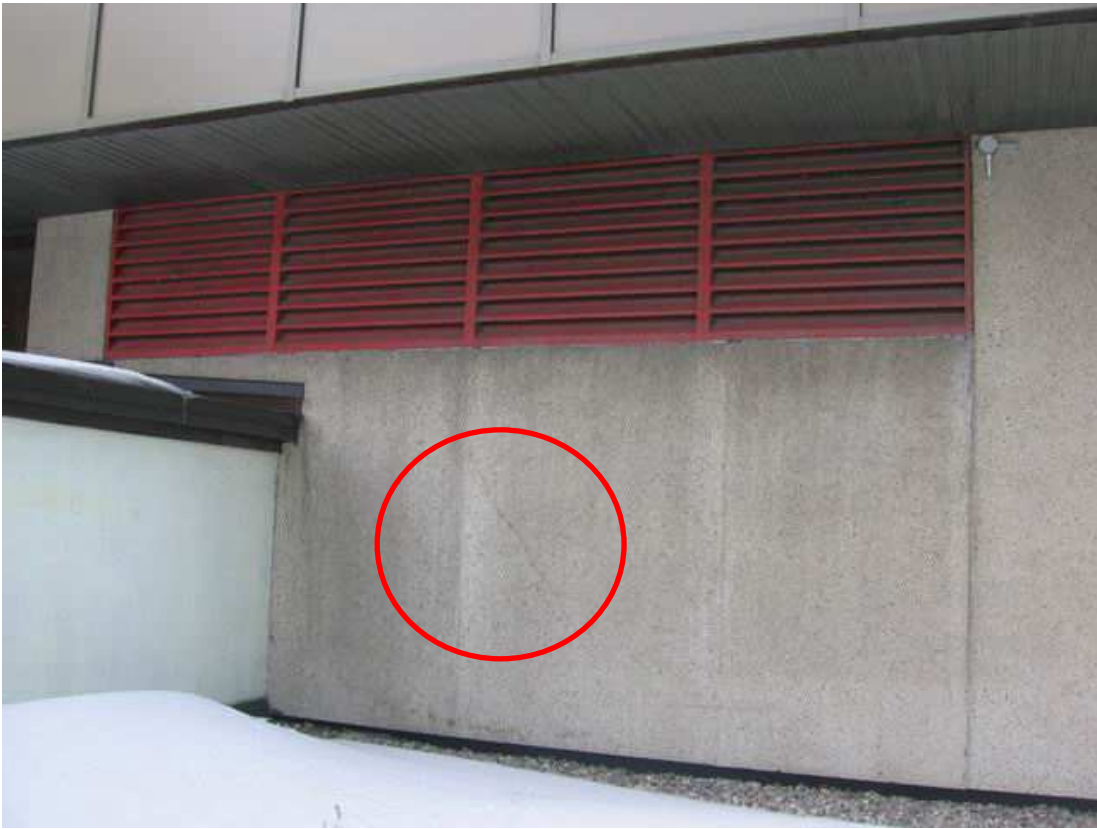
Photograph 11 - Cracking of precast panel

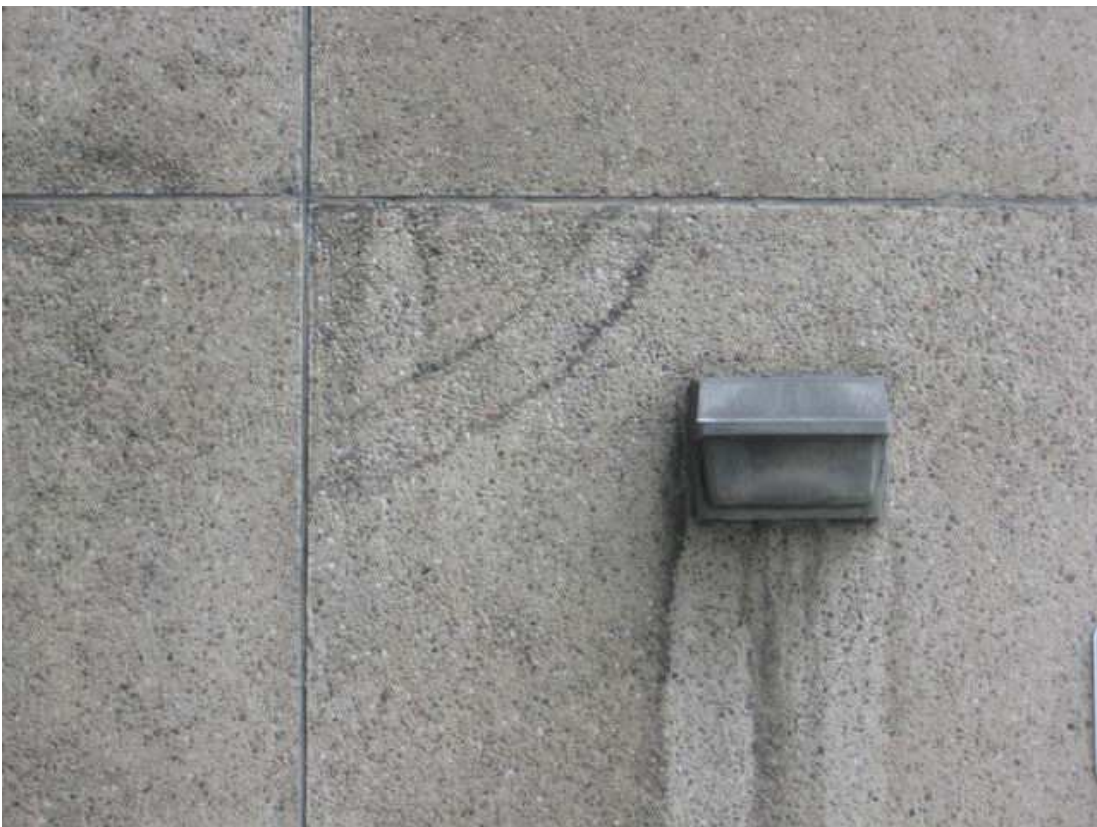
Photograph 12 - Staining of precast panel

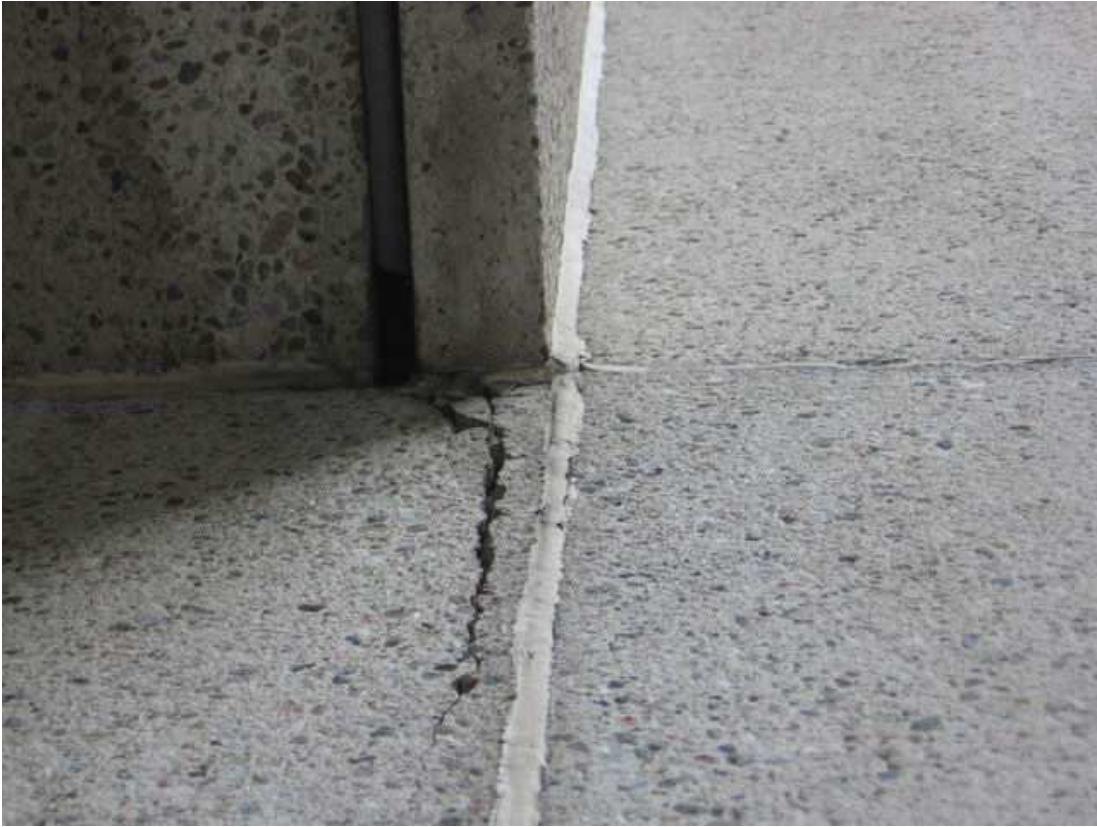
Photograph 13 - Cracked panel at grid line H

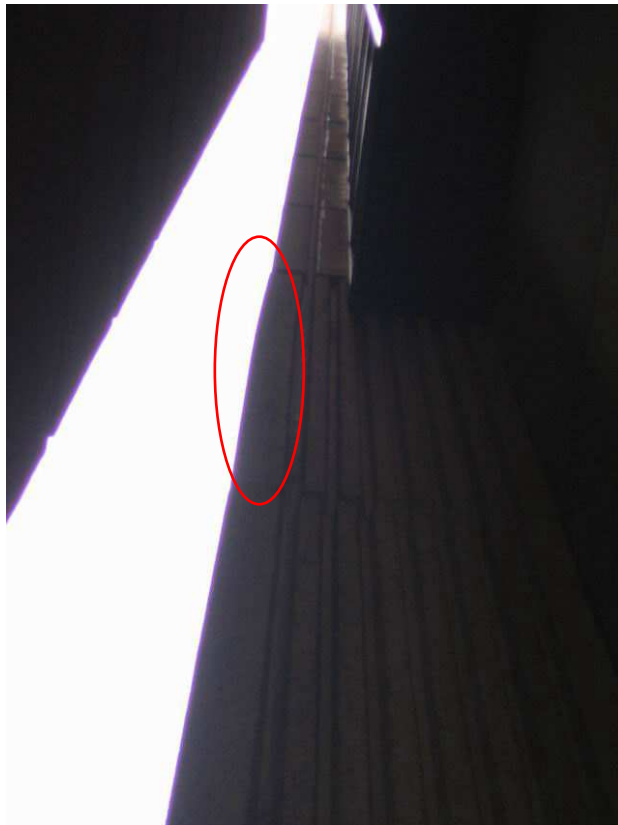
Photograph 14 - Bowed panel

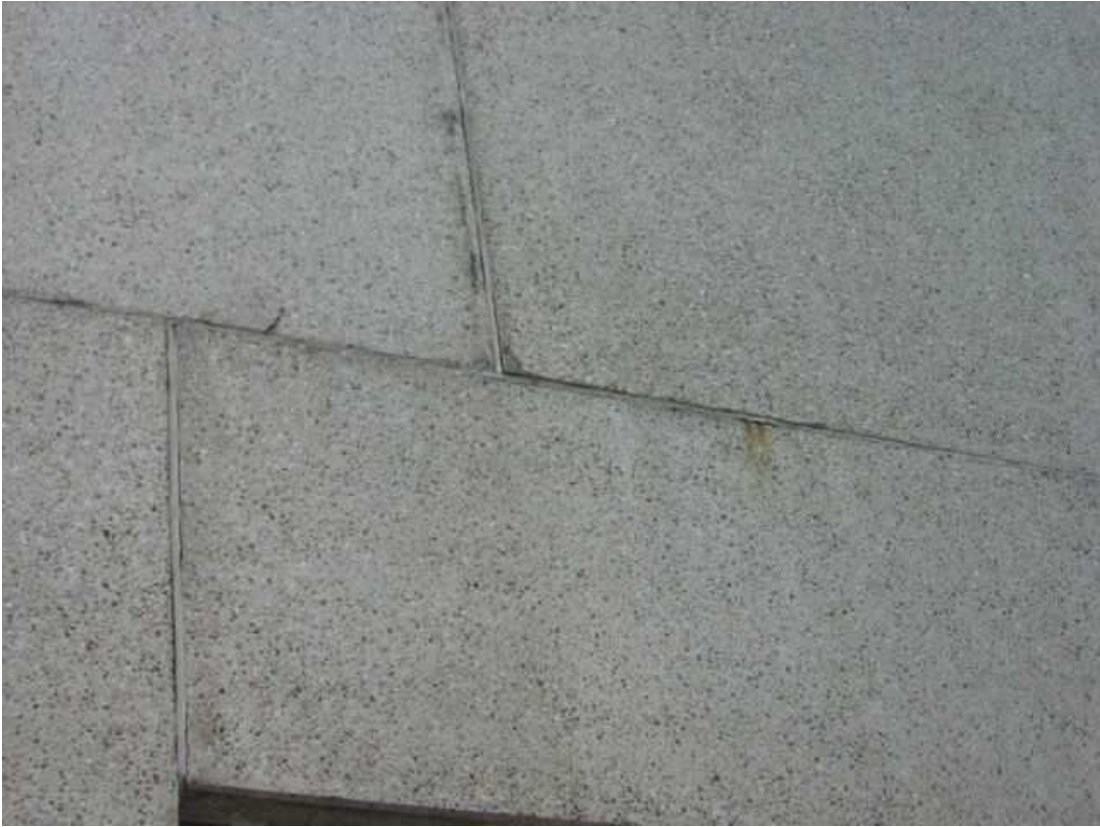
Photograph 15 - Chipped corner and corrosion staining

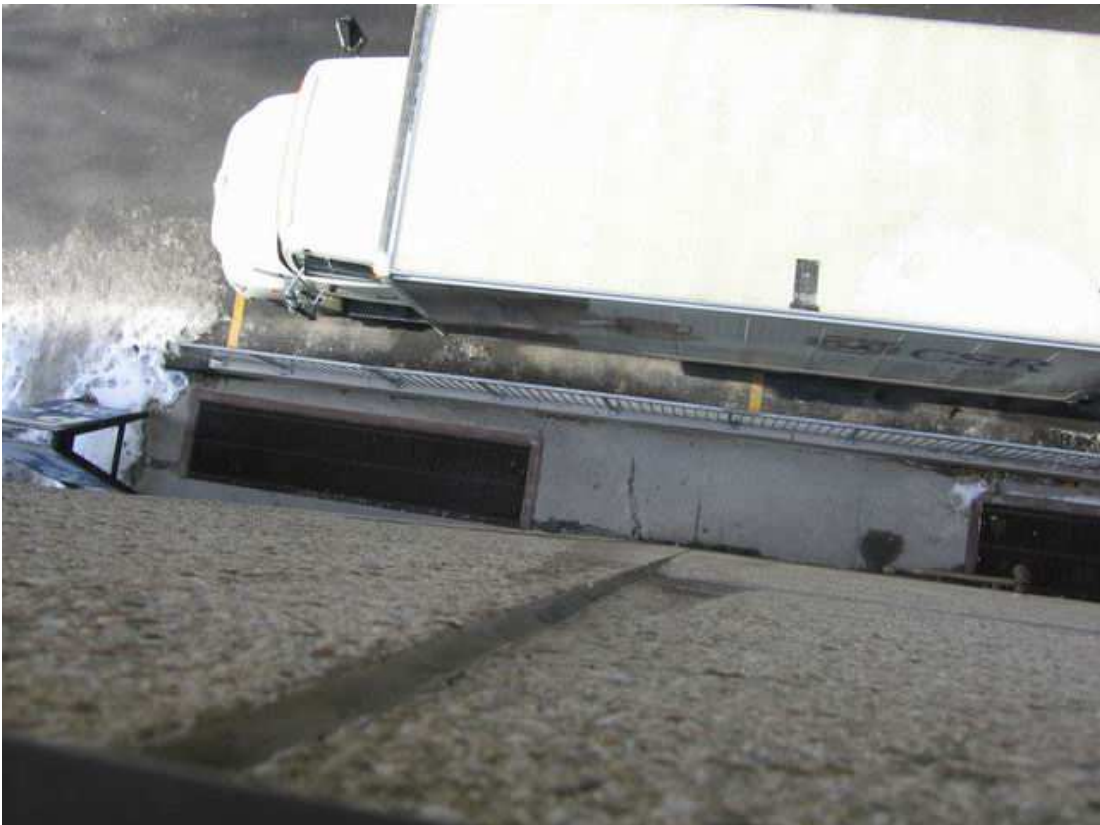
Photograph 16 - Crack in precast panel

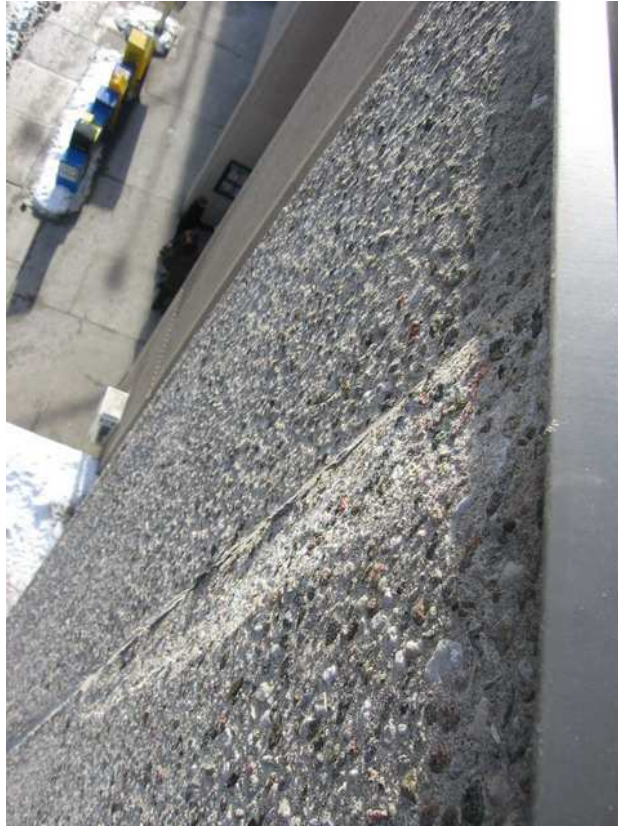
Photograph 17 - Scale on precast panel

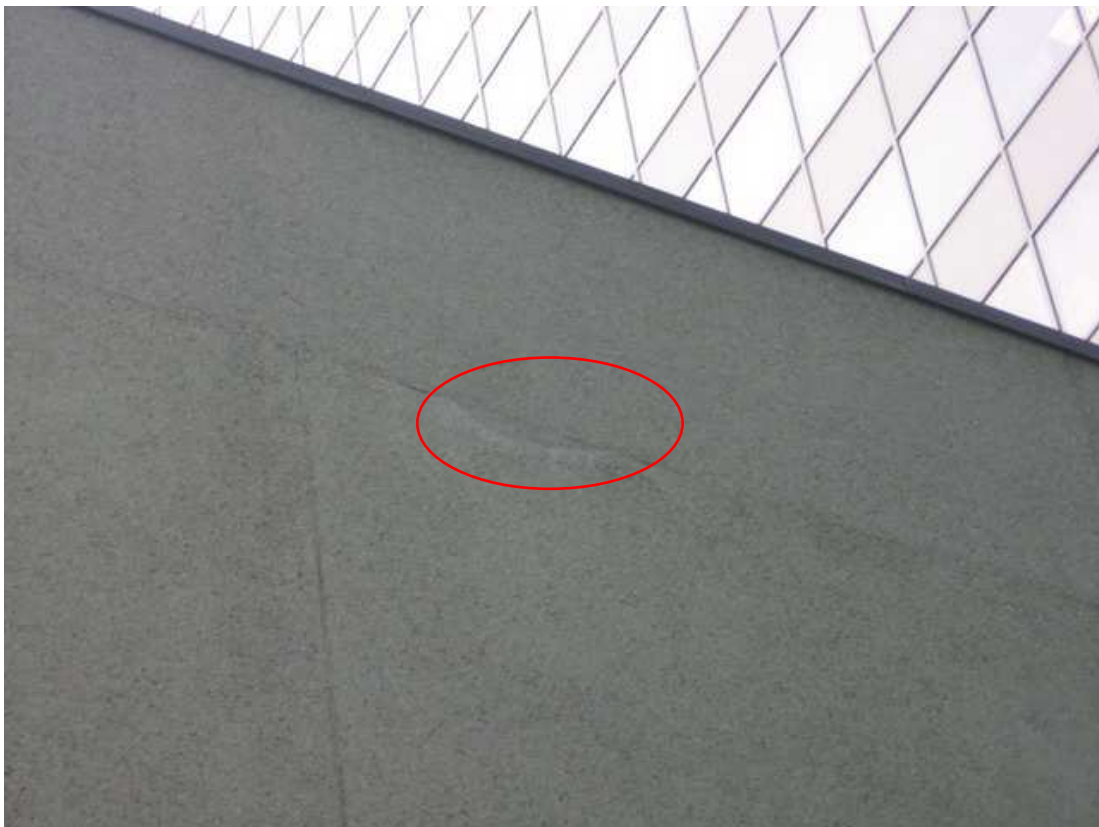
Photograph 18 - Crack in precast panel

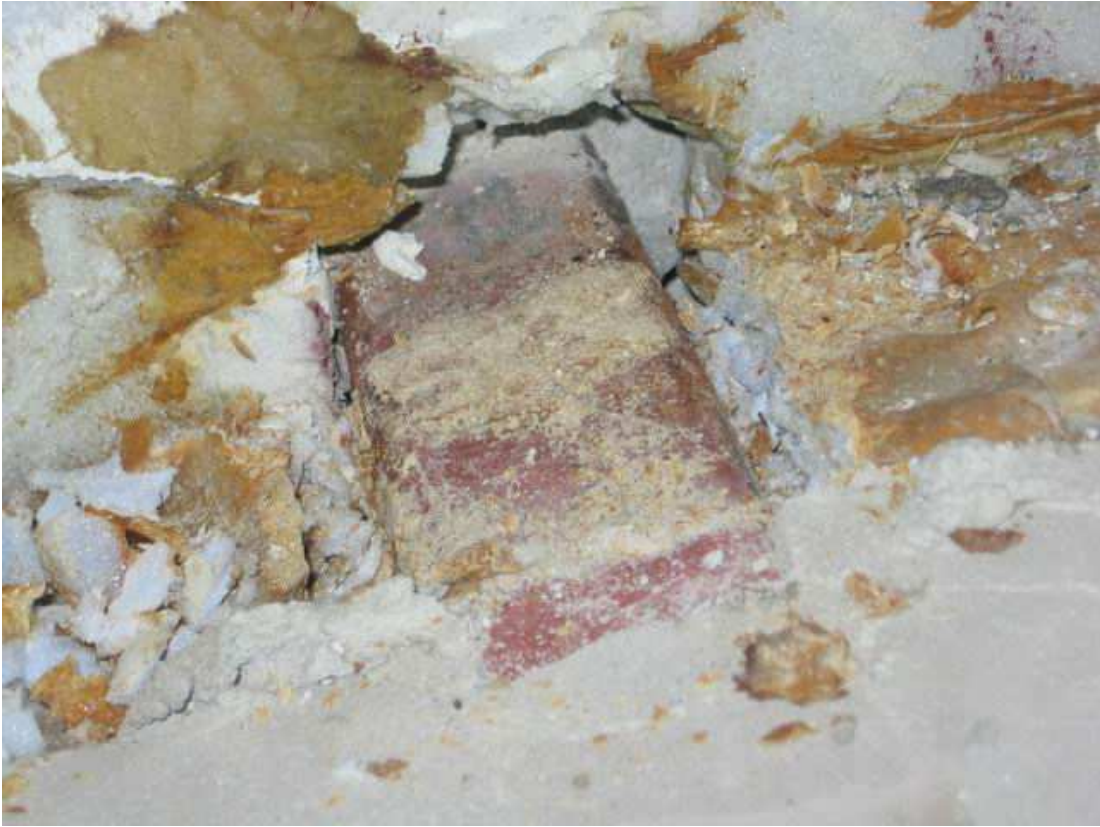
Photograph 19 - Panel connection at floor slab

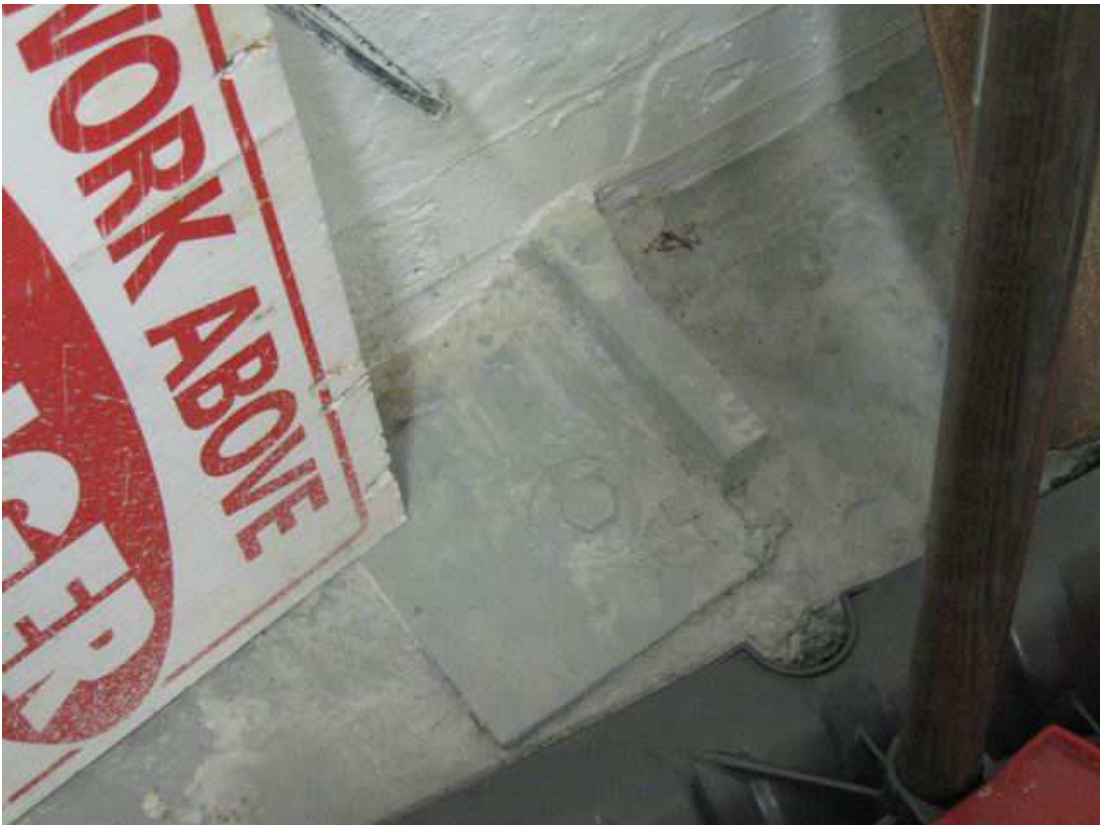
Photograph 20 - Misaligned connection with cast-in plate

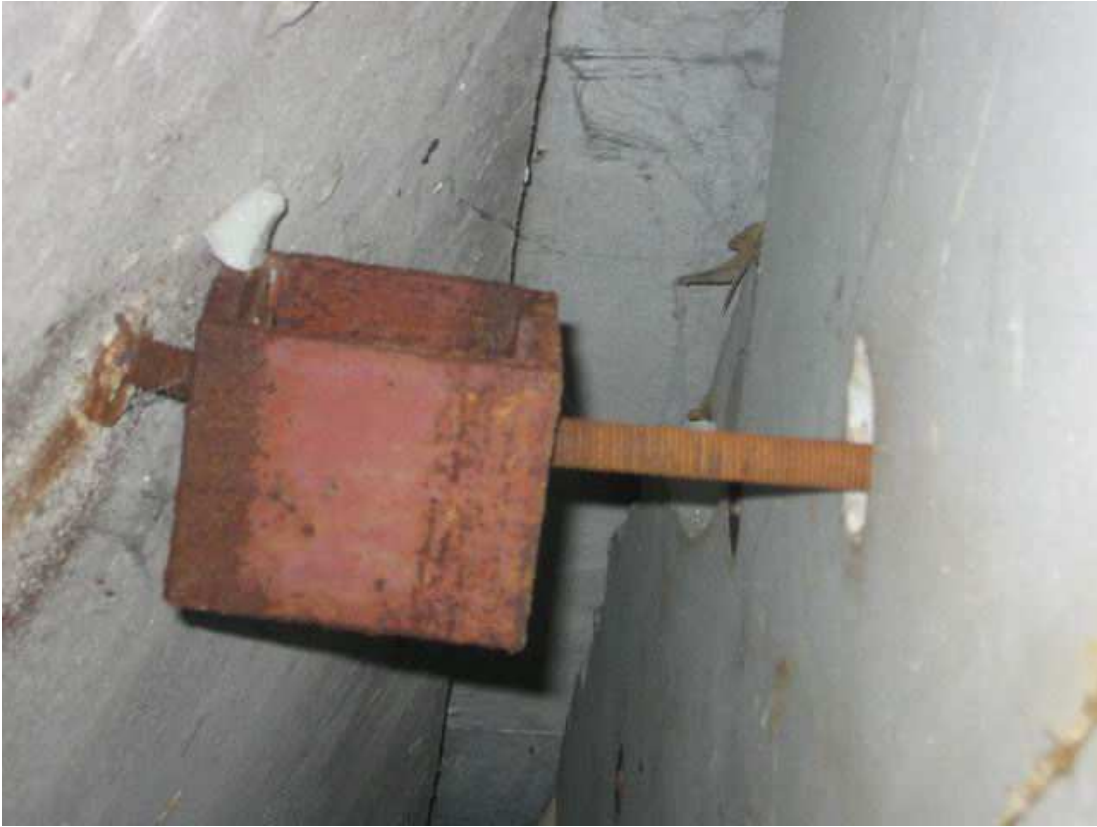
Photograph 21 - Anchor for angled panel

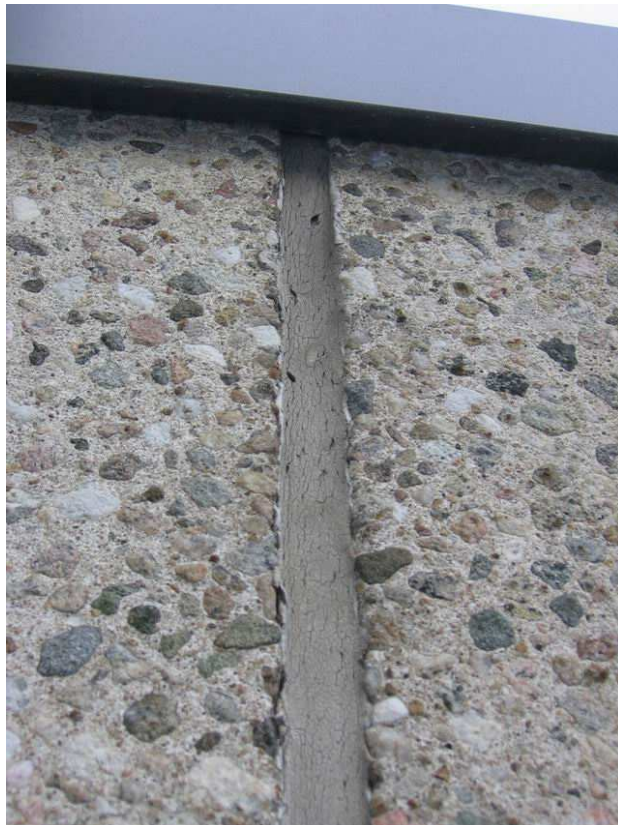
Photograph 22 - Alligator cracking of sealant

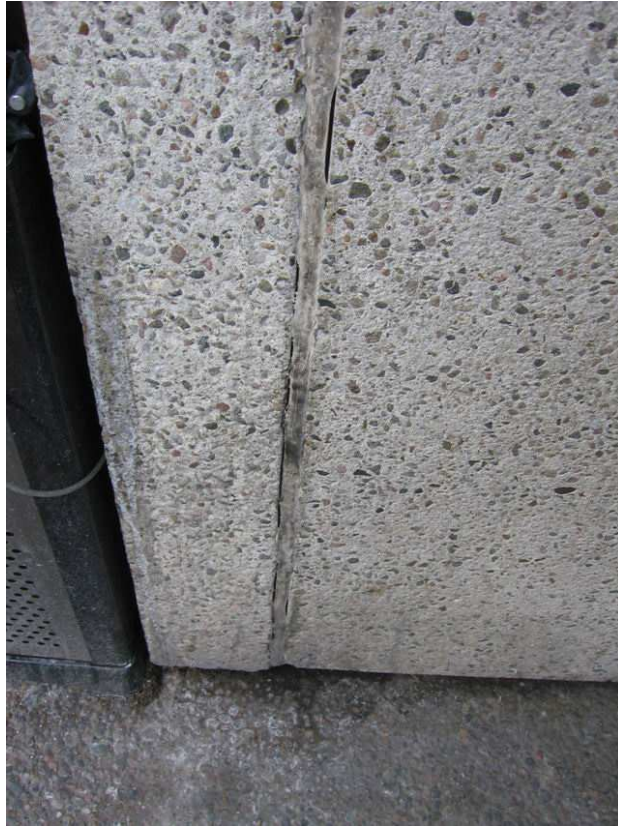
Photograph 23 - Sealant adhesive failure

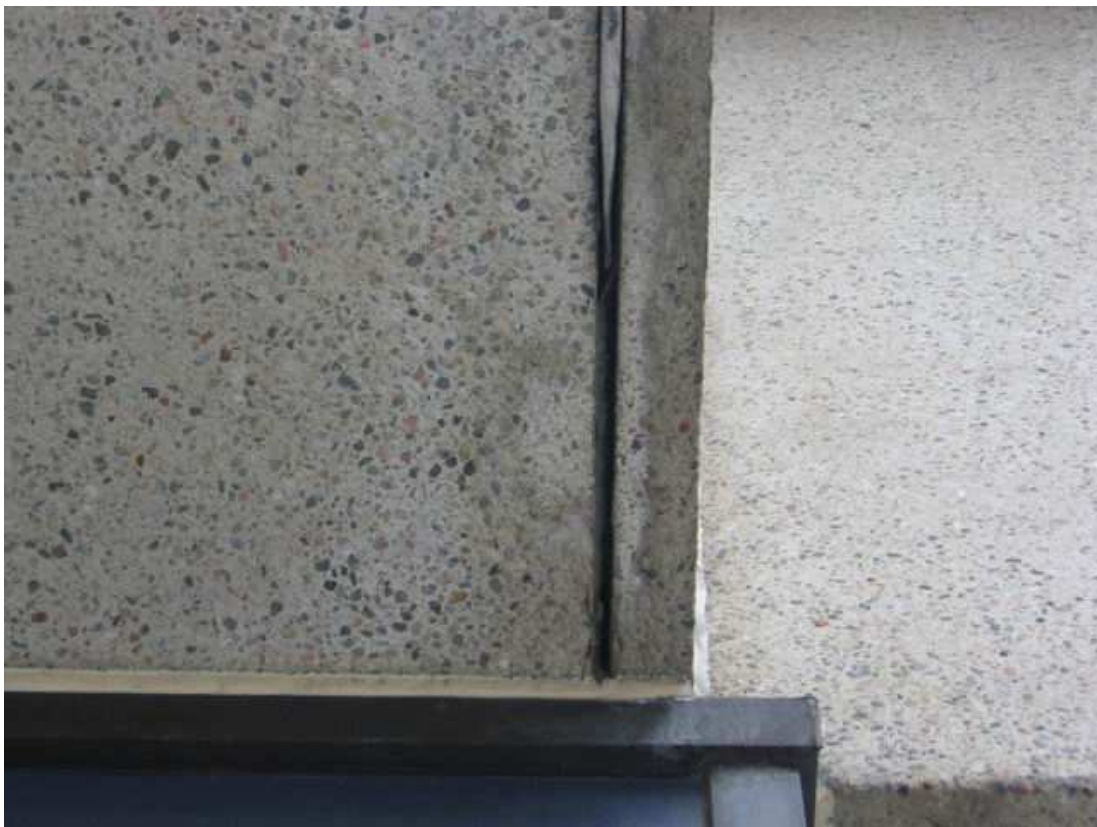
Photograph 24 - Missing sealant at soffit

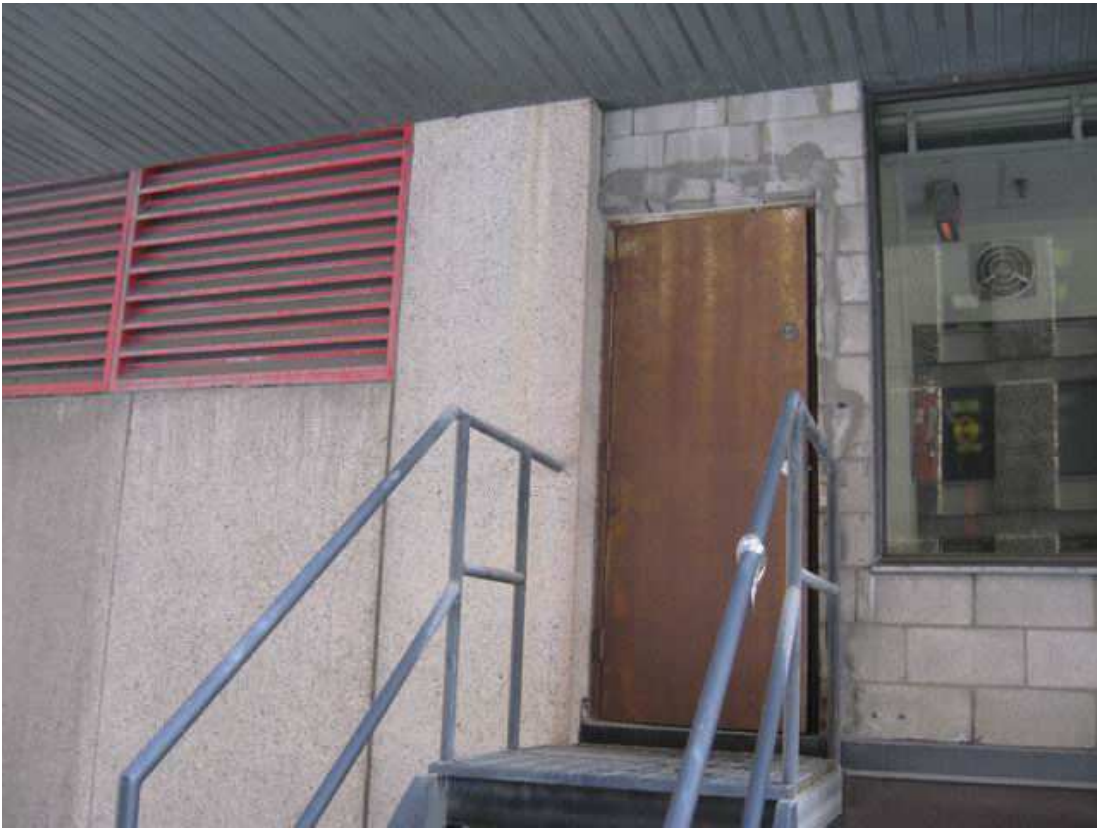
Photograph 25 - Corrosion of roof access door

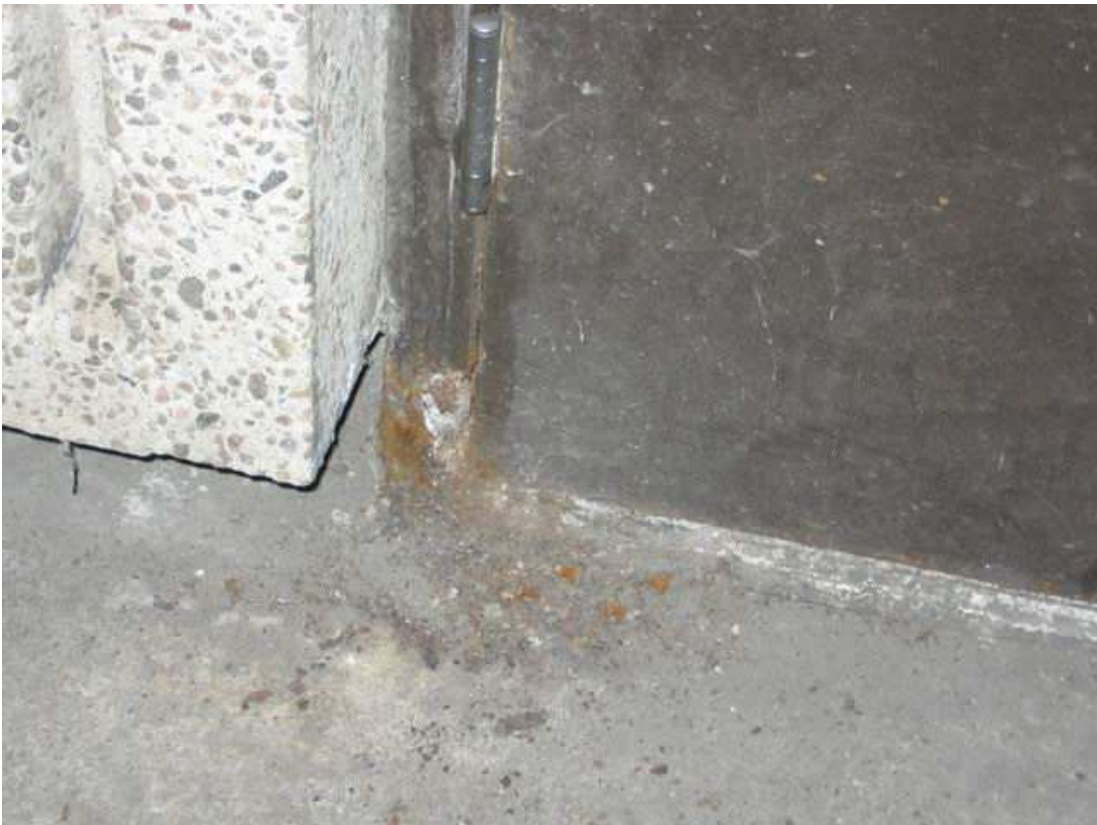
Photograph 26 - Corrosion of exterior door frame

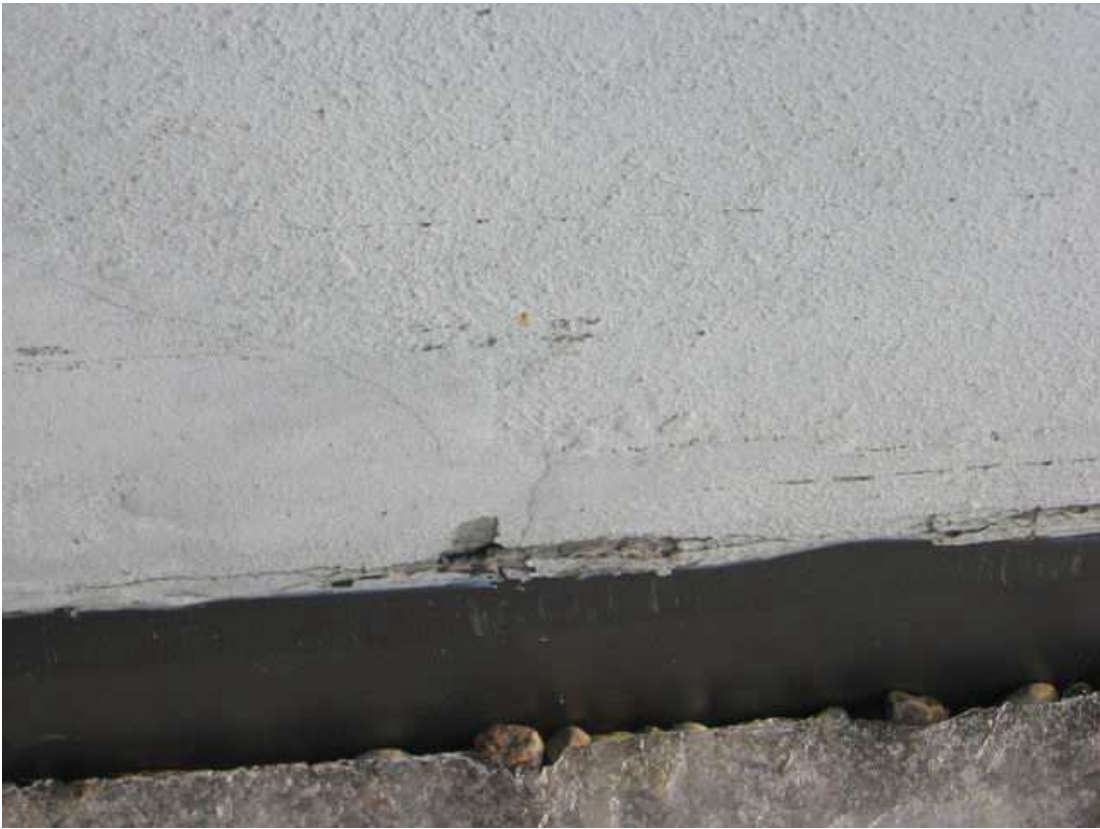
Photograph 27 - Damaged parking at parapet wall
