MORRISON HERSHFIELD

BUILDING CONDITION AUDIT and STRUCTURAL
ASSESSMENT

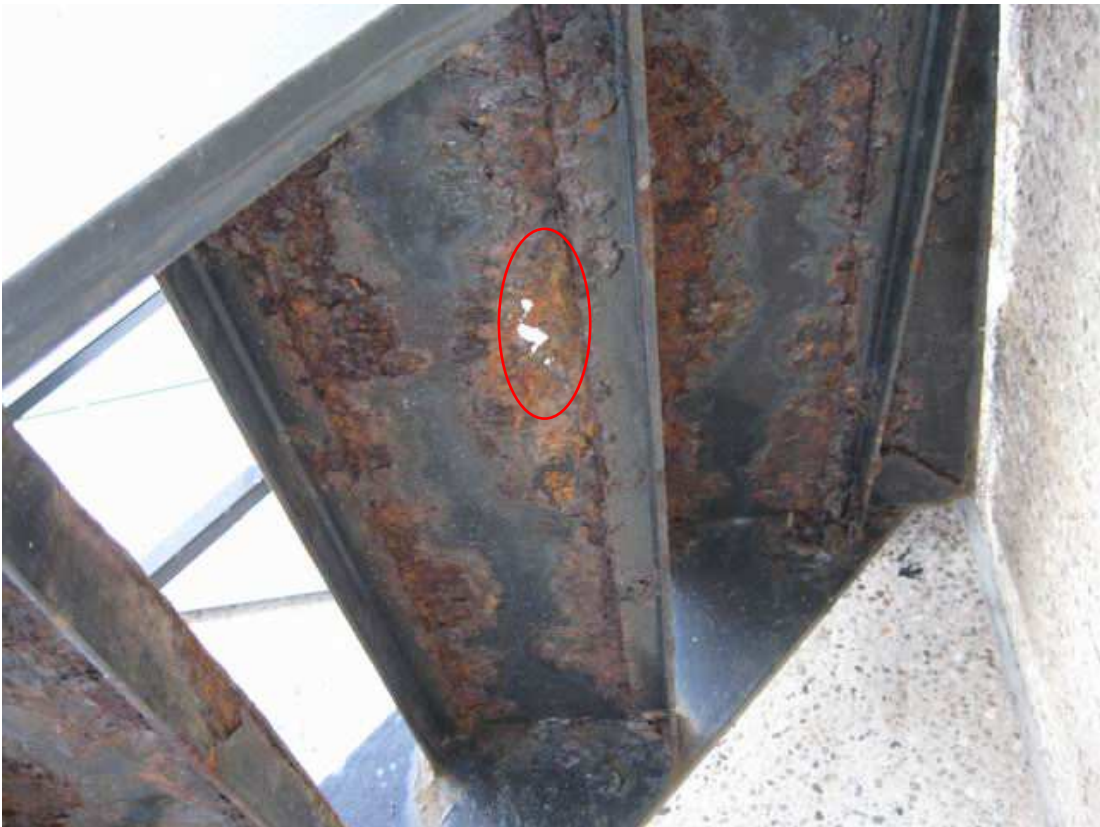
Photograph 28 - Corroded stairs

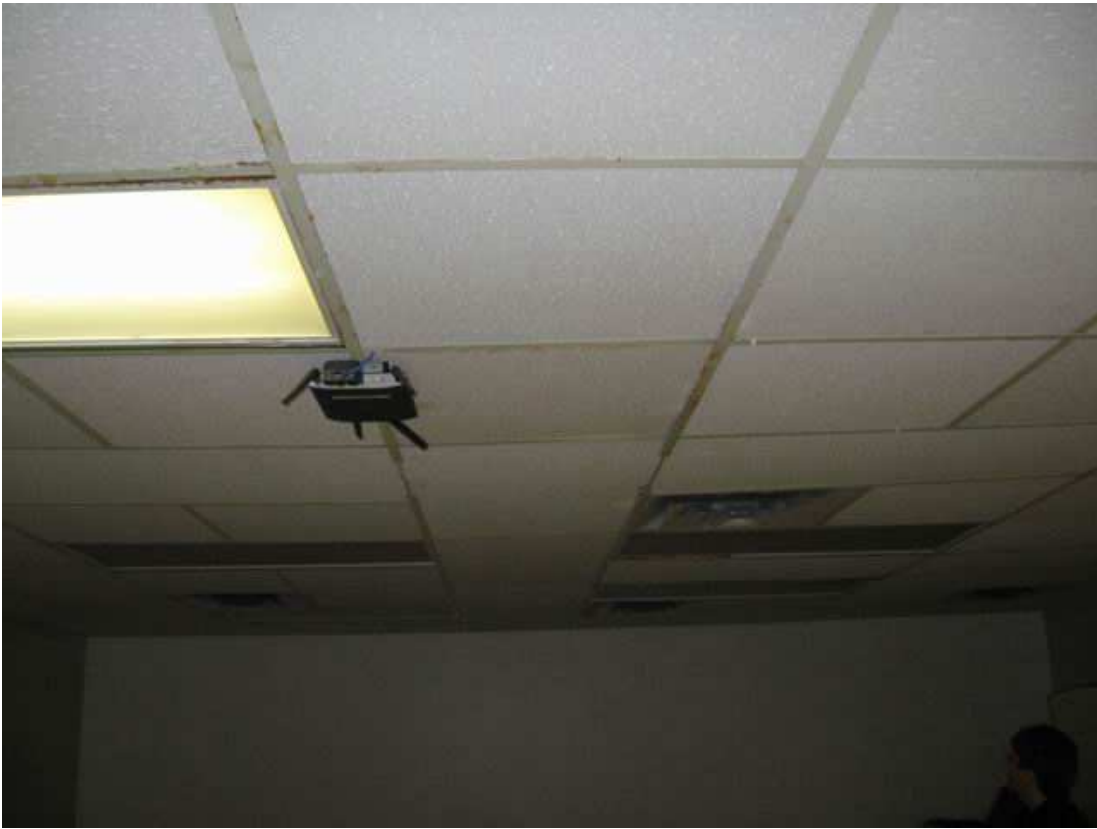
Photograph 29 - Corrosion staining of T-bar grid

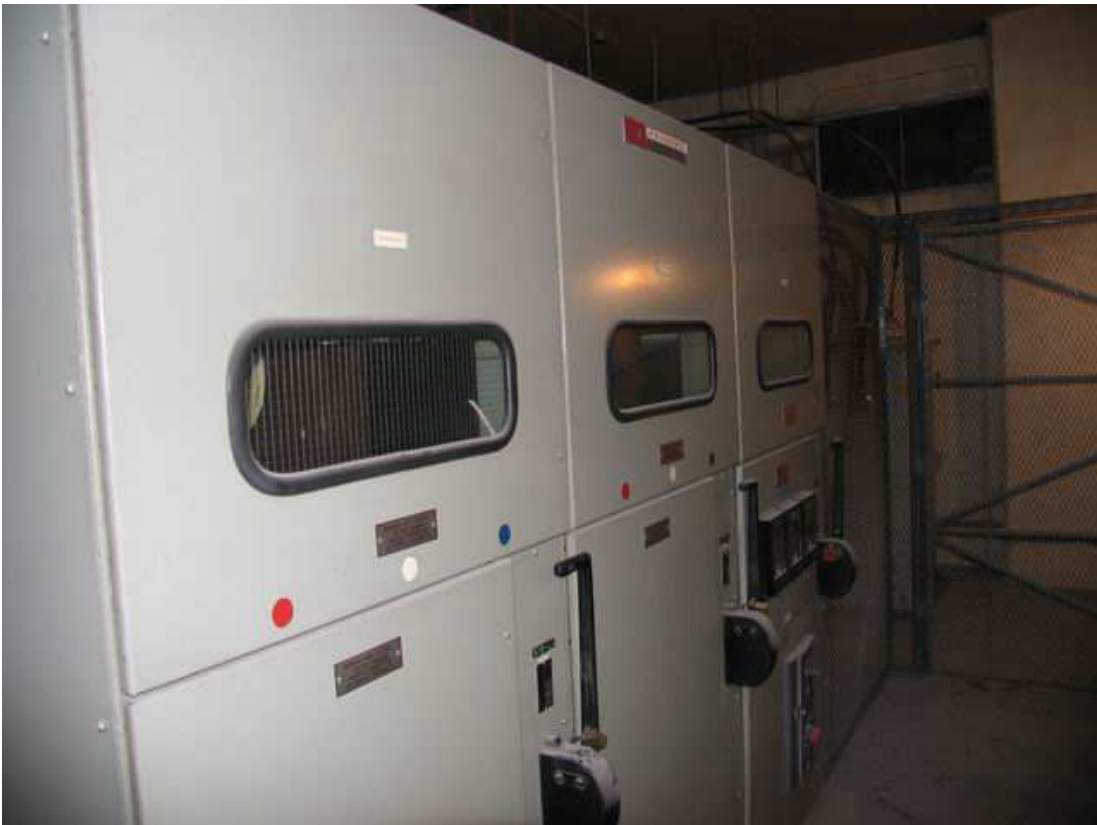
Photograph 30 - 15 kV switchboard in Hydro Vault

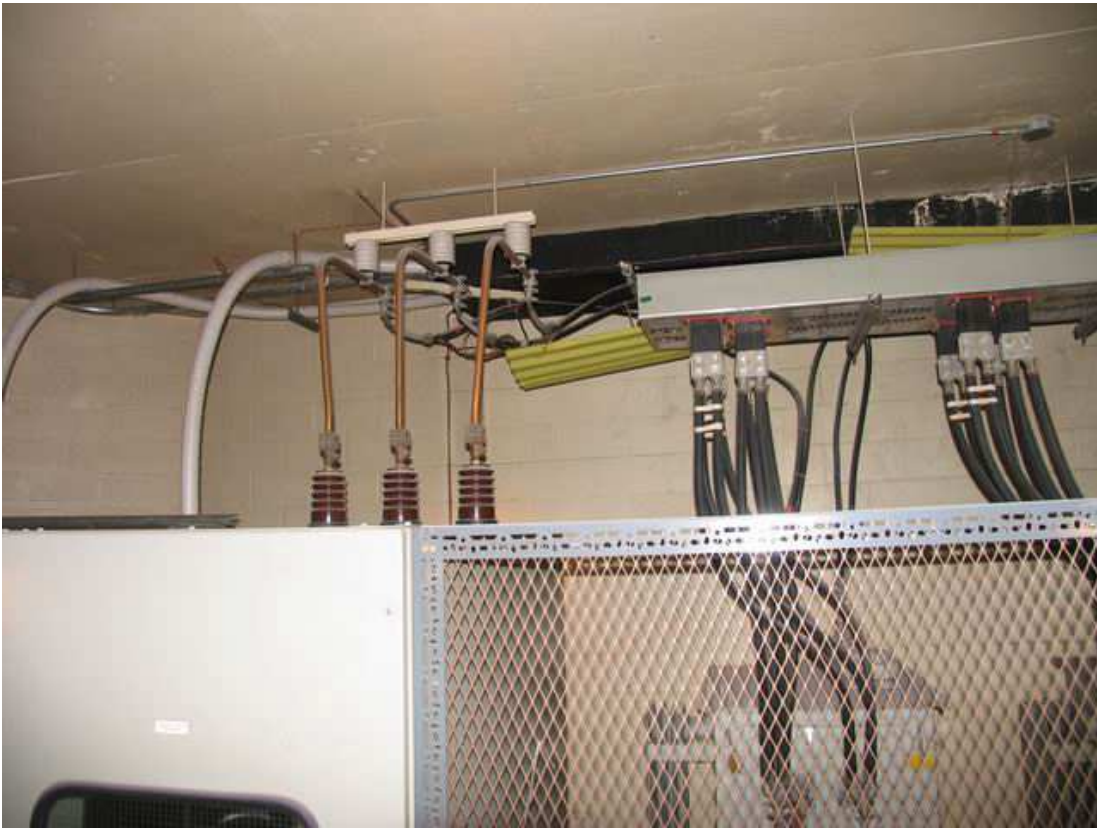
Photograph 31 - IPS bus and bus duct

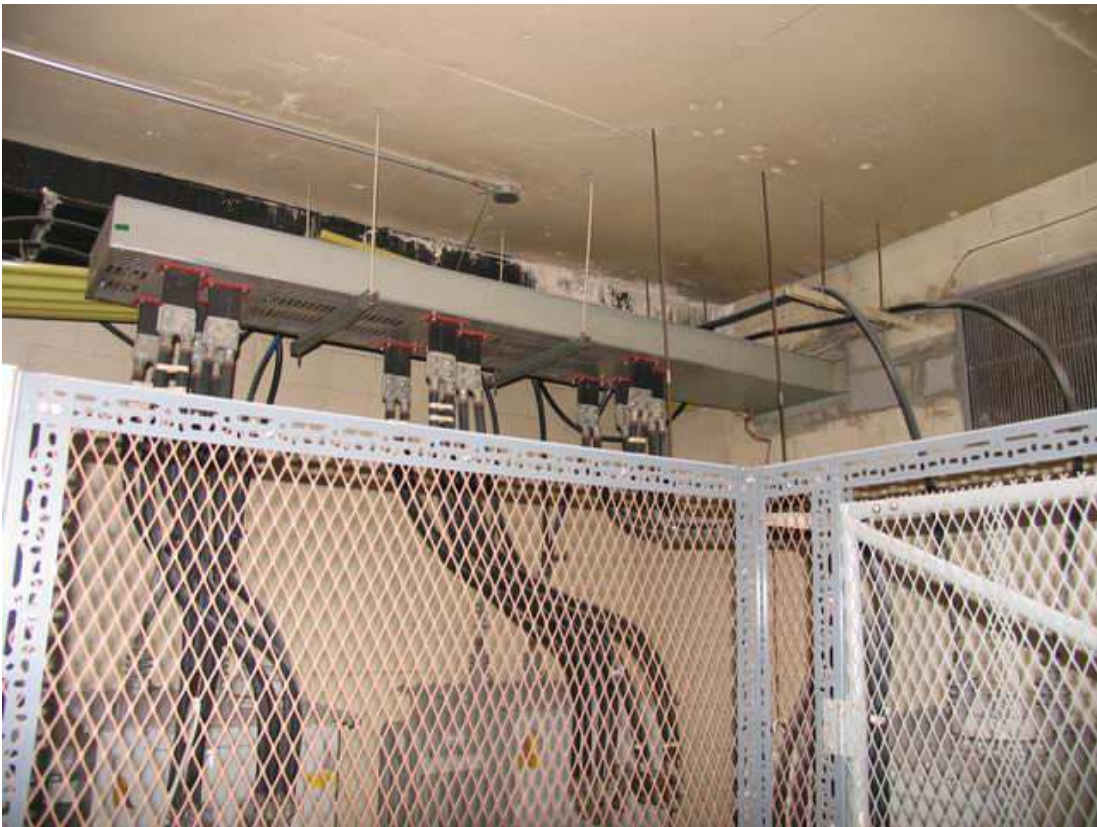
Photograph 32 - Bus duct and drip shields

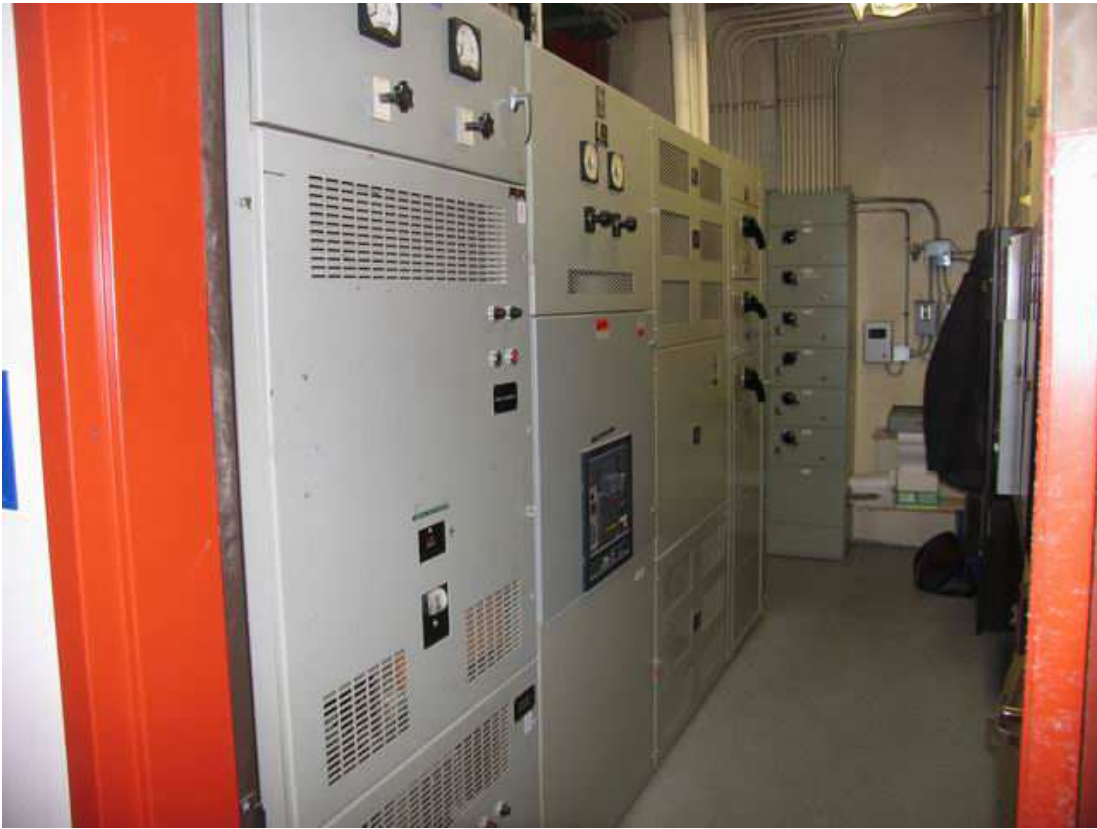
Photograph 33 - Main switchboard

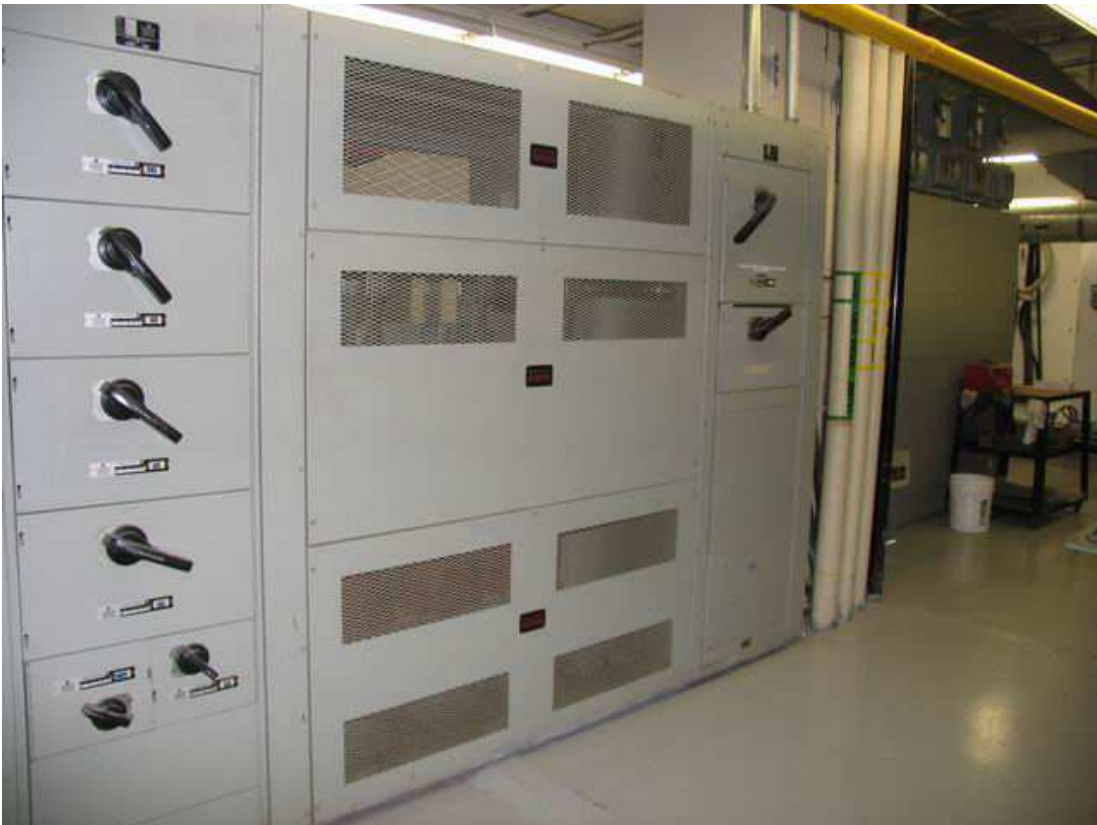
Photograph 34 - Penthouse Mechanical room switchboard

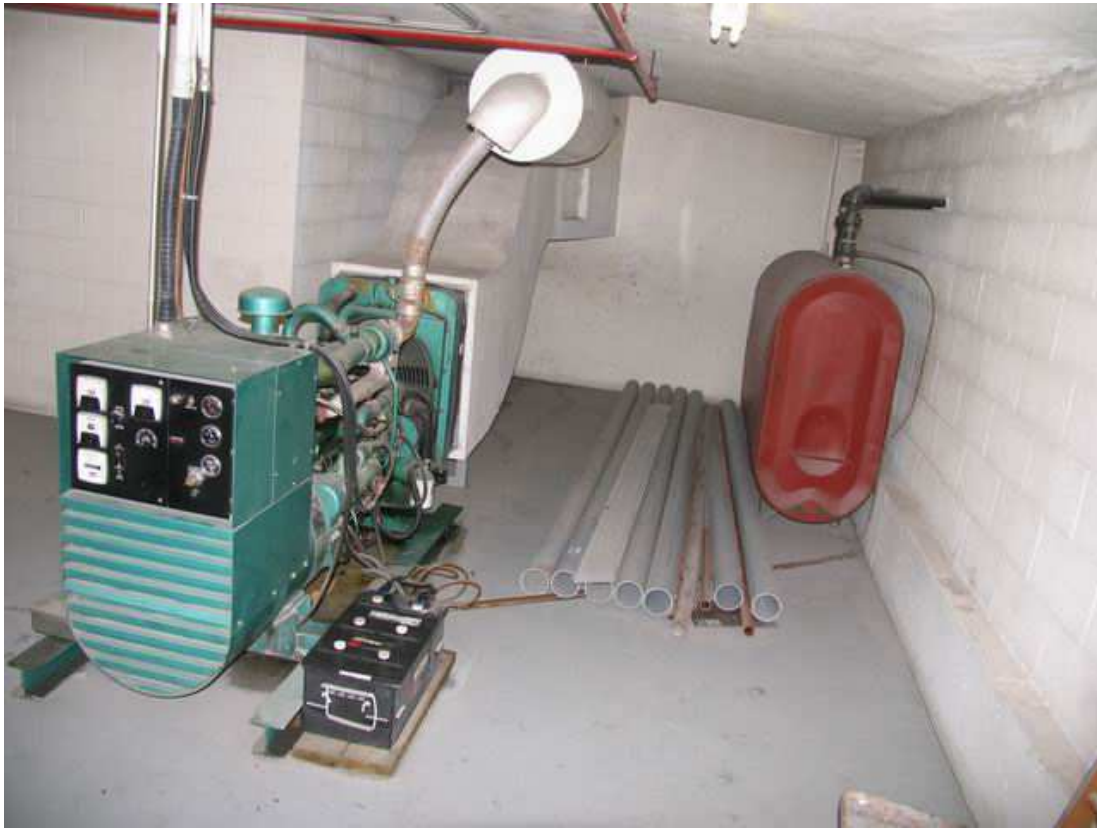
Photograph 35 - Diesel generator

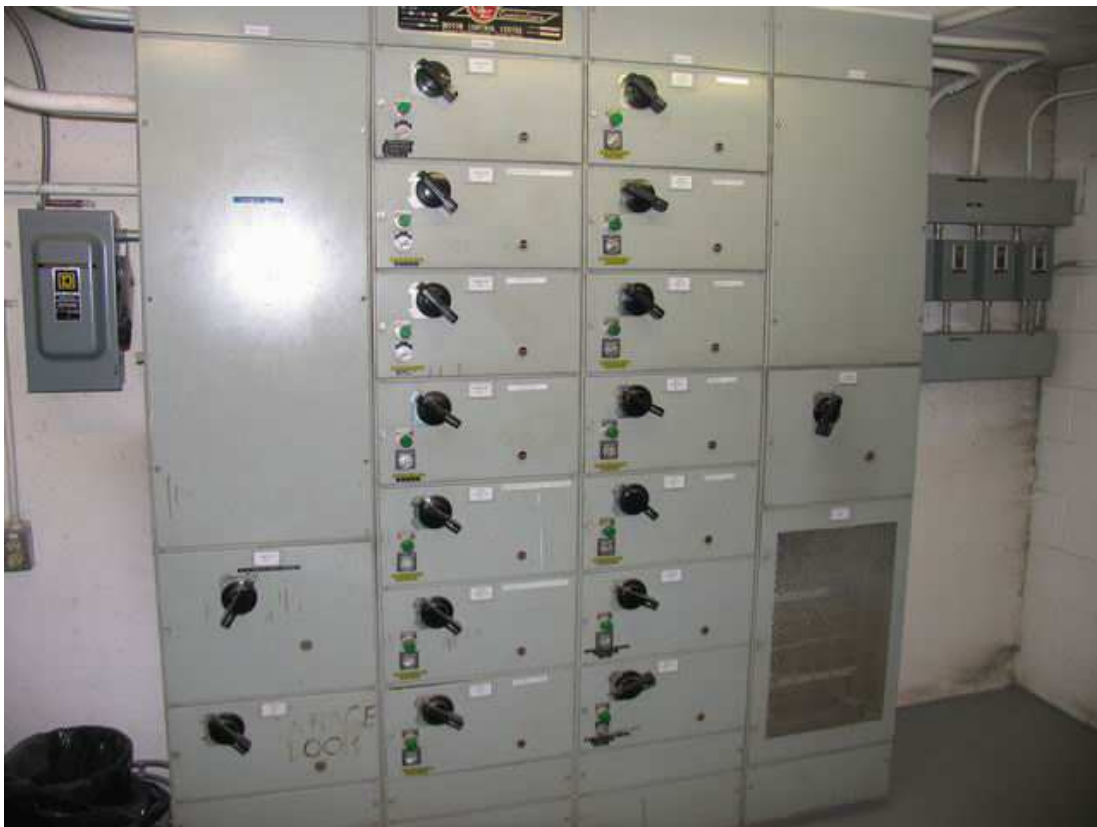
Photograph 36 - MCC#2

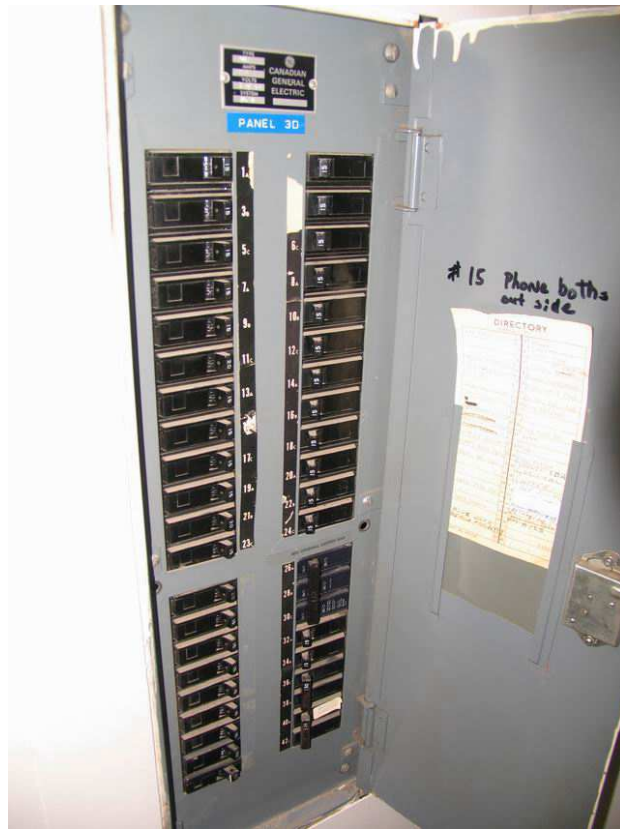
Photograph 37 - Typical panelboard

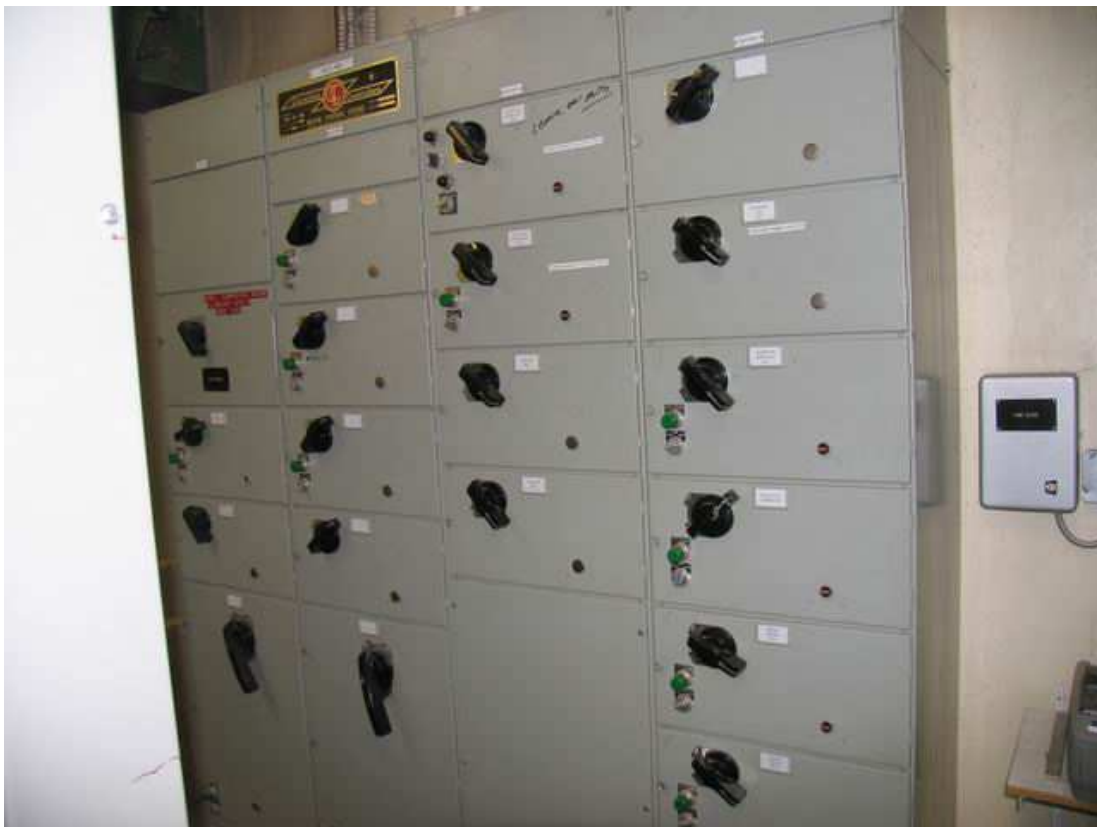
Photograph 38 - MCC#2

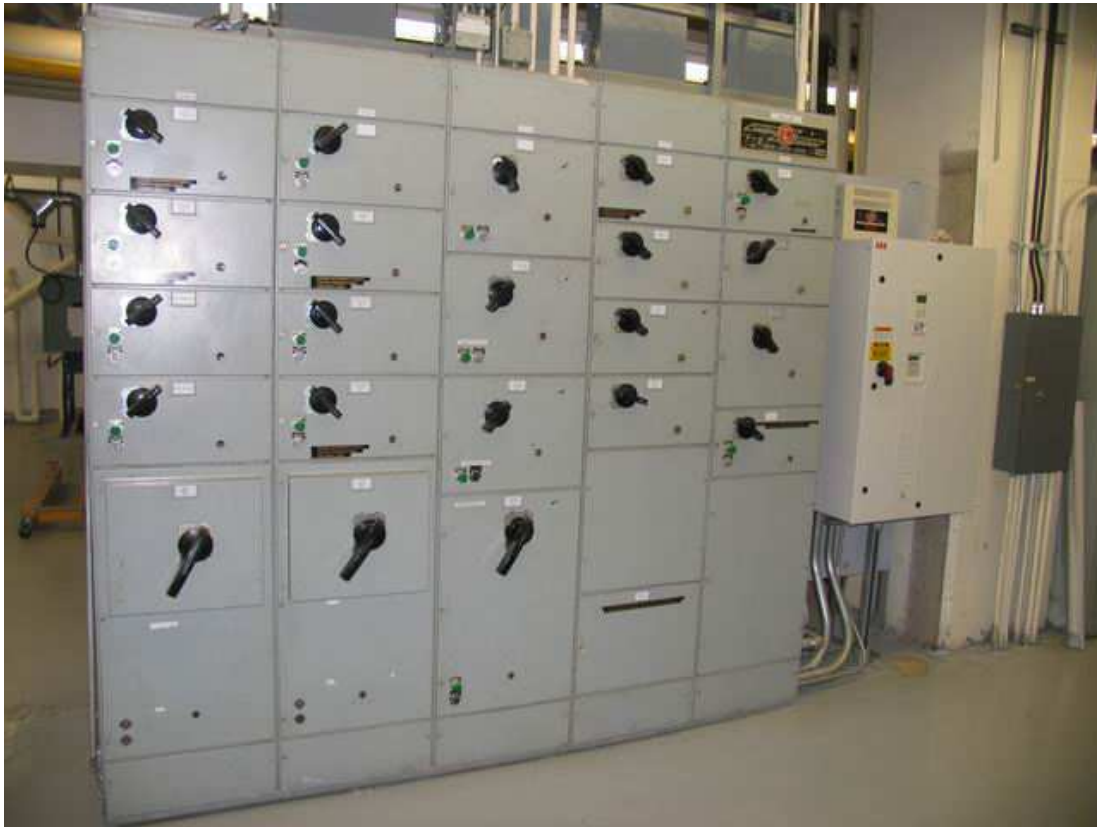
Photograph 39 - MCC#3

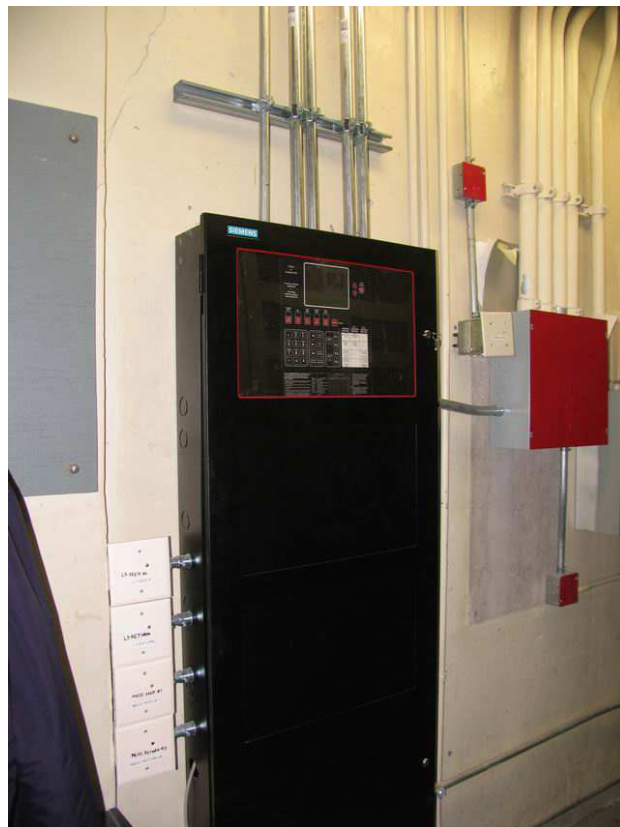
Photograph 40 - Main fire alarm panel

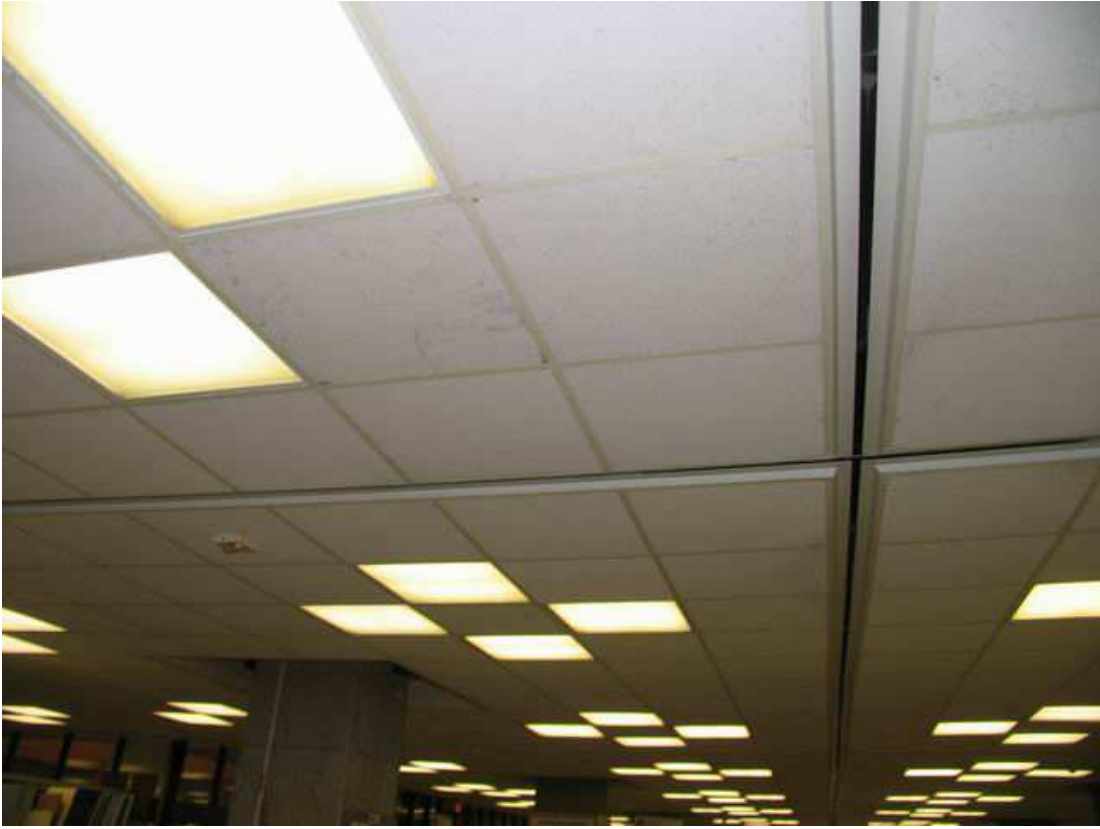
Photograph 41 - Lay-in fluorescent fixtures

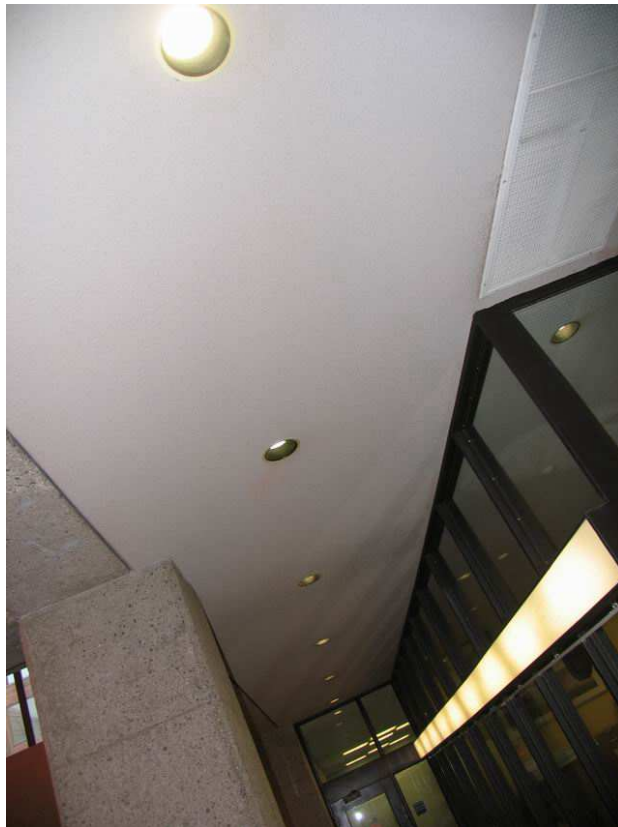
Photograph 42 - Pot lights

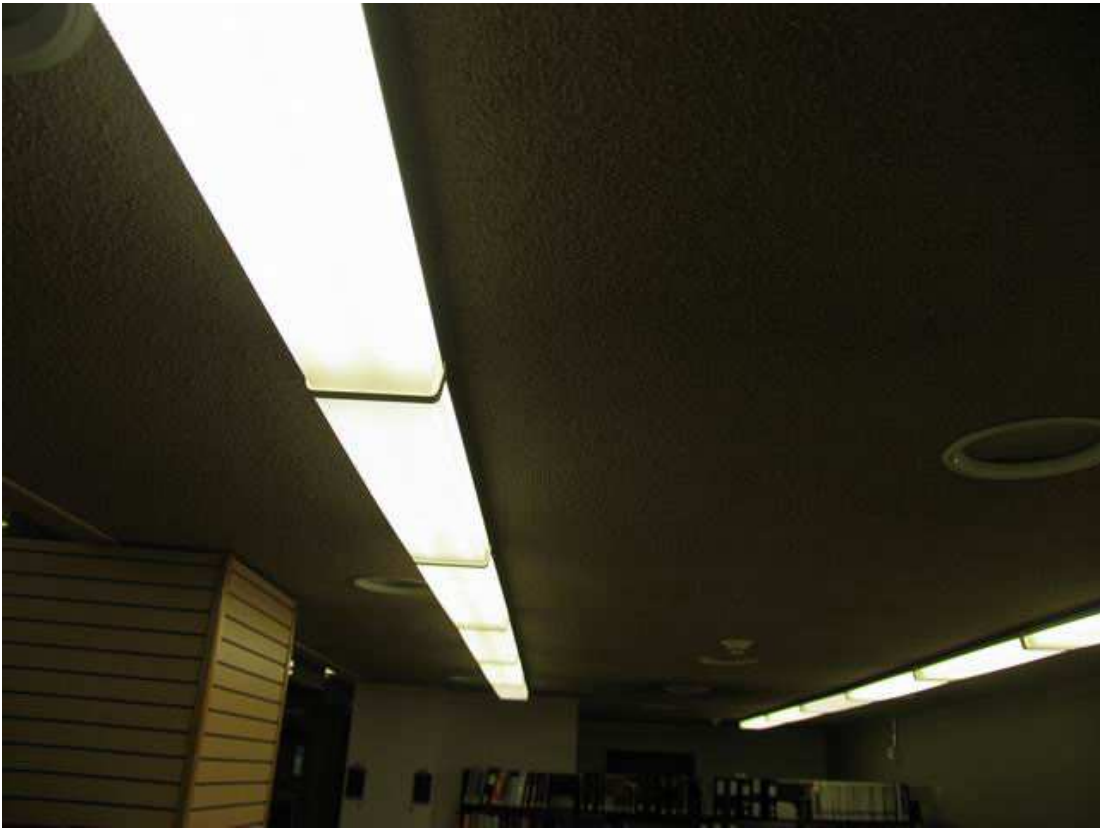
Photograph 43 - Surface mounted wrap around lens fixtures

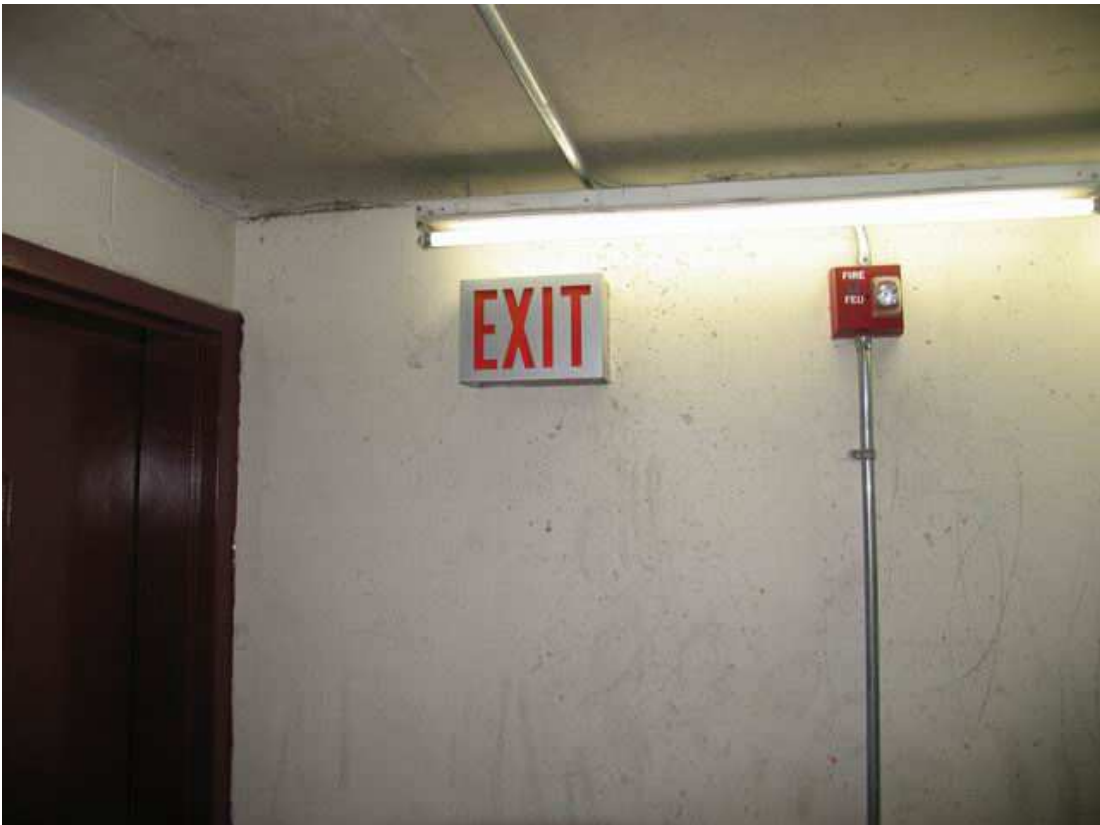
Photograph 44 - Typical exit sign

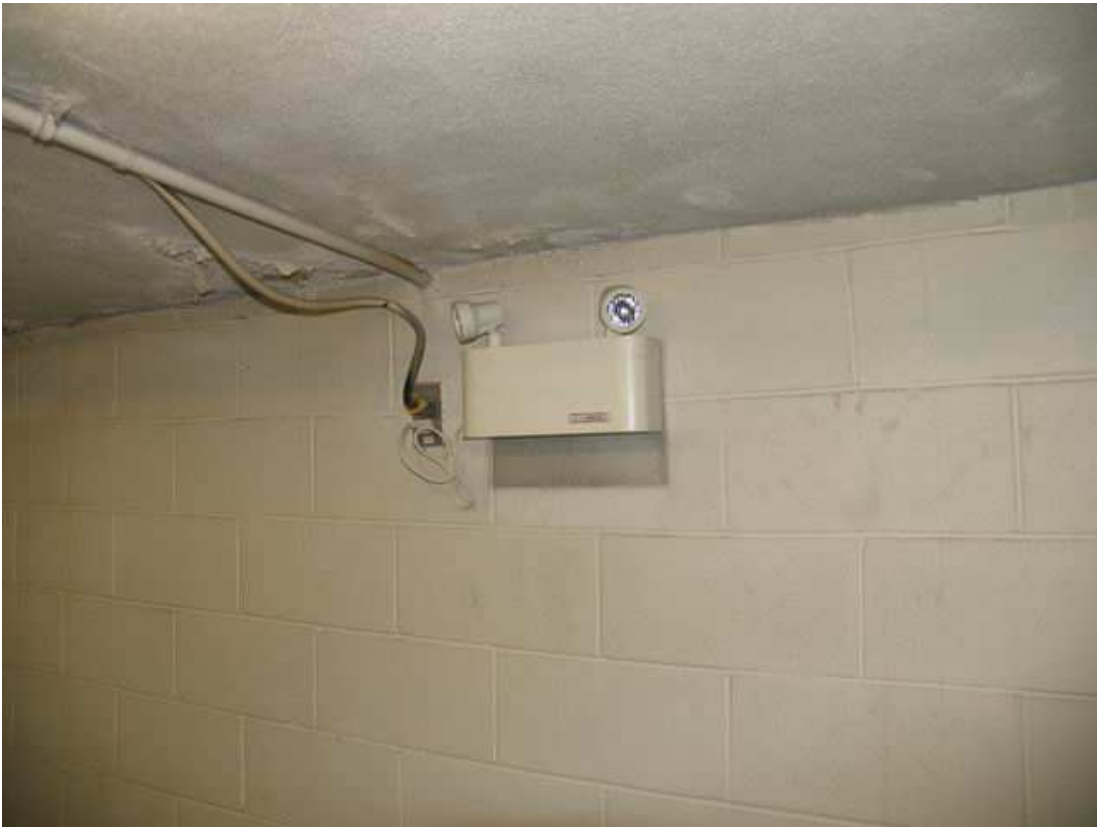
Photograph 45 - Emergency battery unit

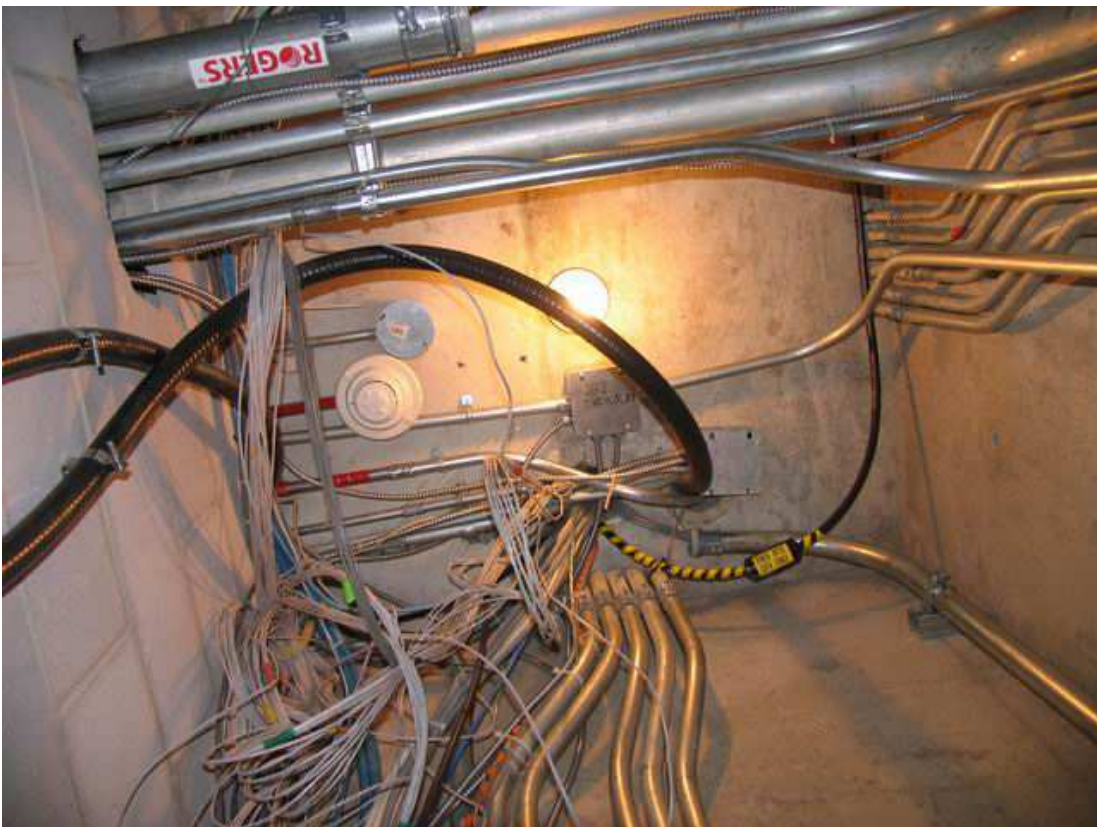
Photograph 46 - Typical data conductor installation

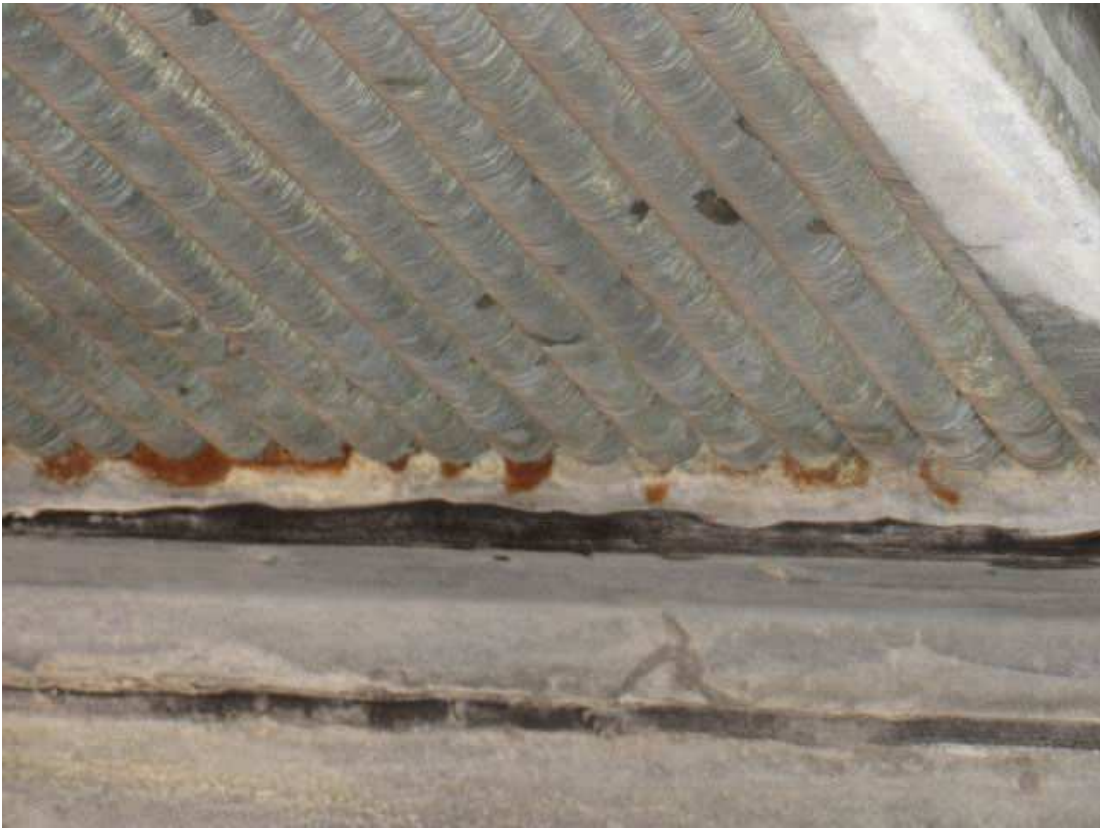
Photograph 47 - Tube end corrosion on cooling coil

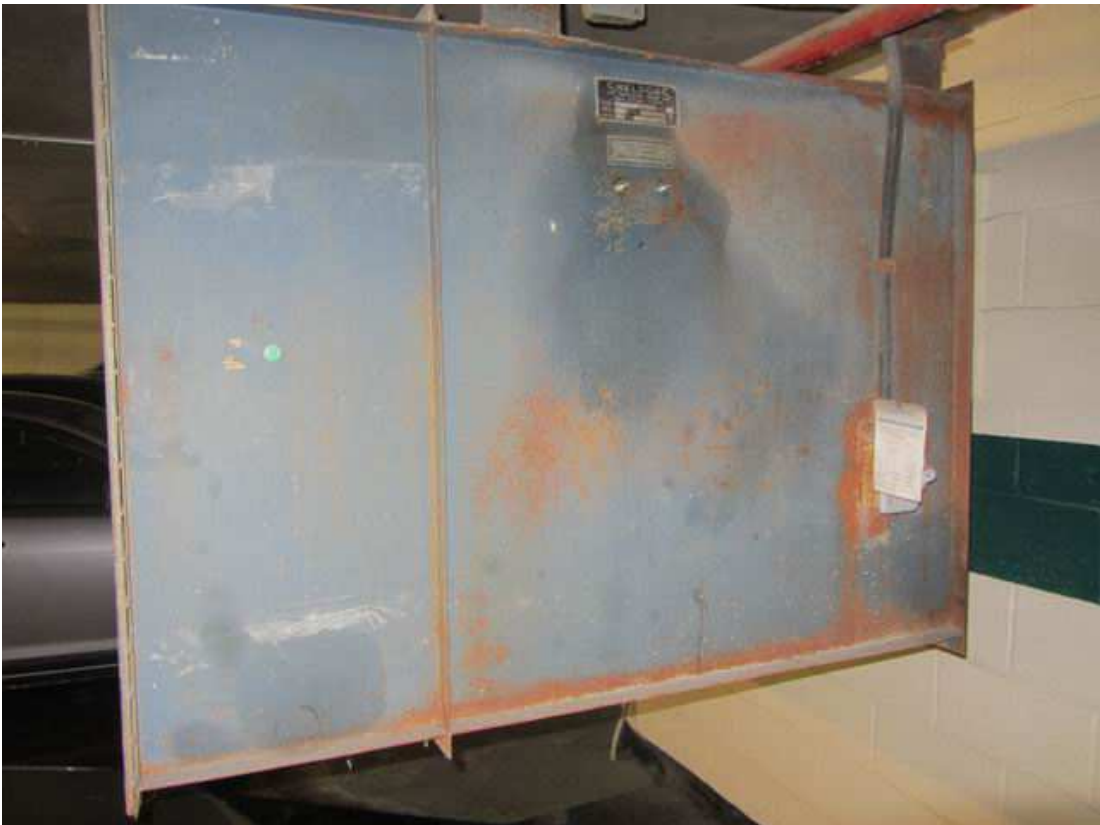
Photograph 48 - Corrosion of parking garage exhaust fans

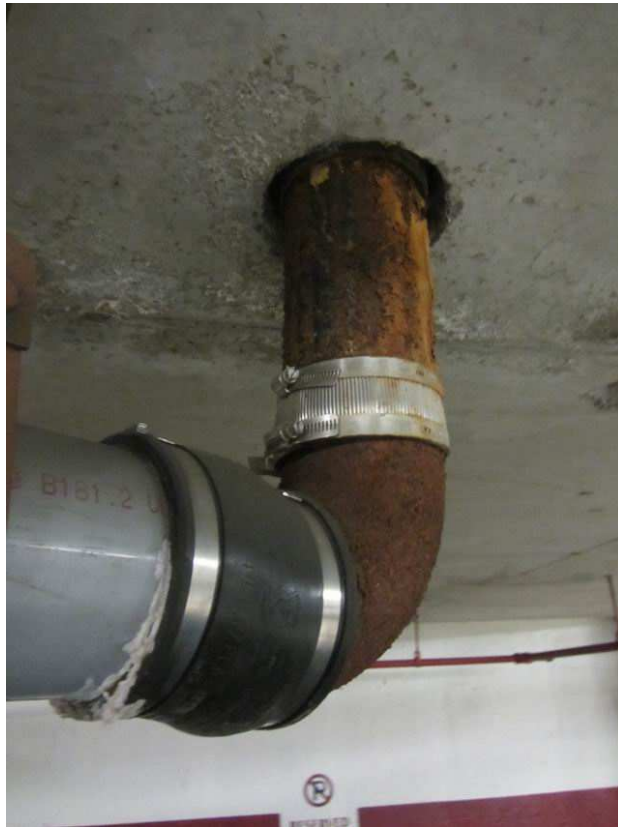
Photograph 49 - Corrosion of drainage piping in the parking garage

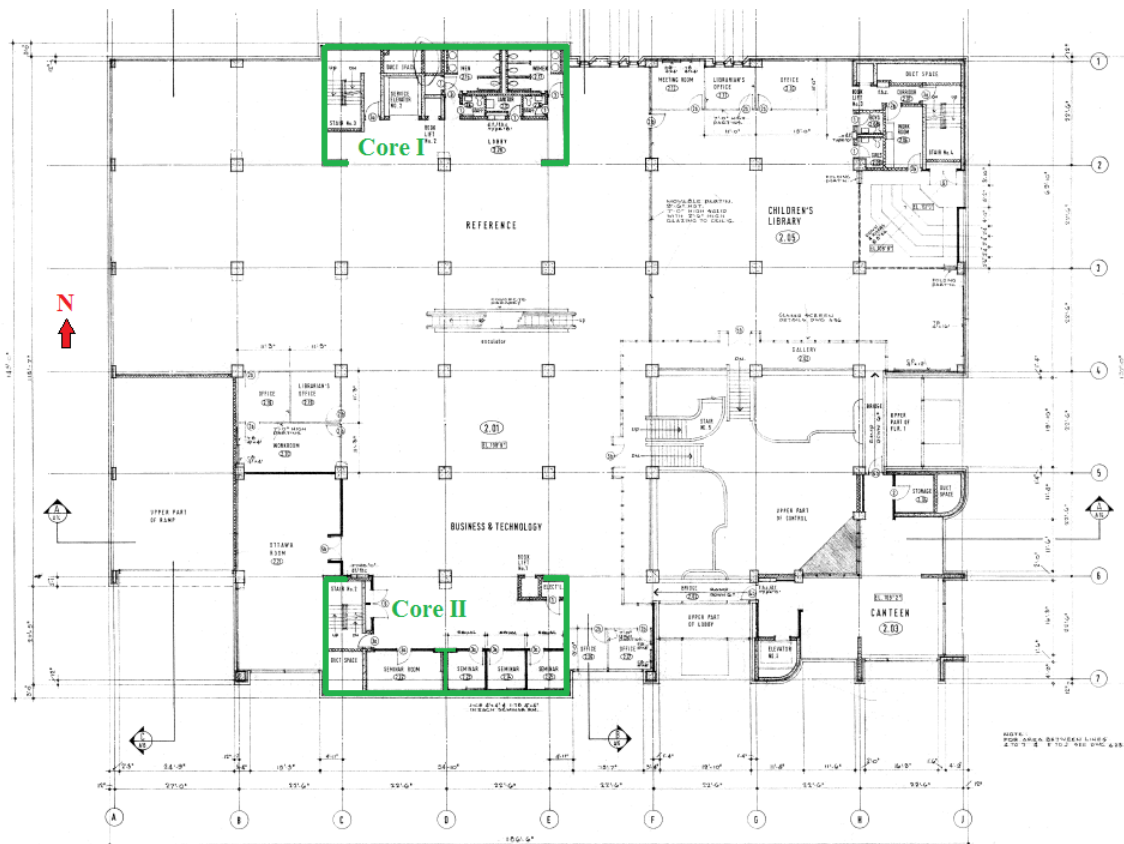
Figure 1 Second floor plan layout

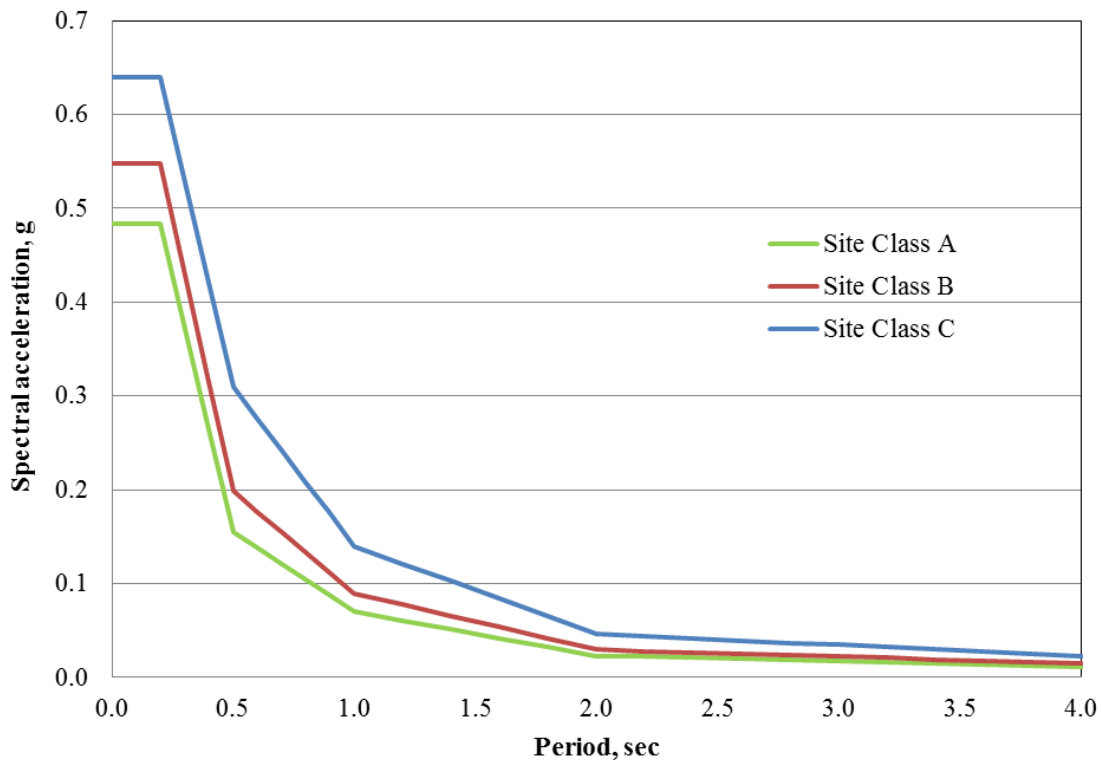
Figure 3 Design spectra for the city of Ottawa on Site Class A, B and C
