MORRISON HERSHFIELD

BUILDING CONDITION AUDIT and STRUCTURAL
ASSESSMENT

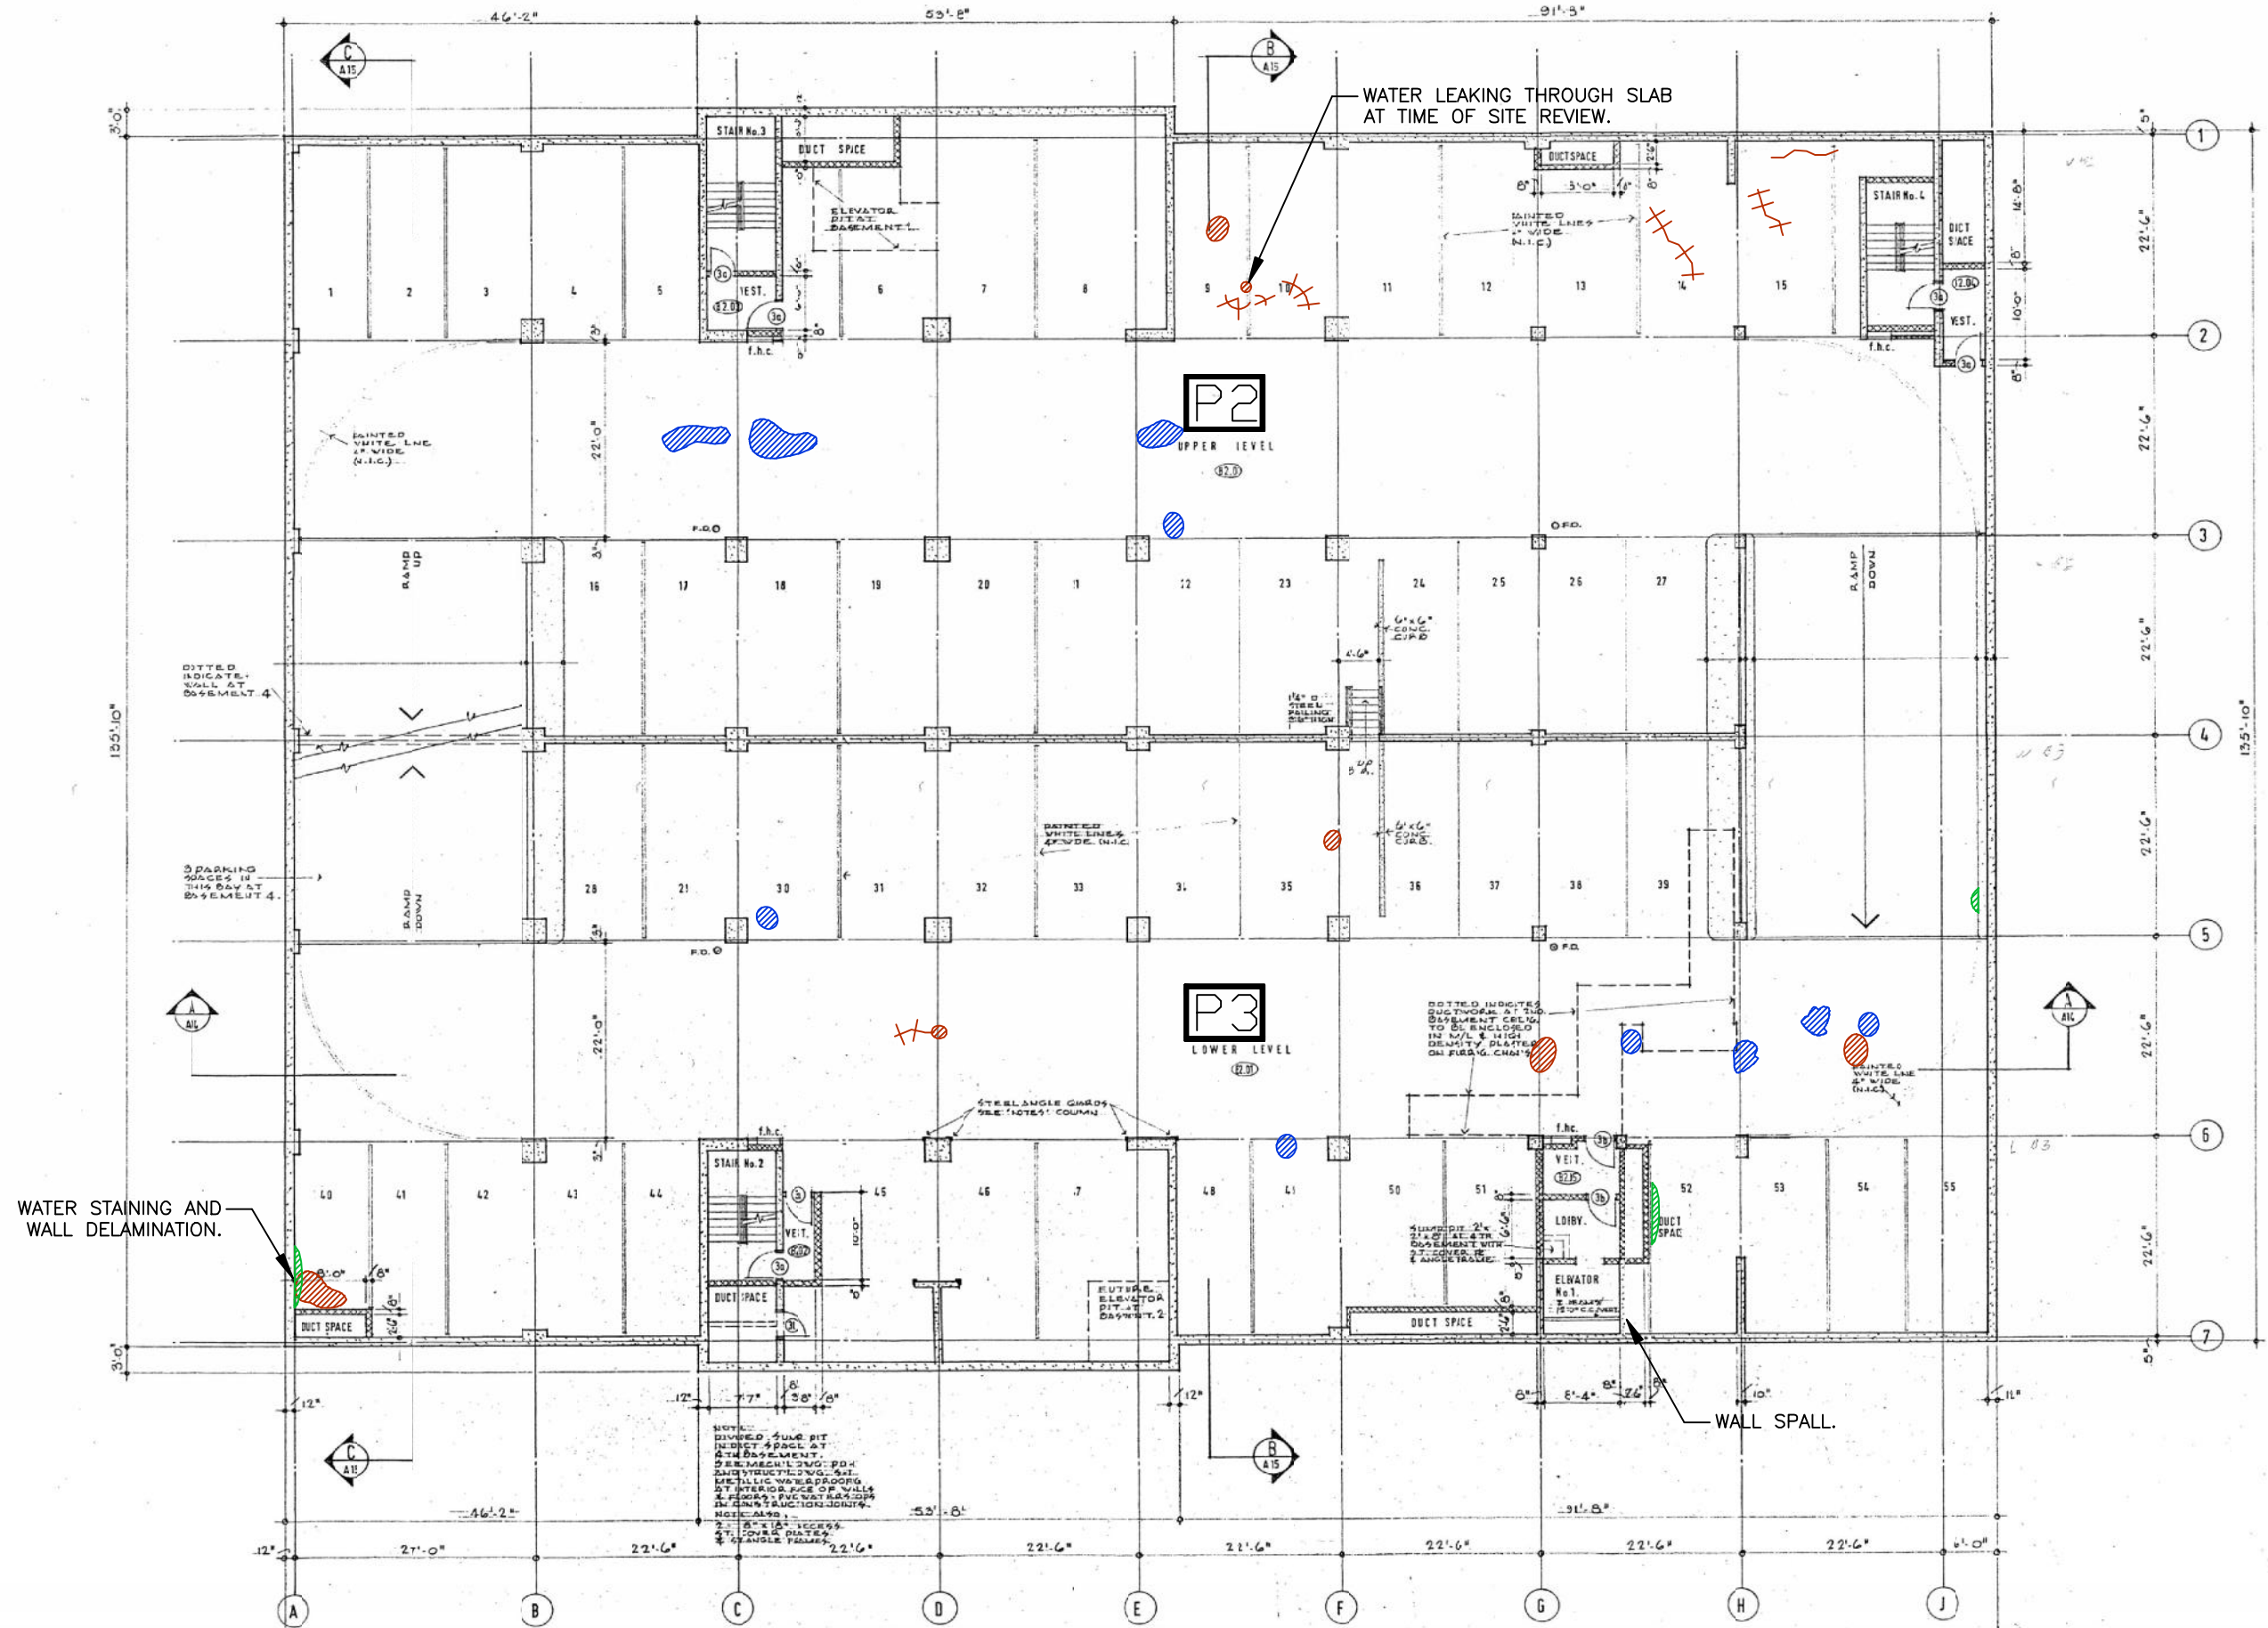
1	ISSUED FOR DRAFT REPORT	30/04/12
ISSUE	DESCRIPTION	DATE

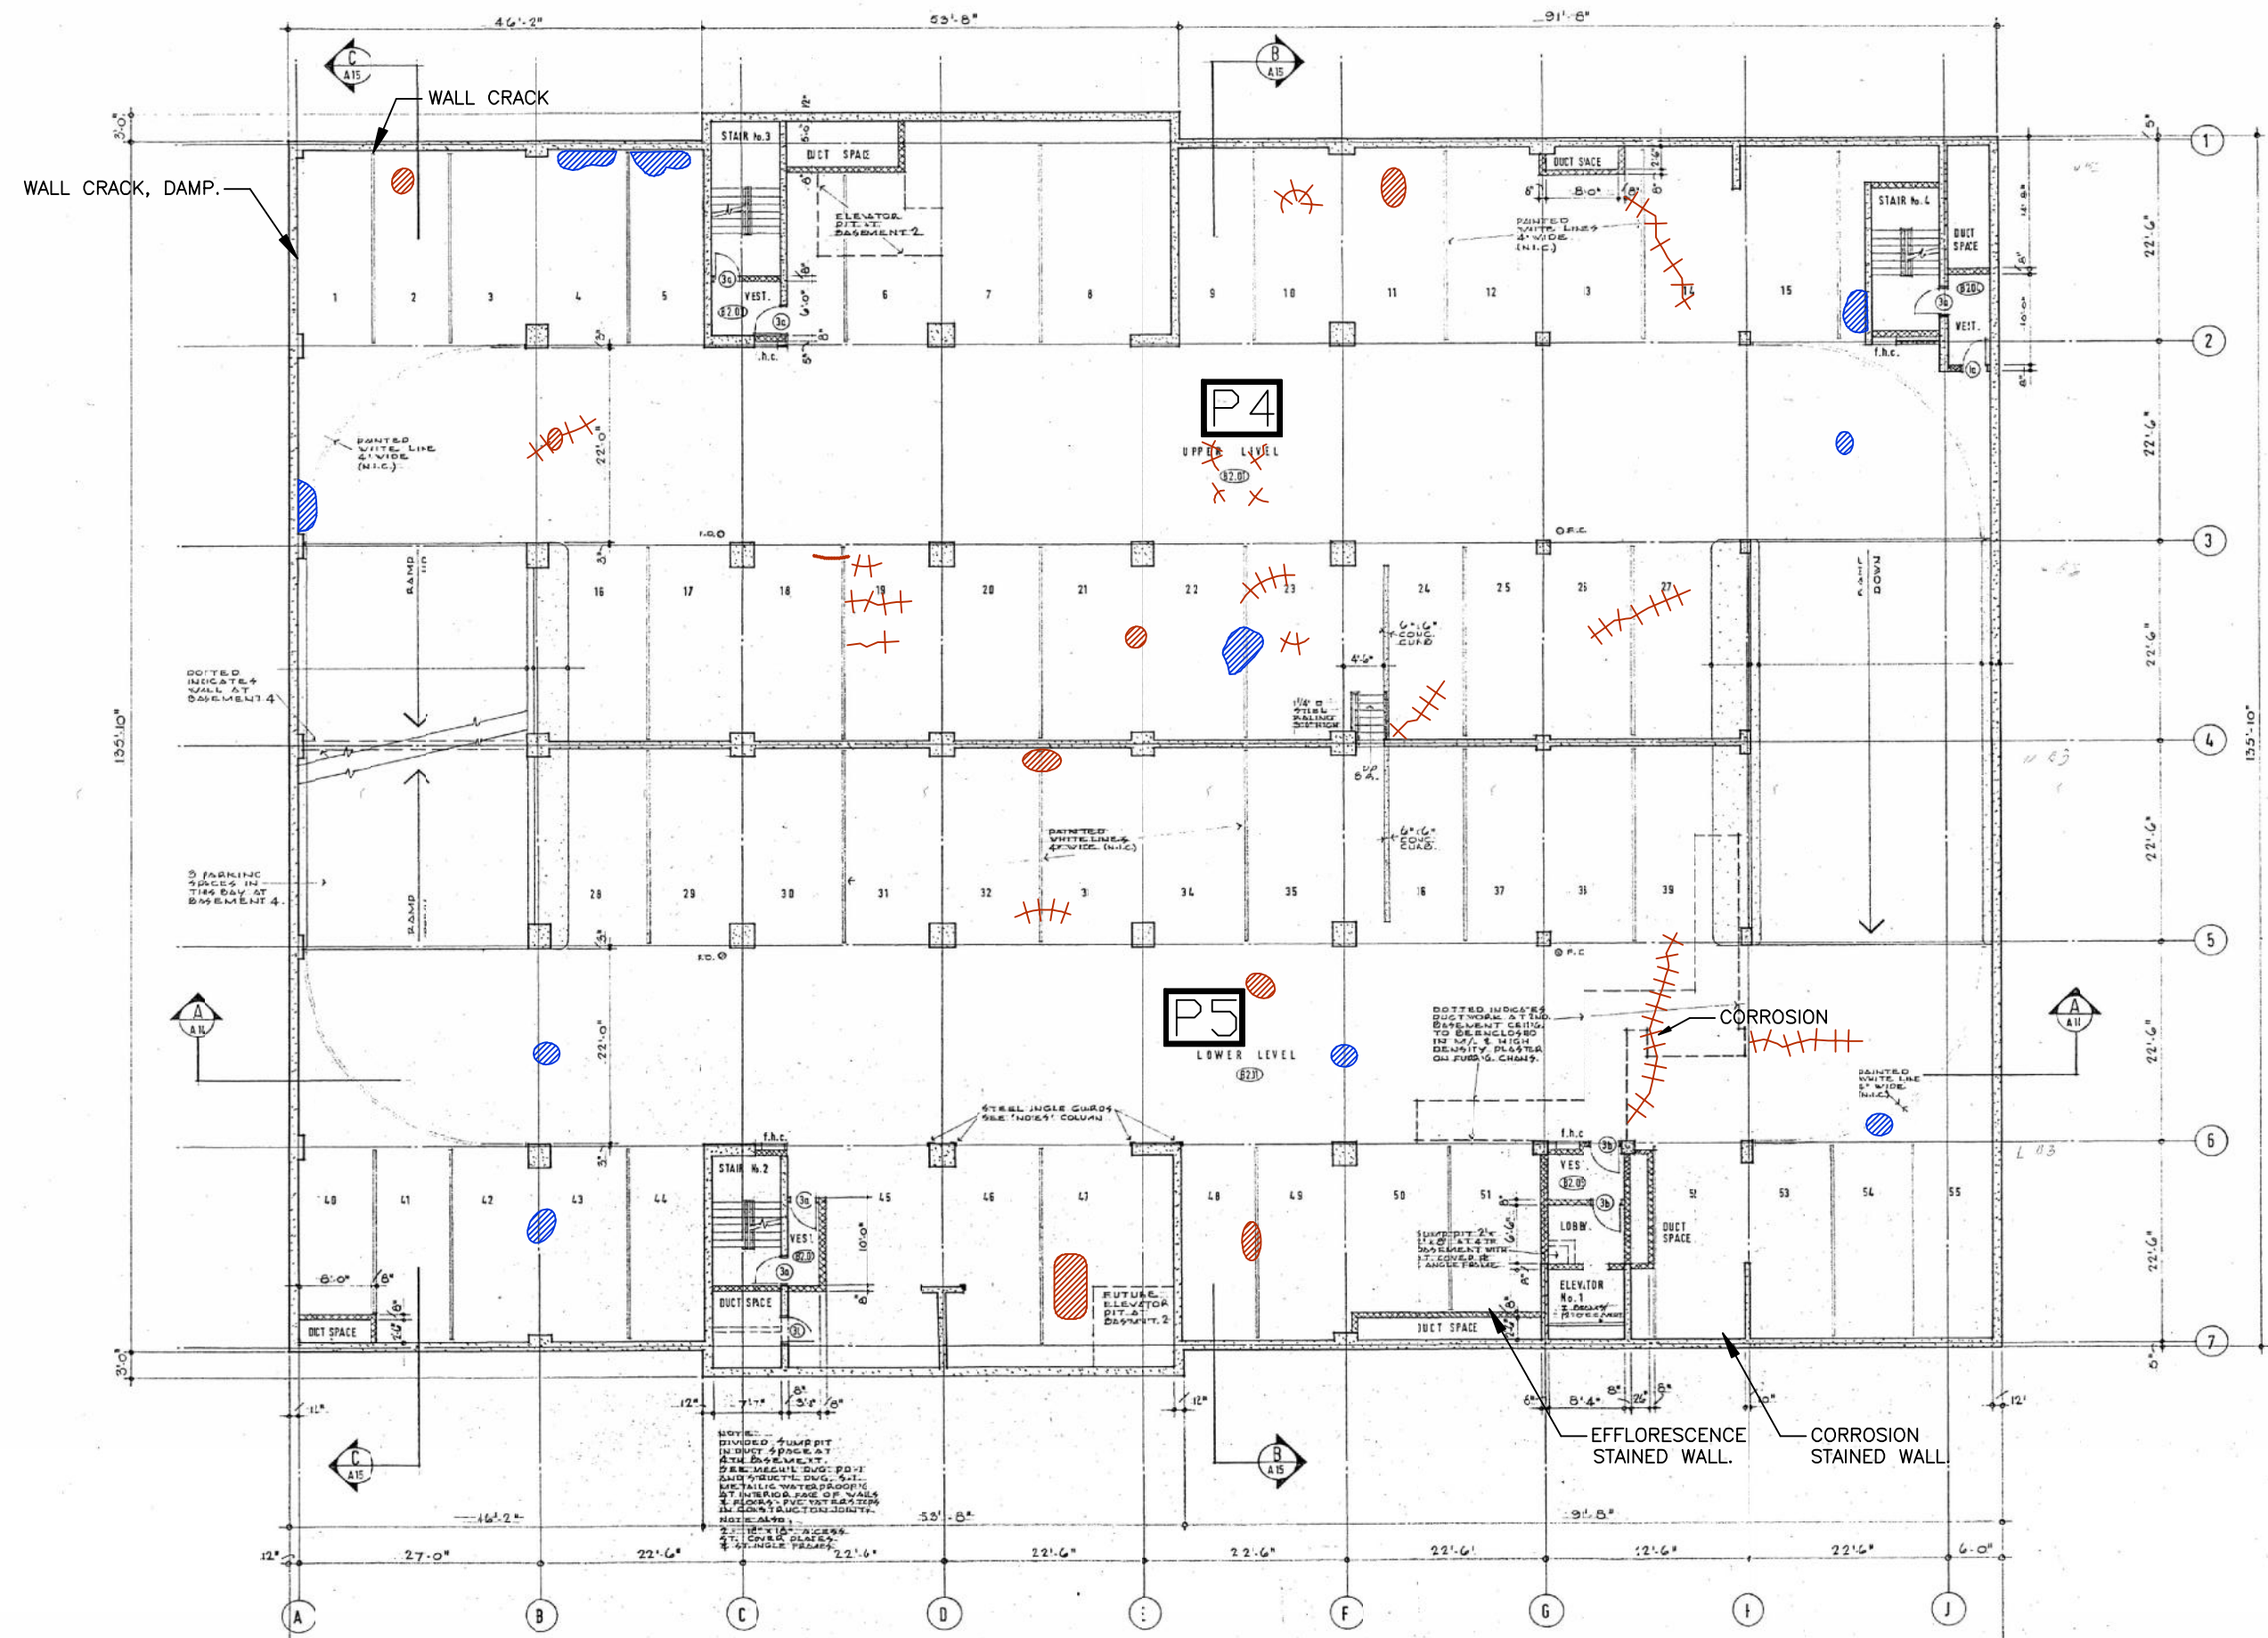
1	ISSUED FOR DRAFT REPORT	30/04/12
ISSUE	DESCRIPTION	DATE

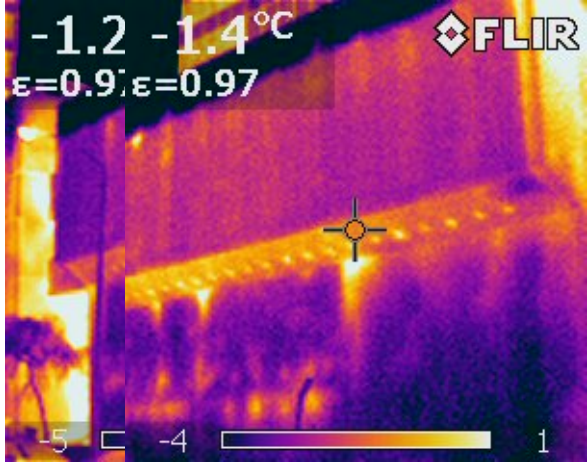
<p>Daylight Photo</p>

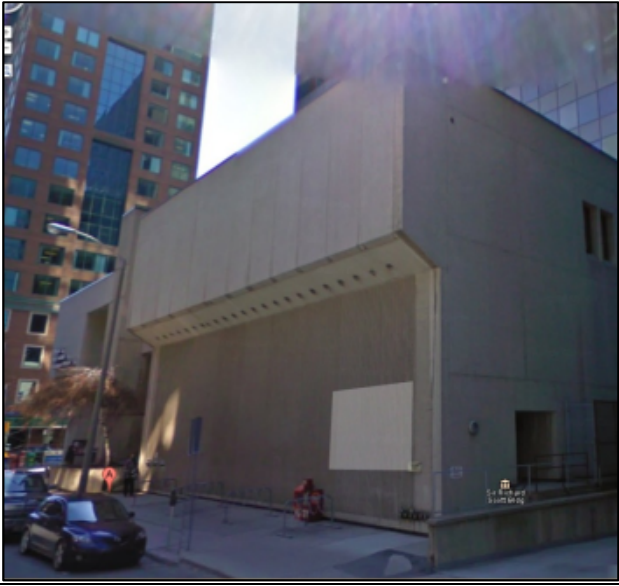
<p>Remarks</p>	<p>East elevation – air leakage beneath slope portion of wall, air leakage at parapet, air leakage above line of floor slab.</p>

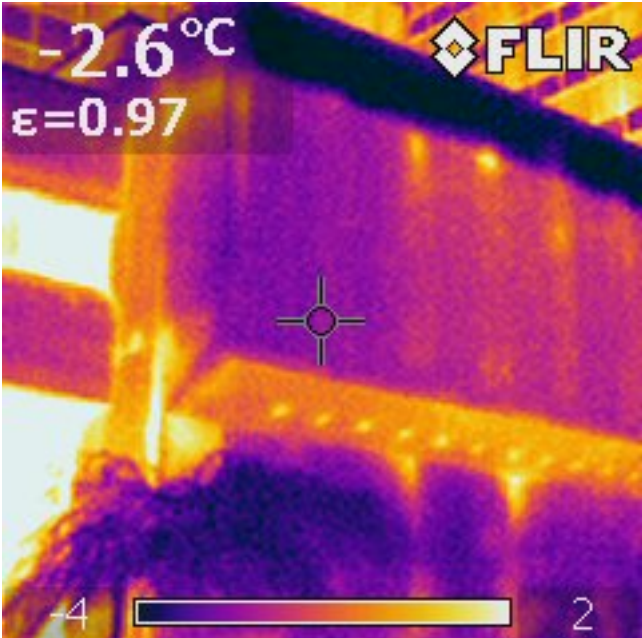
<p>Daylight Photo</p>

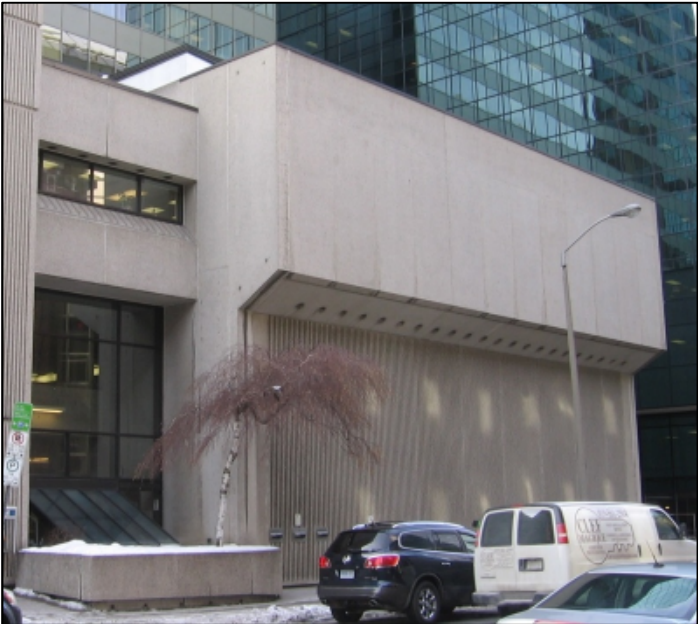
<p>Remarks</p>	<p>East elevation – air leakage at parapet, air leakage at wall intersection</p>

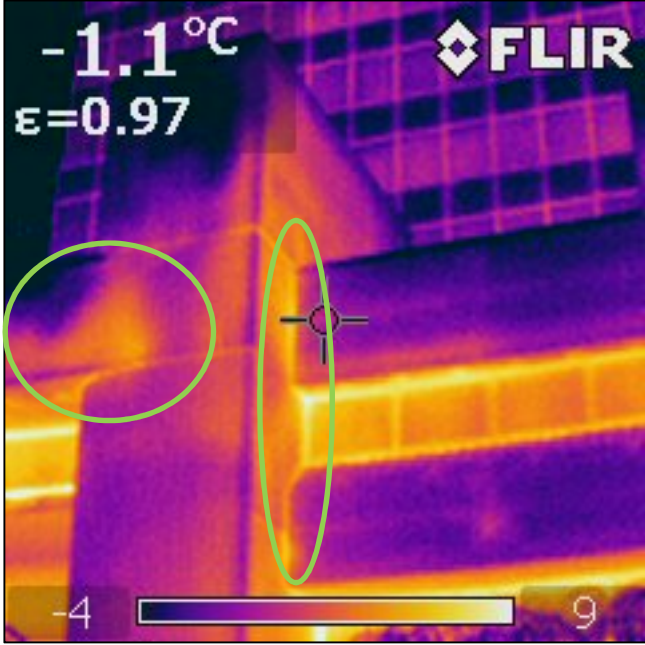
<p>Daylight Photo</p>

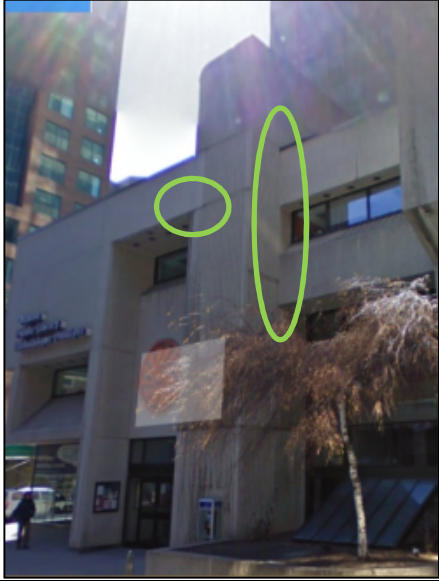
<p>Remarks</p>	<p>Air leakage at intersecting walls, air leakage adjacent to soffit</p>

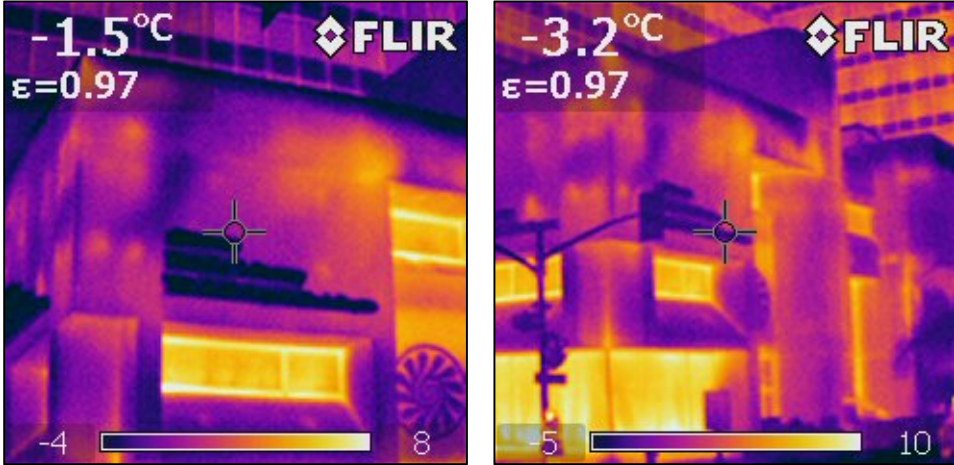
<p>Daylight Photo</p>

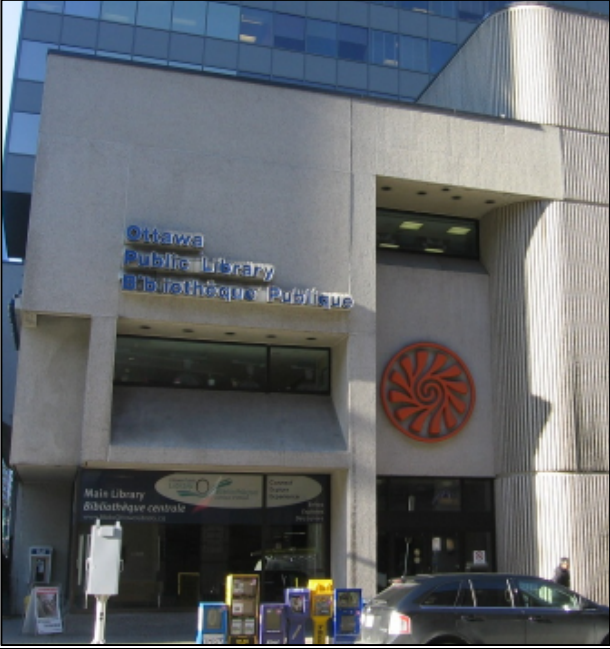
<p>Remarks</p>	<p>East elevation – air leakage/thermal bridging</p>

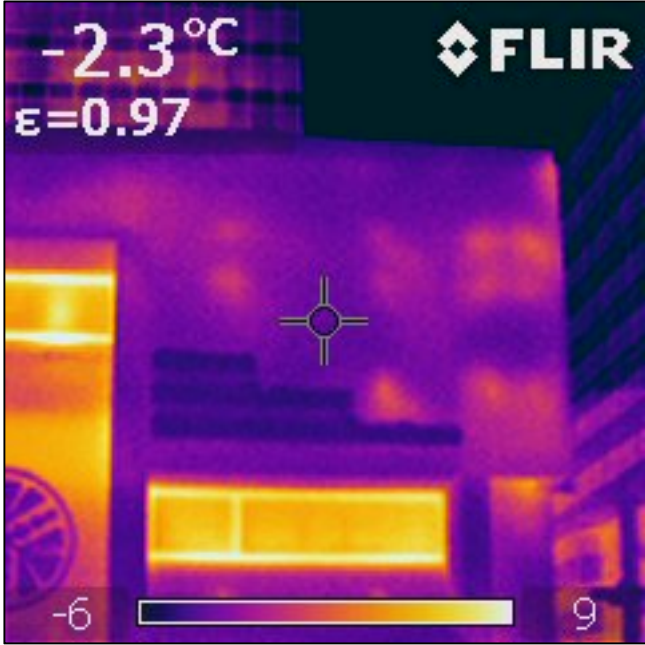
<p>Daylight Photo</p>

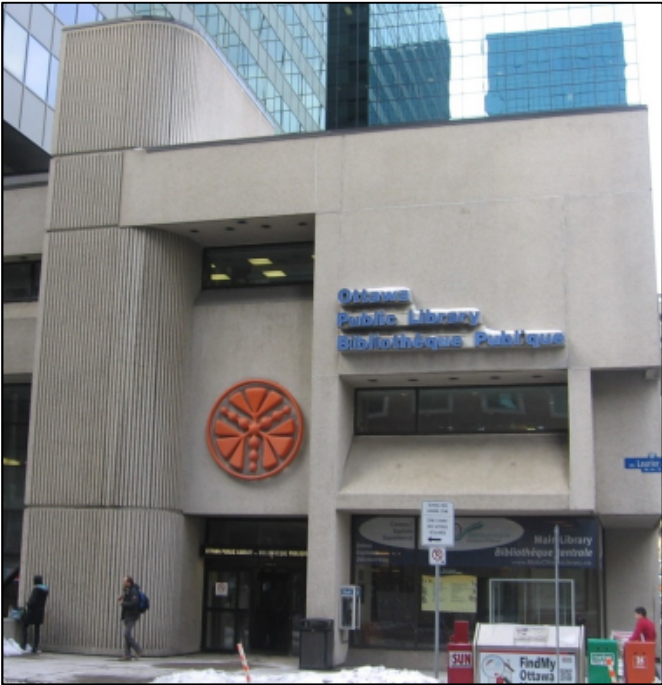
<p>Remarks</p>	<p>South elevation – thermal bridging at precast anchors, air leakage at top corner</p>

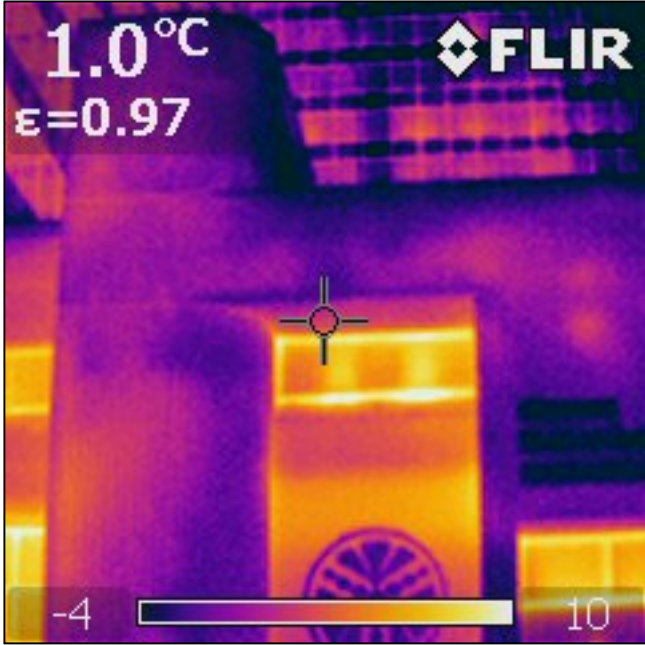
<p>Daylight Photo</p>

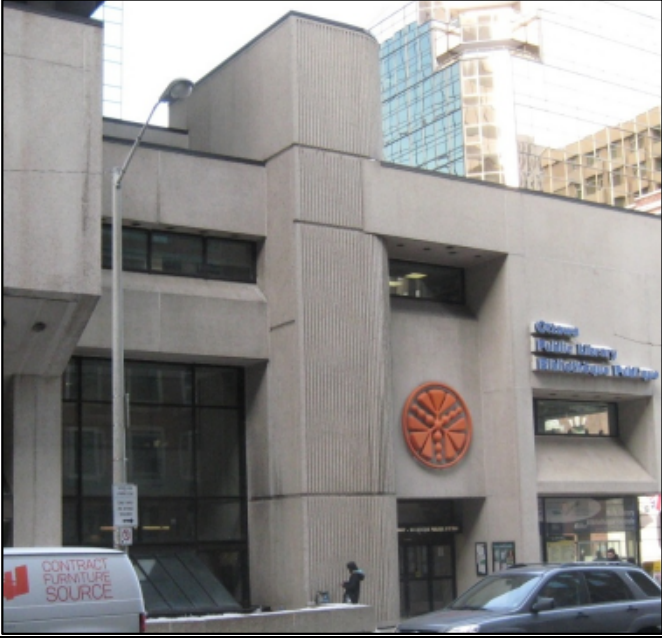
<p>The daylight photograph shows the south elevation of the building. A white van with 'CONTRACT FURNITURE SOURCE' is parked in the foreground. A person is visible near the entrance. The building has a large orange circular logo and a sign that reads 'Ottawa Public Library'. A sloped glazing area is visible on the upper part of the building.</p>
<p>Remarks</p>	<p>South elevation - Air leakage at inset. Note: a garage exhaust is the cause of the warm area adjacent to the sloped glazing.</p>

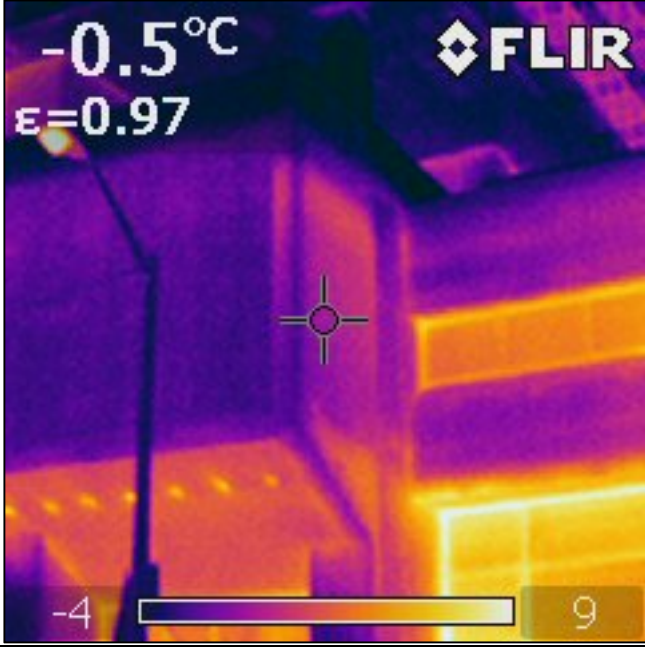
<p>Daylight Photo</p>

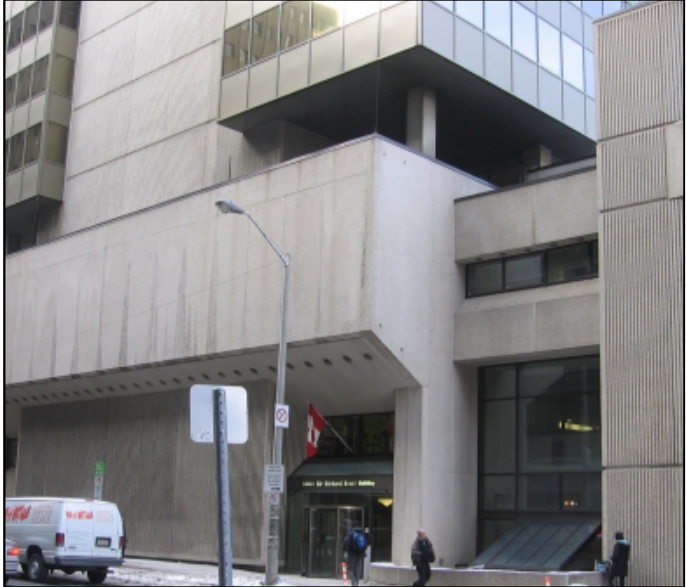
<p>Remarks</p>	<p>South elevation – air leakage on end wall.</p>

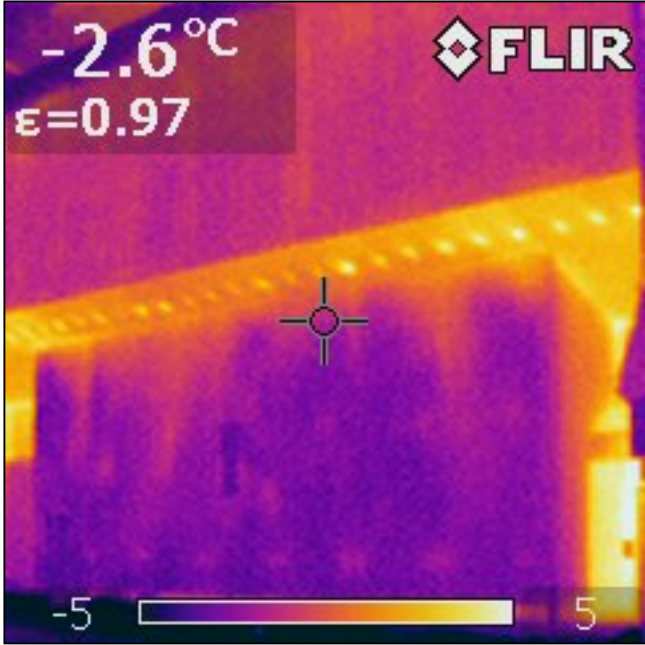
<p>Daylight Photo</p>

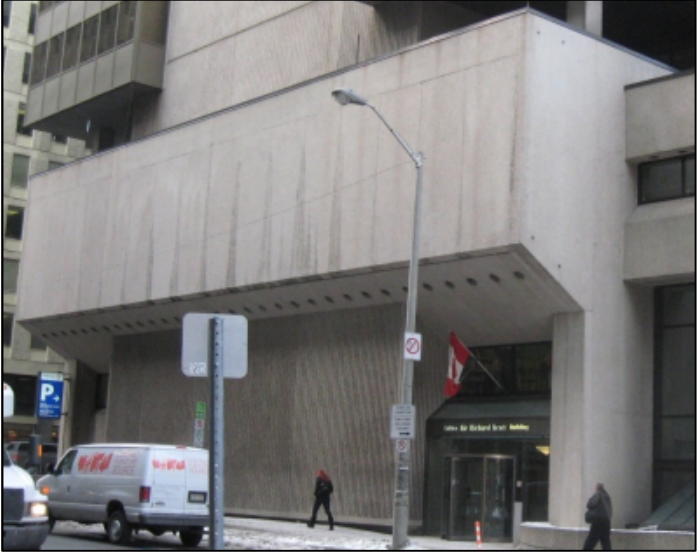
<p>Remarks</p>	<p>South elevation – air leakage below sloped portion of wall</p>

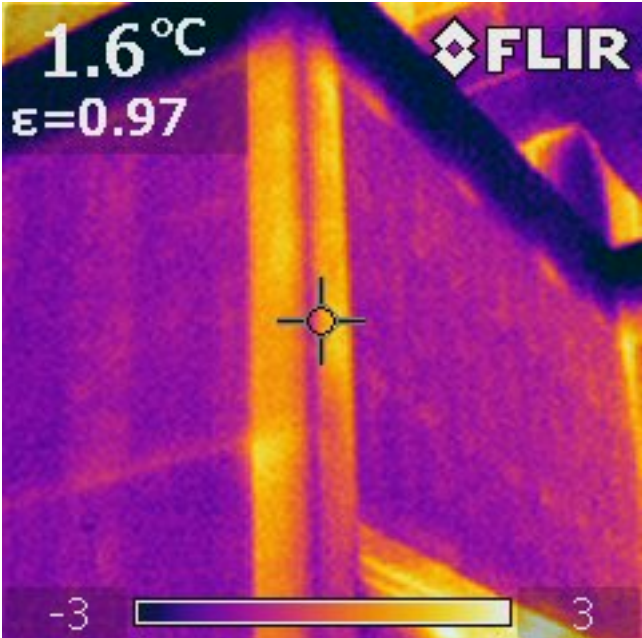
<p>Daylight Photo</p>

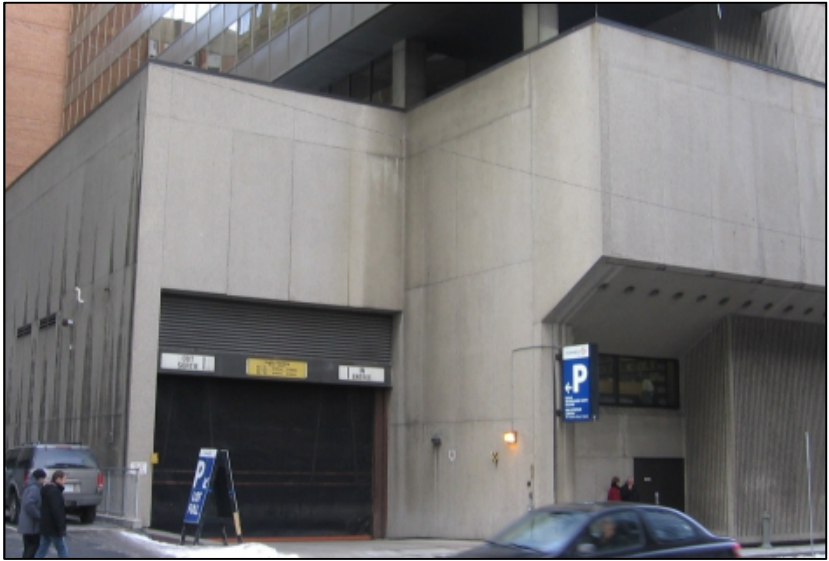
<p>Remarks</p>	<p>South elevation – air leakage around precast panels on end wall.</p>

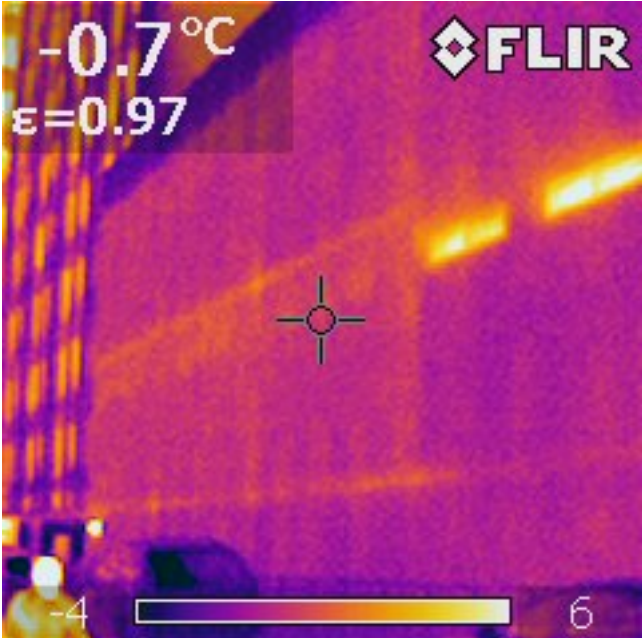
<p>Daylight Photo</p>

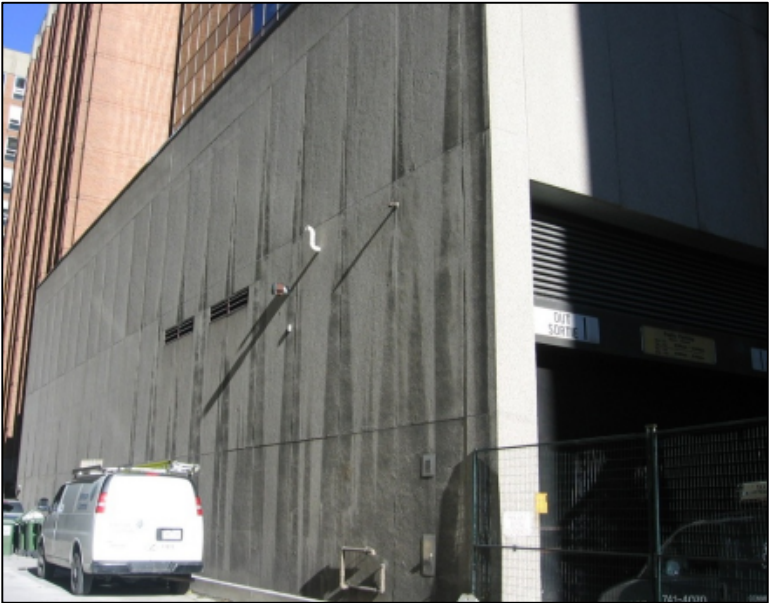
<p>Remarks</p>	<p>West elevation – air leakage.</p>

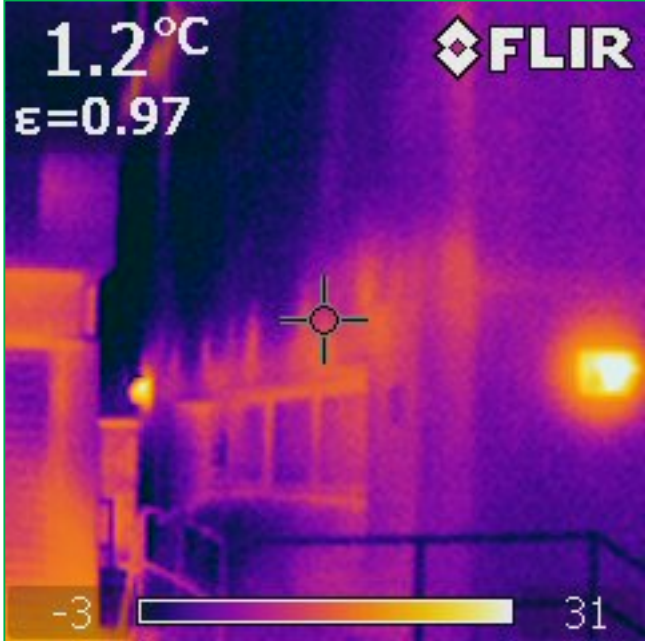
<p>Daylight Photo</p>

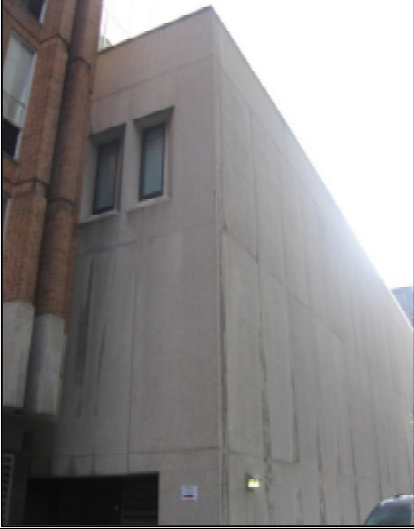
<p>Remarks</p>	<p>North elevation at northwest corner – air leakage above ground floor windows</p>

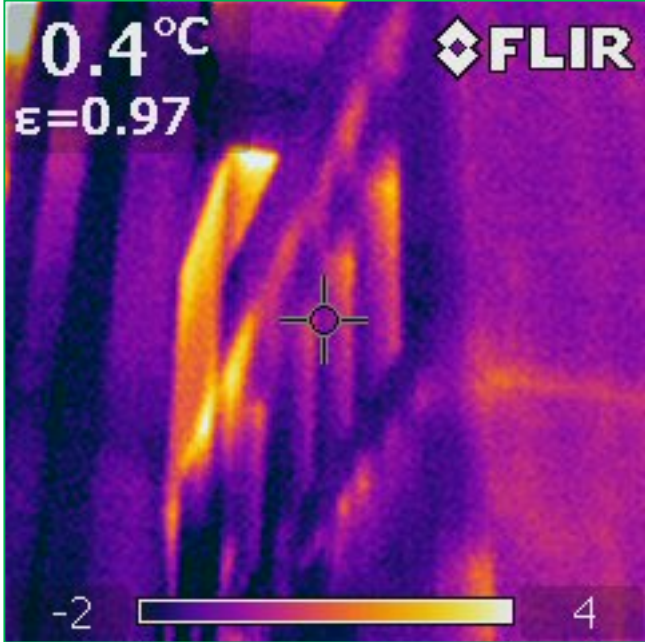
<p>Daylight Photo</p>

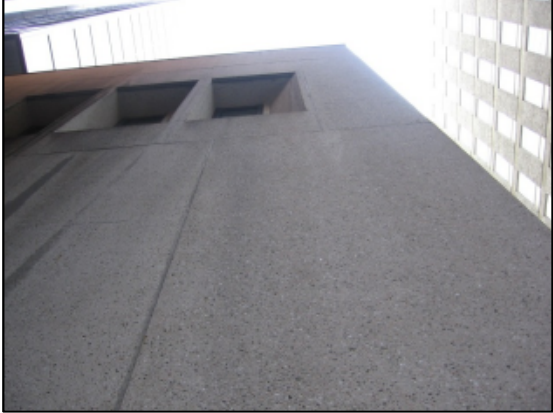
<p>Remarks</p>	<p>North elevation at northwest corner – air leakage above second floor</p>

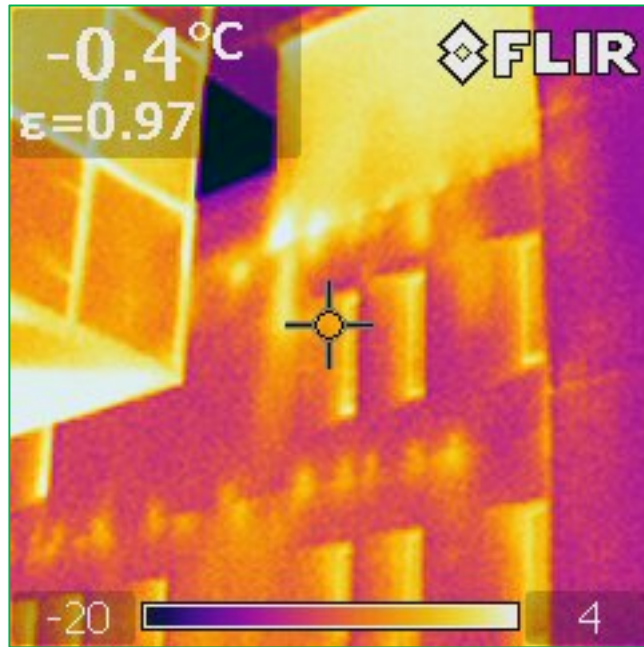
Thermographic Image 15

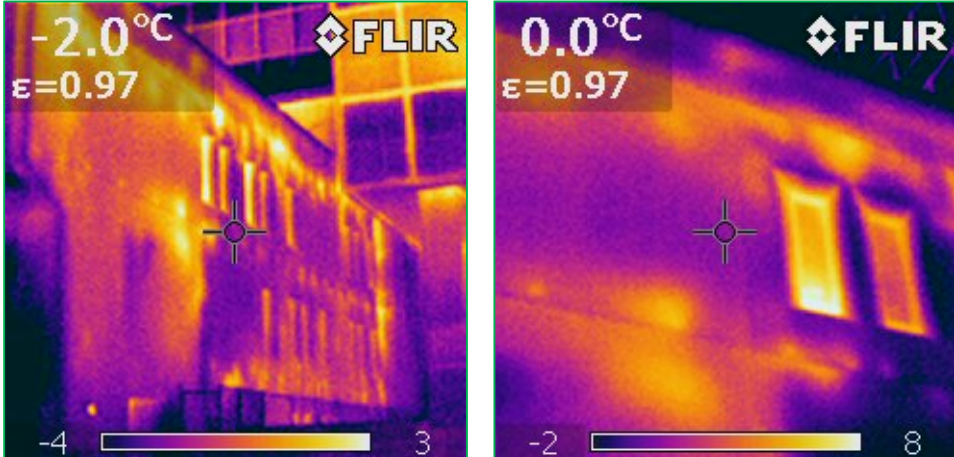
<p>Daylight Photo</p>

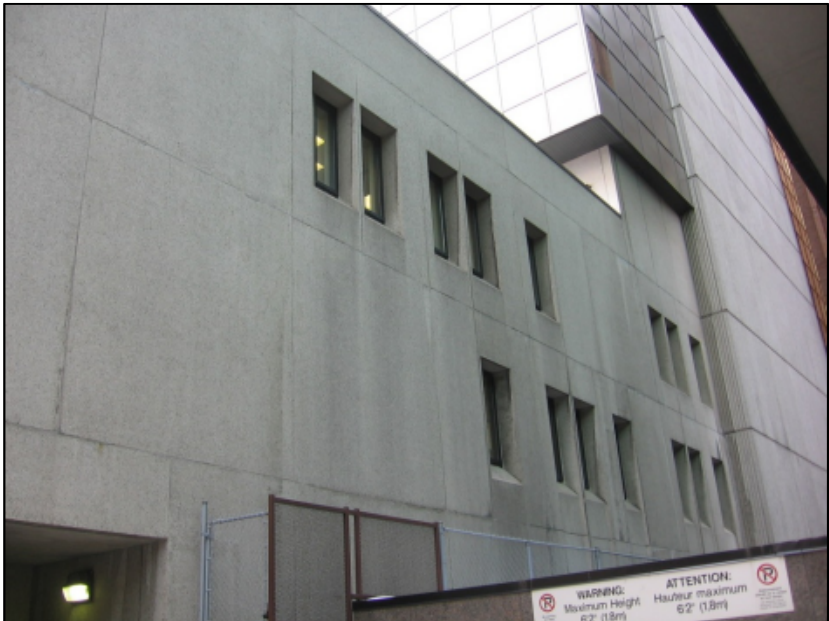
<p>Remarks</p>	<p>North elevation west of Metcalfe St. – air leakage</p>
