# **LOWER SOUTH SIDE STANDS**

**LANSDOWNE PARK  
FRANK CLAIR STADIUM**

## **STRUCTURAL ADEQUACY REPORT 2007**

**Structural Adequacy Report**  
**AAR Reference No. 3061-26**

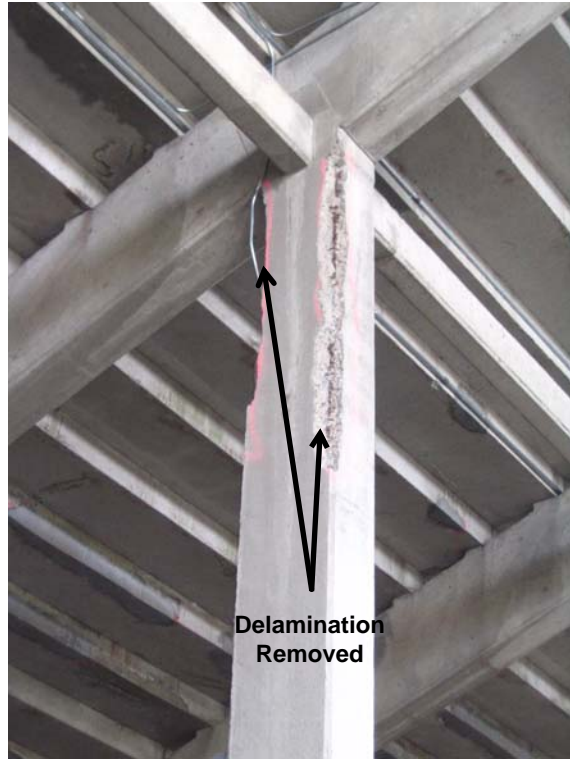
Photo 01 - Column @ Raker Beam: Concrete Spall

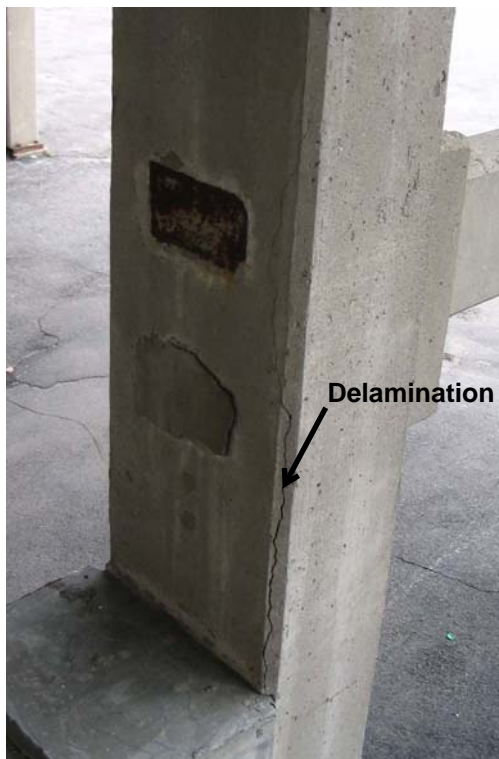
Deterioration was noted in the columns such as at grid location C2. This could have initiated as cracks as a result of local bending distress. With time, water would have entered the cracks causing rusting of the reinforcing steel and additional cracking and delamination. See Photo 02.

Photo 02 – Column C2: Local Deterioration

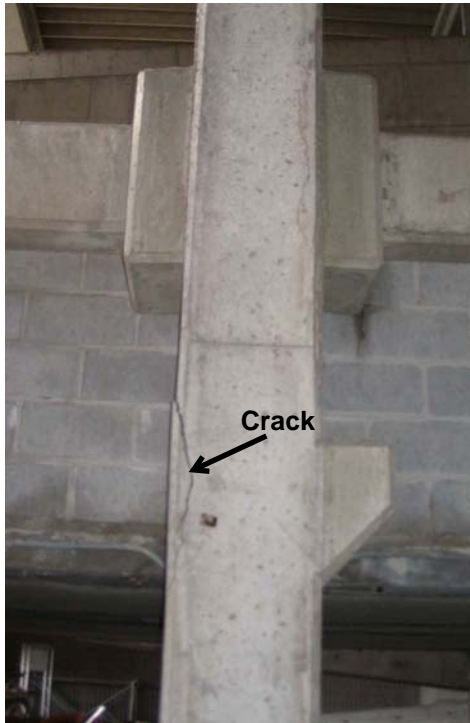
A delamination was noted on column C4 as noted in photo 03 & 04. This condition is located at the ramp landing and is associated with an as found interconnection between the ramp system and the column. The column was not originally connected to this ramp; however, it appears that an inadvertent connection was made resulting in this local distress.

Photo 03 – Column at Landing Ramp: Concrete Delamination

- 9.1.1.** Column C4 has local distress as a result of thermal movement and concrete repair to the column and ramp landing slab will be required.
- 9.1.2.** The deteriorated concrete at areas on the frames, precast seating panels, columns and ramp system will require repairs, in our opinion, within two years.

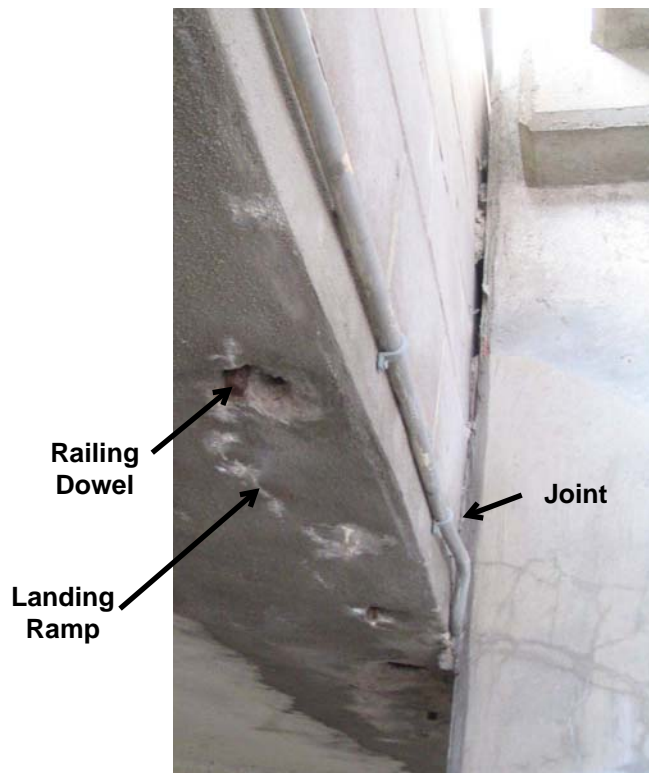
Photo 04 – Landing ramp @ column C4:  
Joint built solid; guard rebar anchors

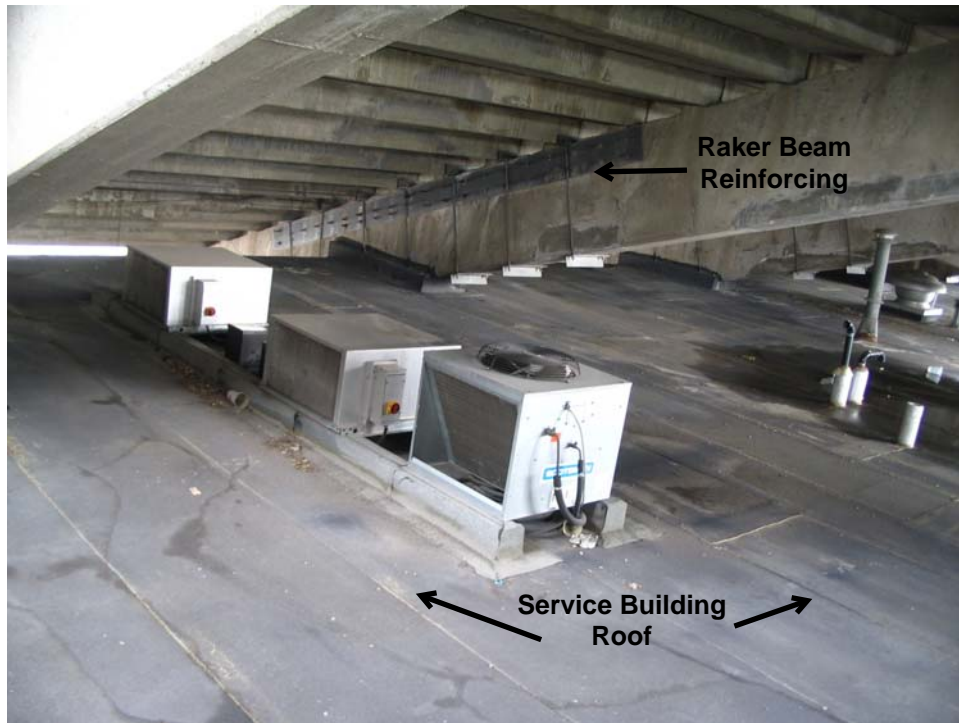
The cast-in-place concrete beams on frame lines 2, 3 and 4 were noted to have structural steel added to provide both flexural and shear reinforcing for the beam at grid line A. See Photo 05. The year in which the beams were reinforced was unknown and was reportedly required to reinforce the beams after the area was overloaded as a result of a temporary loading condition not related to the intended use of the seating.

Photo 05 – Raker Beam over service building:  
Structural steel reinforcing of Raker Beam

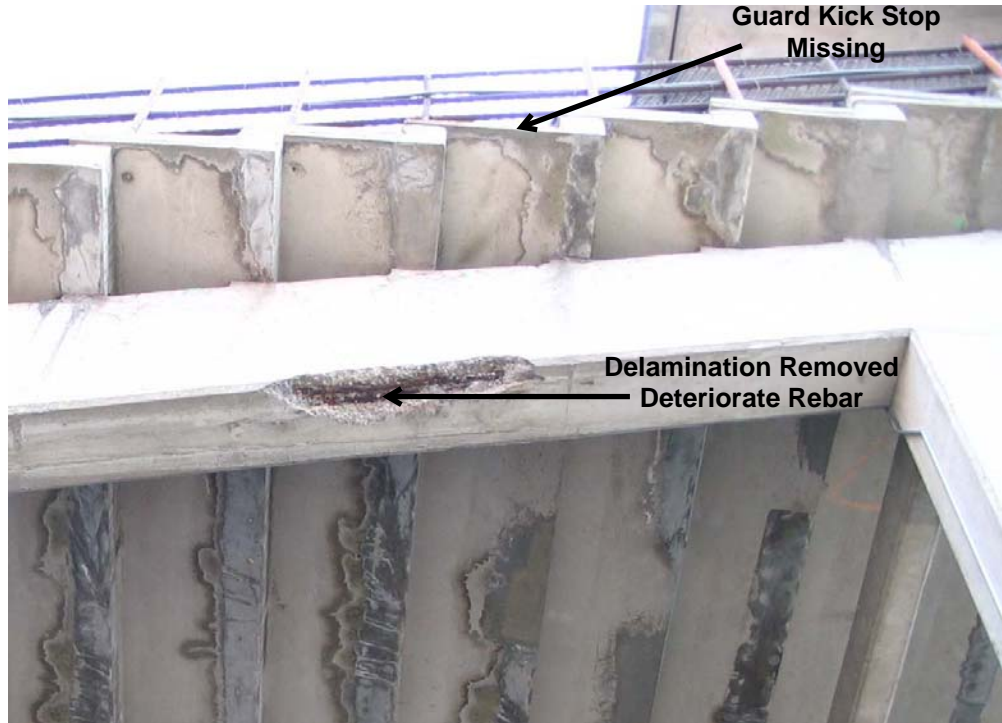
The side sections of railings for seating include a kick stop that is cast on top of the precast seating panels. These sections of concrete were noted as missing at various locations. See photo 06.

Photo 06 – Raker Beam 19: Deteriorated concrete/rebar;  
railing kick stop missing

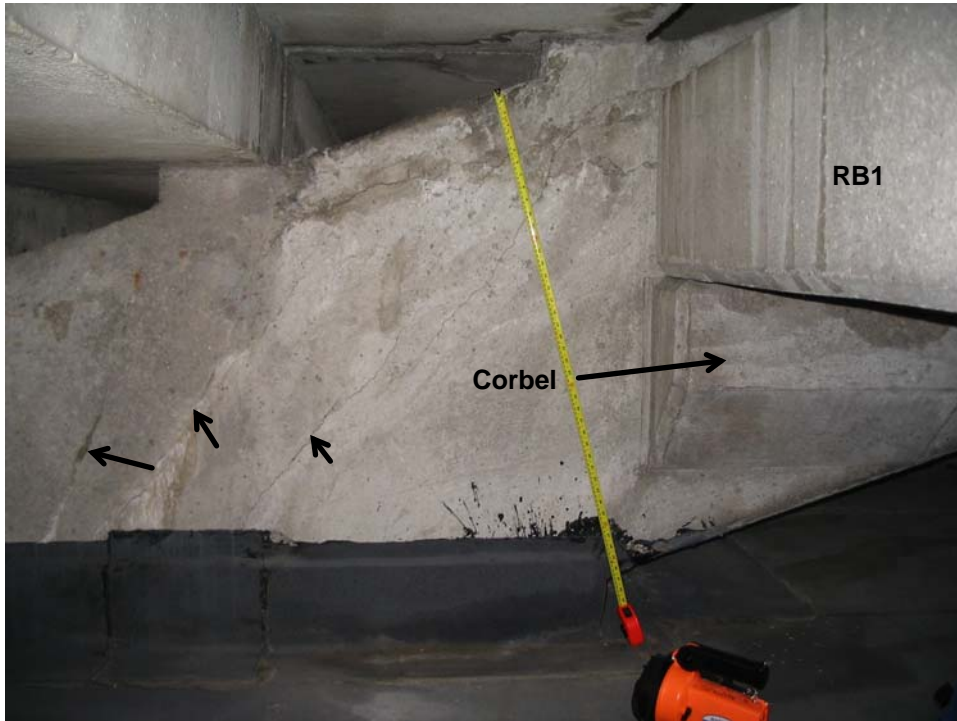
Some of the raker beams were noted to have shear and / or flexural cracks in the either the front cantilever section and / or the interior span at column line A. See Photo 07 & 08. The cracks in raker beam 5 were measured with the largest recorded in the range of 2 mm at a location between the column on Line A and RB1. This width is substantially larger than a 0.3 mm hair line crack which could be expected for acceptable performance of reinforced concrete structures.

Photo 07 – Raker 5: Cracks

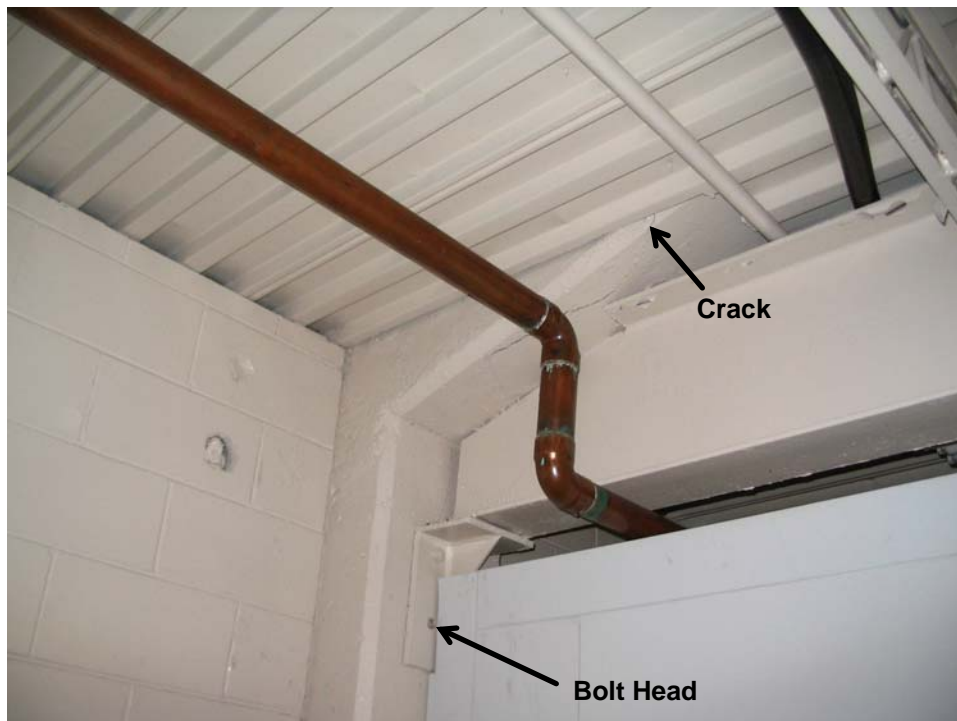
No structural distress or deterioration was evident. It was noted, however, that at frame line 5, a structural steel bracket has been modified with a bolt head cut off as evident in photo 08. This modification was only evident at this location; however, similar modifications may be present at all hidden connections where the freezer was installed.

Photo 08 – Service building roof support at Frame 5:  
Bolt head removed; Raker Beam Cracks

- 9.1.7.** The service building roof beam support bracket at concrete frame 5 will require additional assessment to determine if the as found condition can support the service building roof design loading.

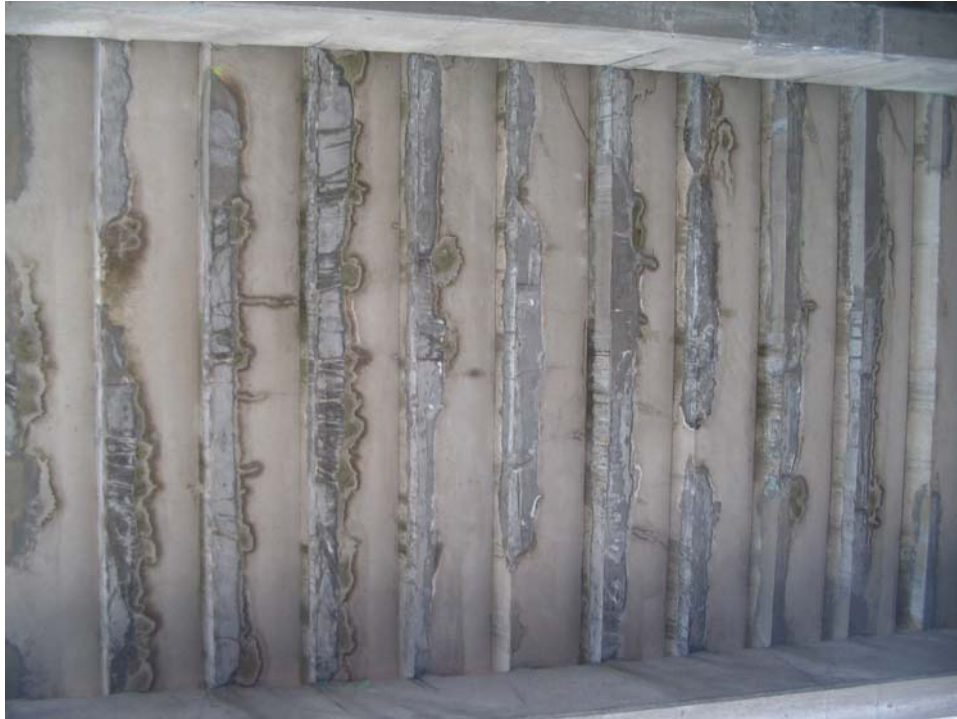
The precast seating panels have been repaired at various times over the life of this building with the repair patches typically as evident in Photo 09. The latest known date of concrete repair was reported as 2004. The repair patches were randomly hammered with patches noted as sound and in good condition.

Photo 09 – Precast Seating Panels: typical soffit repair patches

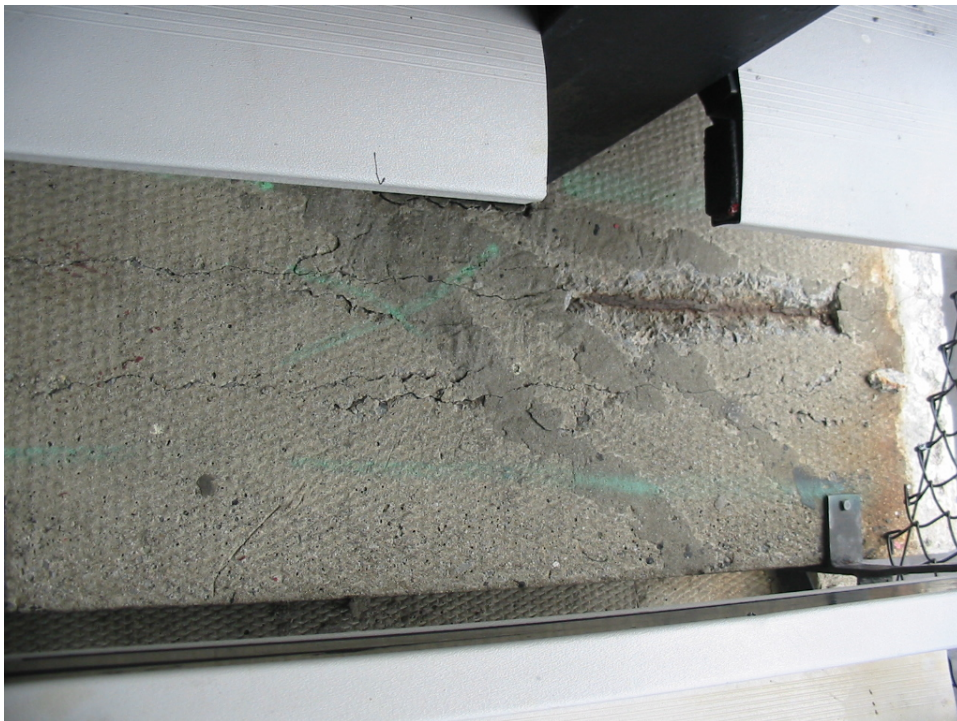
The upper surface of the precast seating sections was found to have local areas of spalled concrete with the reinforcing steel exposed and deteriorated as evident in Photo 10.

Photo 10 – Top of Precast Seating Panels:  
Deteriorated concrete and reinforcing

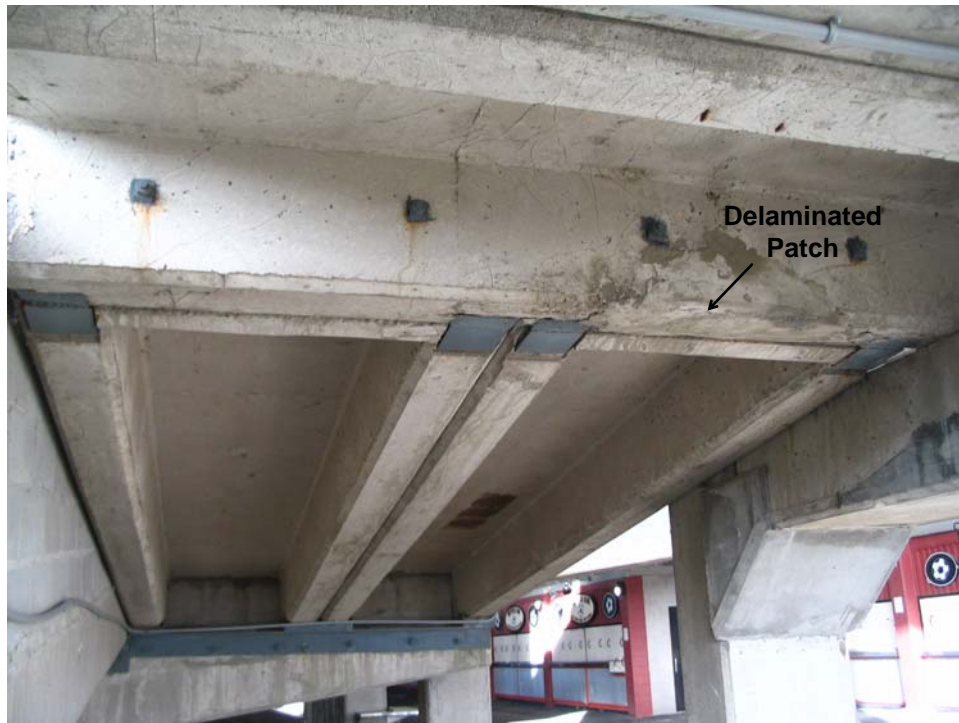
The areas that were previously repaired were randomly sounded with various patches found to be again delaminated as evident in photo 11. The areas where the patches have again delaminated were typically where ramp section R3 is hung off ramp section R2. Ramp section R2 has a crack, as evident in photo 12, down the centre of the cantilever portion that supports the hangers. This condition was noted to varying degrees at a majority of these ramp locations.

Photo 11 – Ramp R3 Hangers at R2:  
Delamination repair cracked

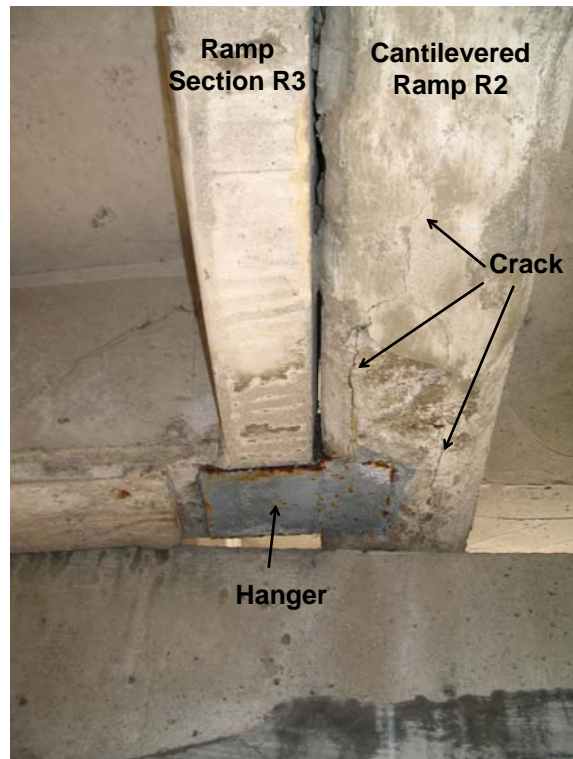
Photo 12 – Ramp R3 Hanger @ R2: cracks

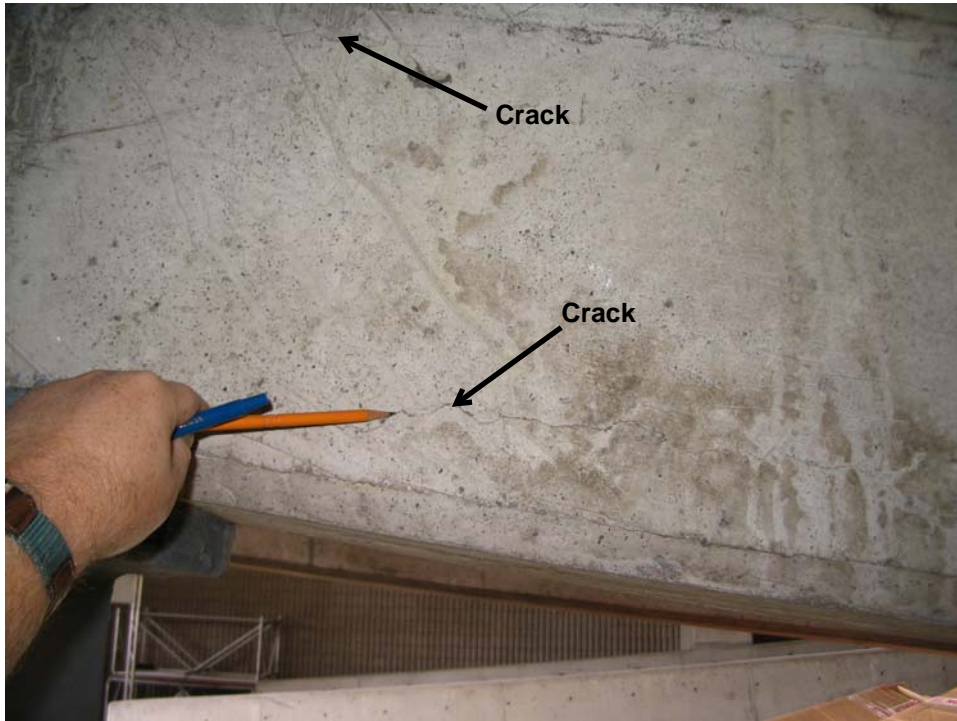
Ramp section R4 was noted to have cracks in the beam near the support at the column tee as evident in photo 13.

Photo 13 – Ramp R4 @ Column Support: cracks

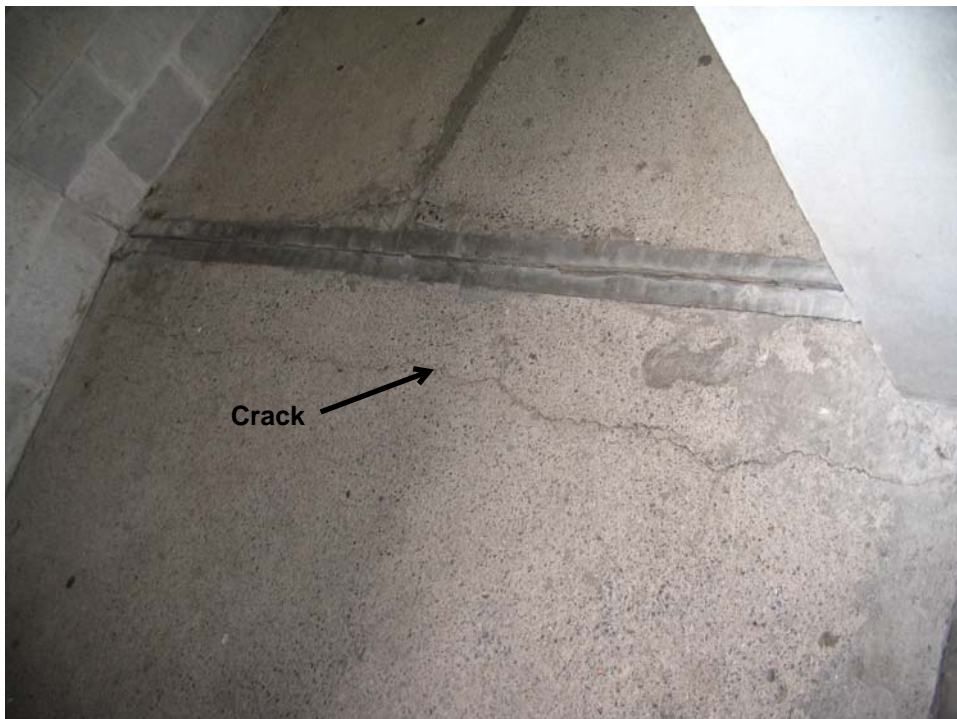
The landing slabs were noted to have cracks in the top of slab that have existed overtime as evident in photo 14. Diagonal cracks are evident at the side of the panels at the supports that align with the top of slab crack as evident in photo 21.

Photo 14 – Ramp Landing @ Support Column:  
Top of slab crack

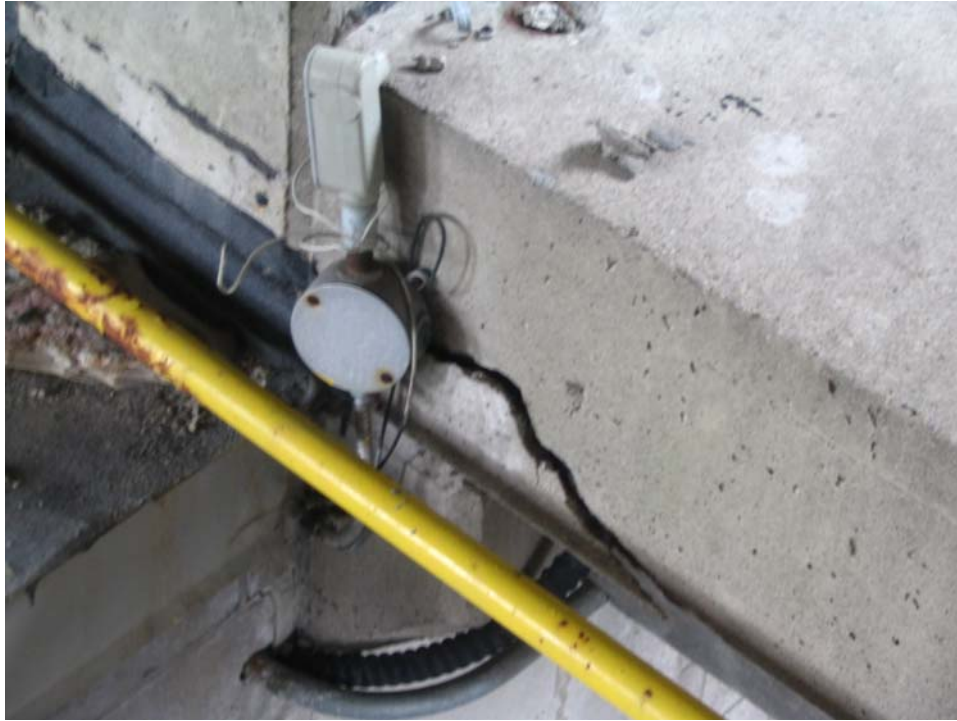
Ramp beams RB1 and RB2 were noted to have local distress / deterioration at one location only. Ramp beam RB2 is cracked at the support at frame line 6 as evident in photo 15.

Photo 15 – Ramp Support Beam RB2: crack at support

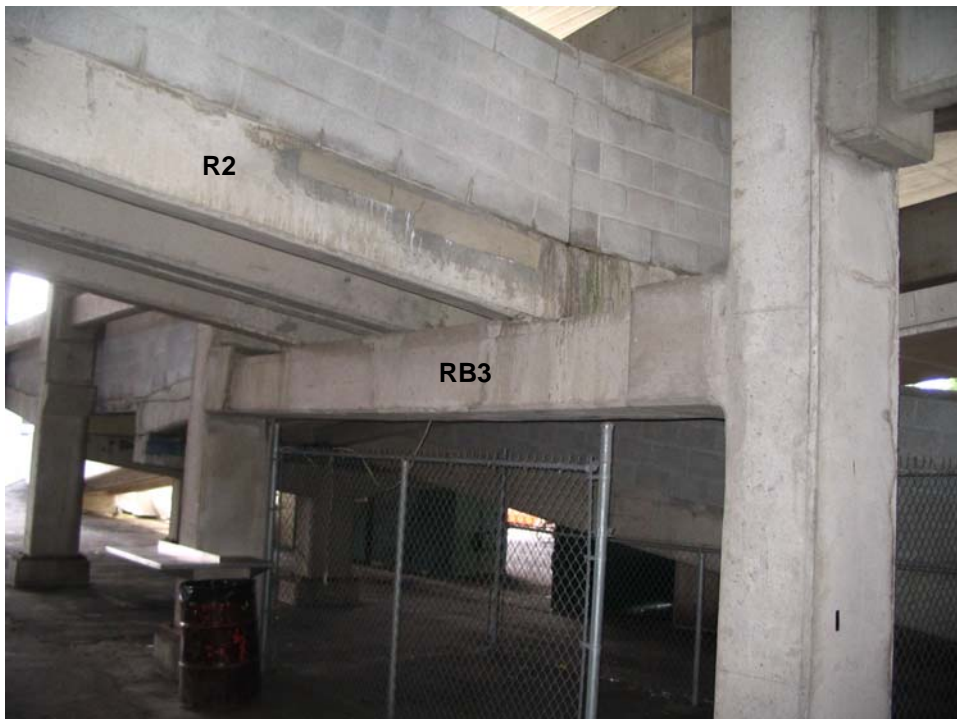
Ramp beams RB3 were noted at this time to typically have visible deflection (photo 16) with varying forms of longitudinal and transverse cracks (photo 17). In addition, these beams have areas of delamination which are either new or at and beyond previous repairs (photo 18). The brackets supporting these beams at the columns were noted to have two different repair details with the most recent repair detail including a new corbel support to the column. The beam connections to the columns were all typically noted as cracked.

Photo 16 – Ramp Beam RB3: Deflection

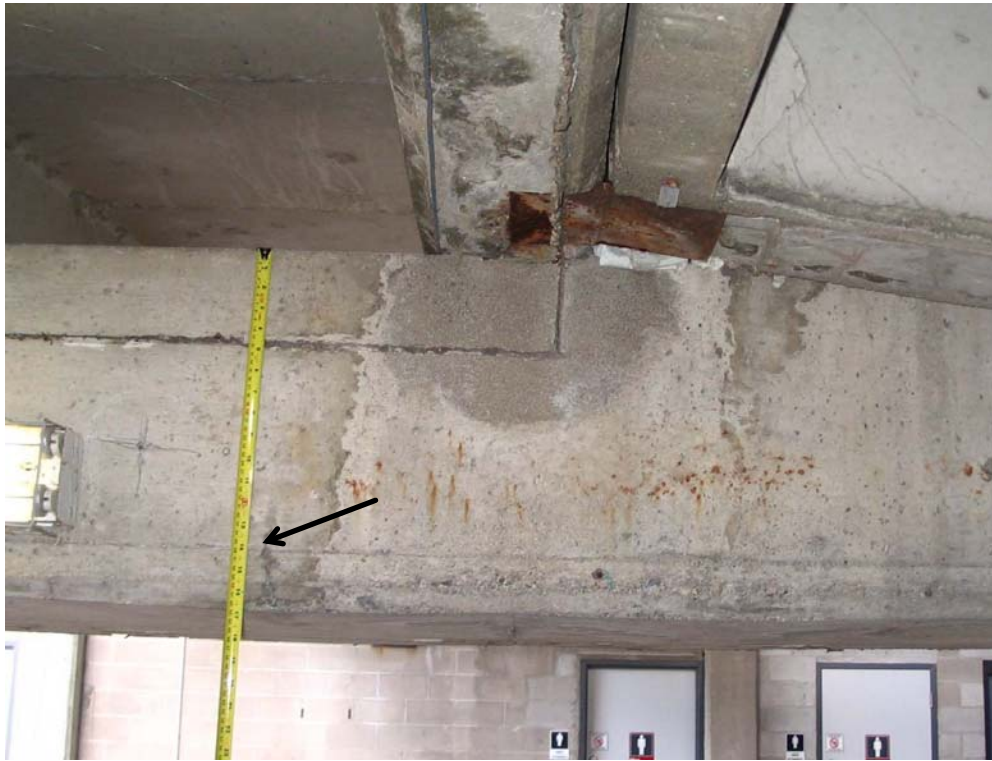
Photo 17 – Ramp Support Beam Cracks

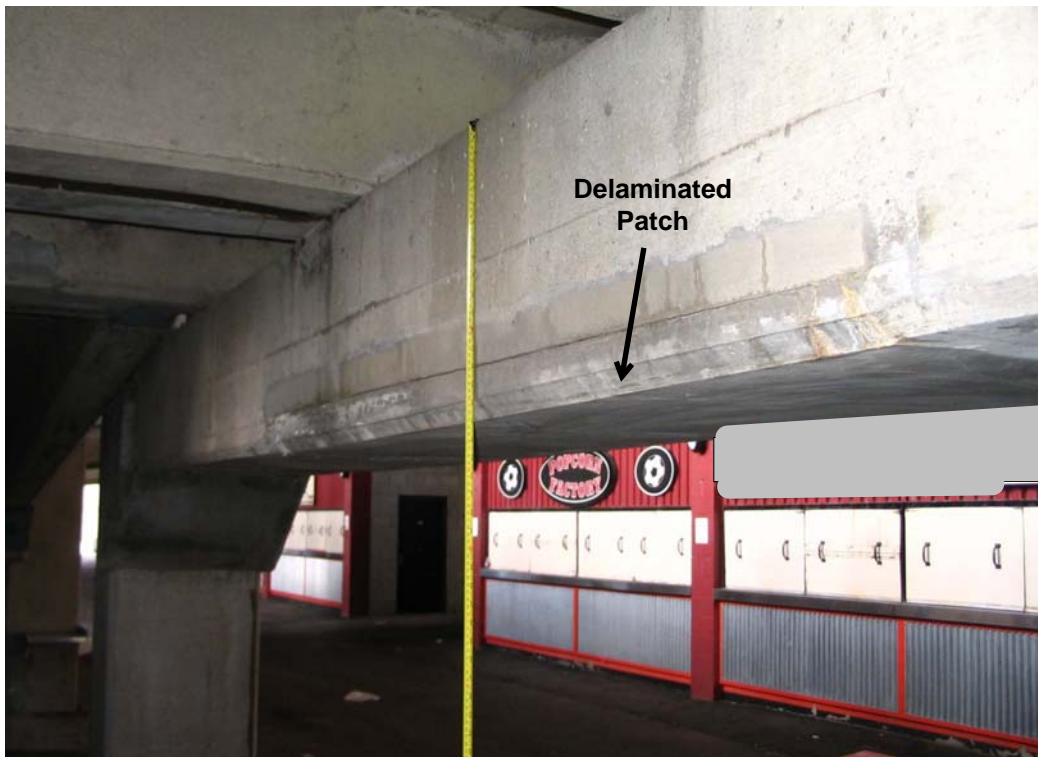
Photo 18 – Ramp Support Beam Delamination

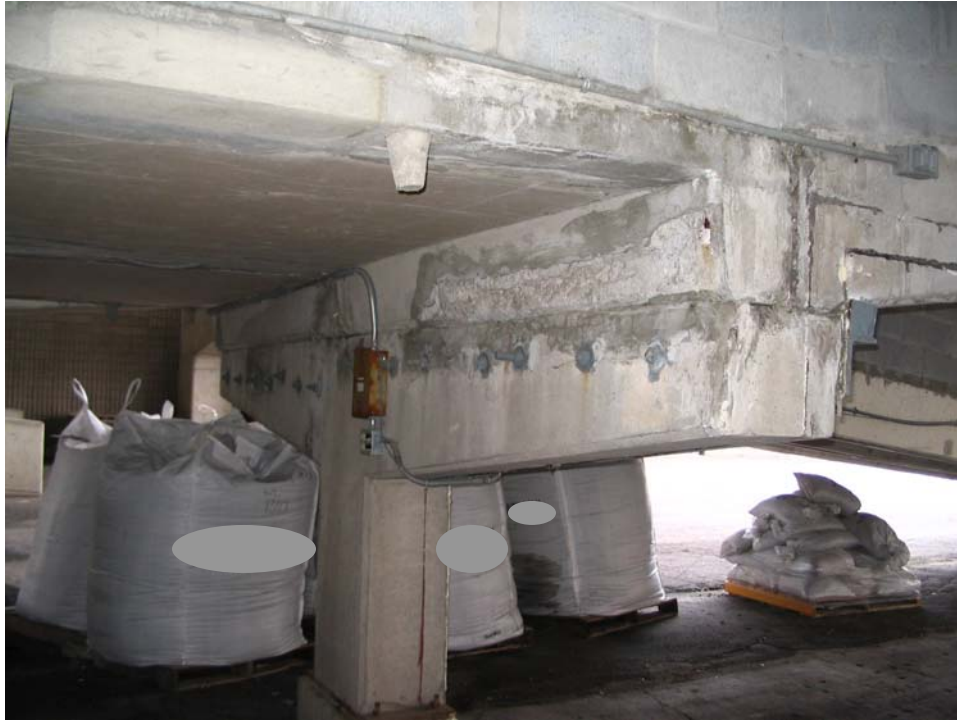
The ramp support columns are precast and T-shaped as evident in photo 19 with the stem having a steel base plate bolted to the foundation. The ramp slabs are pinned to the top of the tee portion of these columns.

Photo 19 – Ramp Column Support @ Landing Slab:  
Guard rebar anchors; landing slab cracks;  
ramp column tee crack

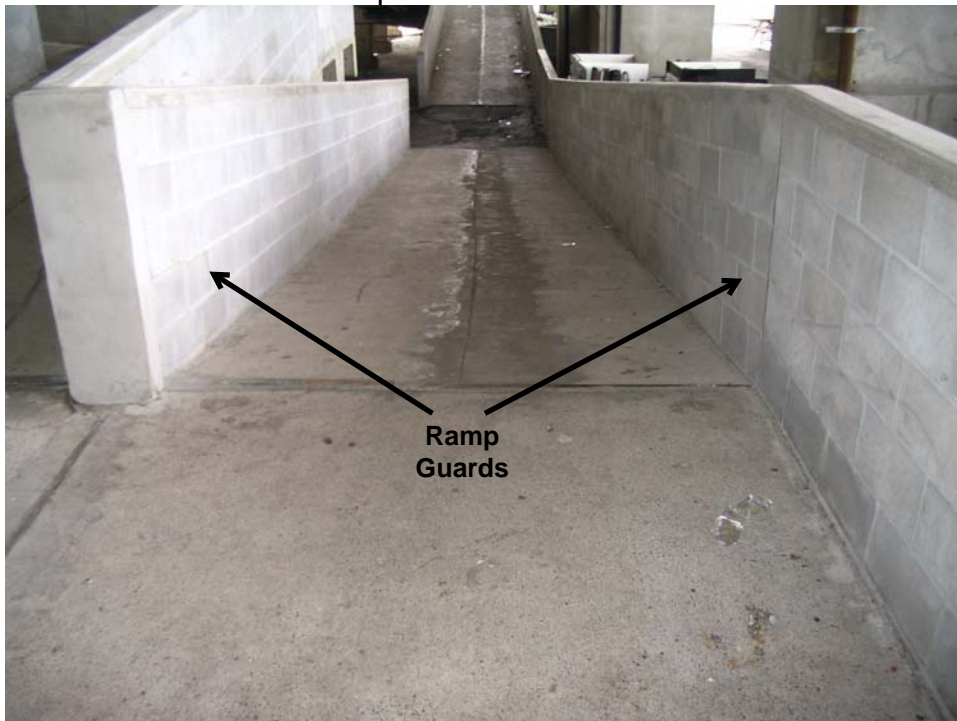
The access ramp guardrails consist of reinforced 150mm concrete blocks with a concrete cap as shown in Photo 20. These rails were reconstructed in 2001 and are considered in good condition.

Photo 20 – Ramp R4: Block Guards

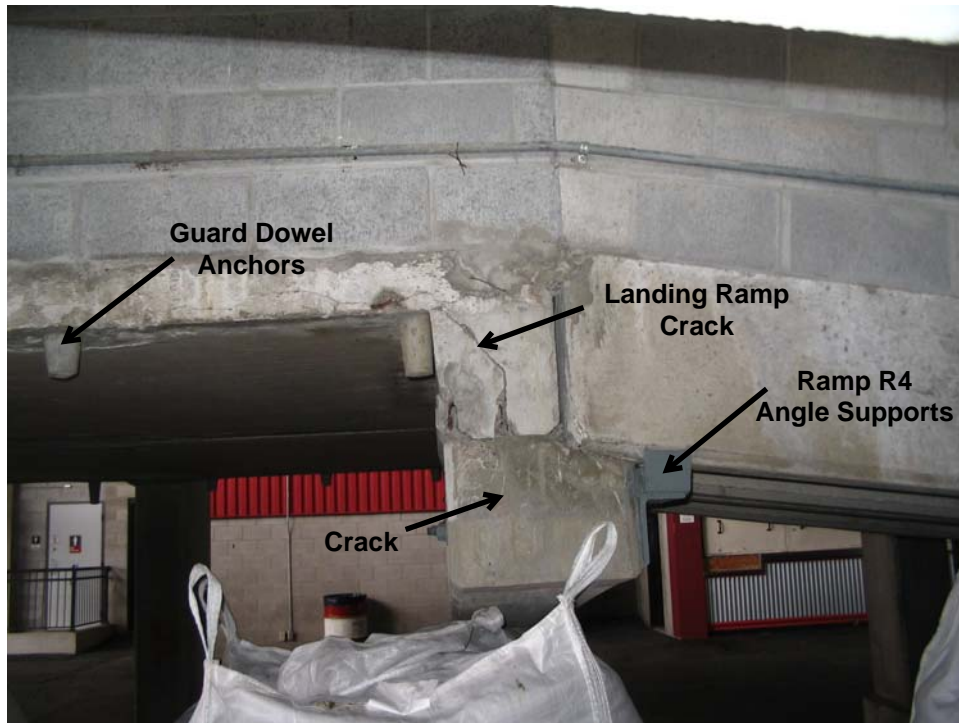
The tee portion of the column has longitudinal and transverse cracks with diagonal longitudinal cracks evident at the ends. The angle and through bolts appear to have been added to reinforce the tee, providing additional support for the sloped ramp sections. The landing ramp side of the tees are now distressed as evident, in photo 21, by the diagonal crack.

The anchorage of the block railing to the ramp landings was found to have the concrete extension below the slab, as shown in photo 21, to suit the required development of the reinforcing steel into the precast slab. At section BB, many of the railing dowel concrete sections below the slab were noted as missing with deterioration of the slab edge. See photo 04 and 22. The design of the railings required the development of the reinforcing through the precast slab and as such these rails are considered locally as no longer anchored.

Photo 21 – Ramp Column End View: Guard rebar anchors; Landing slab cracks; Ramp column cracks; Ramp R4 bearing support previous repairs

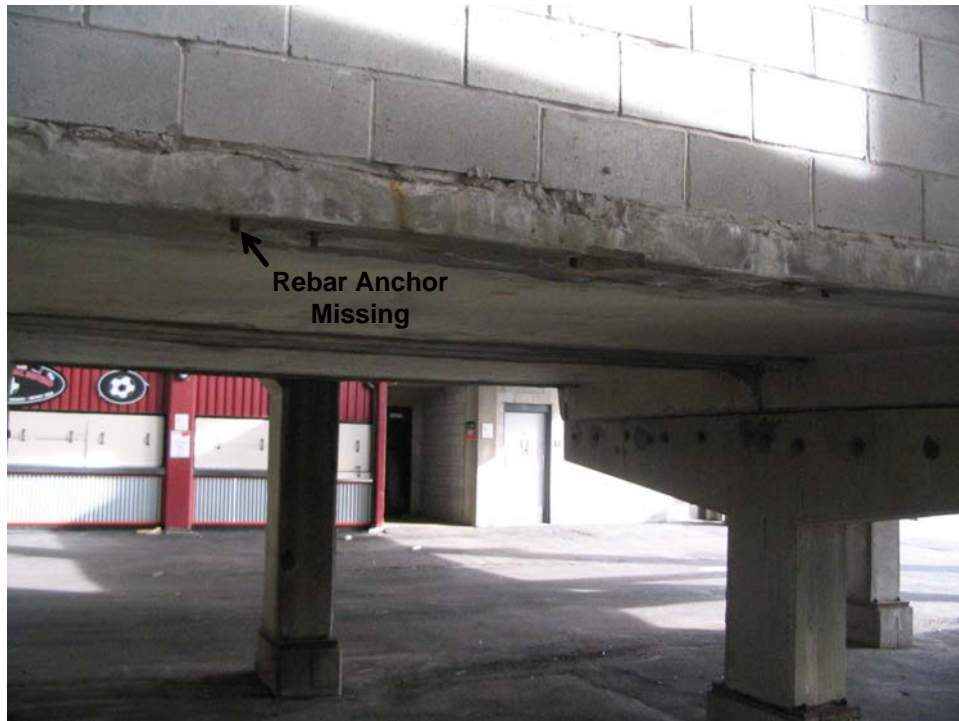
Photo 22 – Landing Ramp: Delamination slab edge; Guard rail anchors

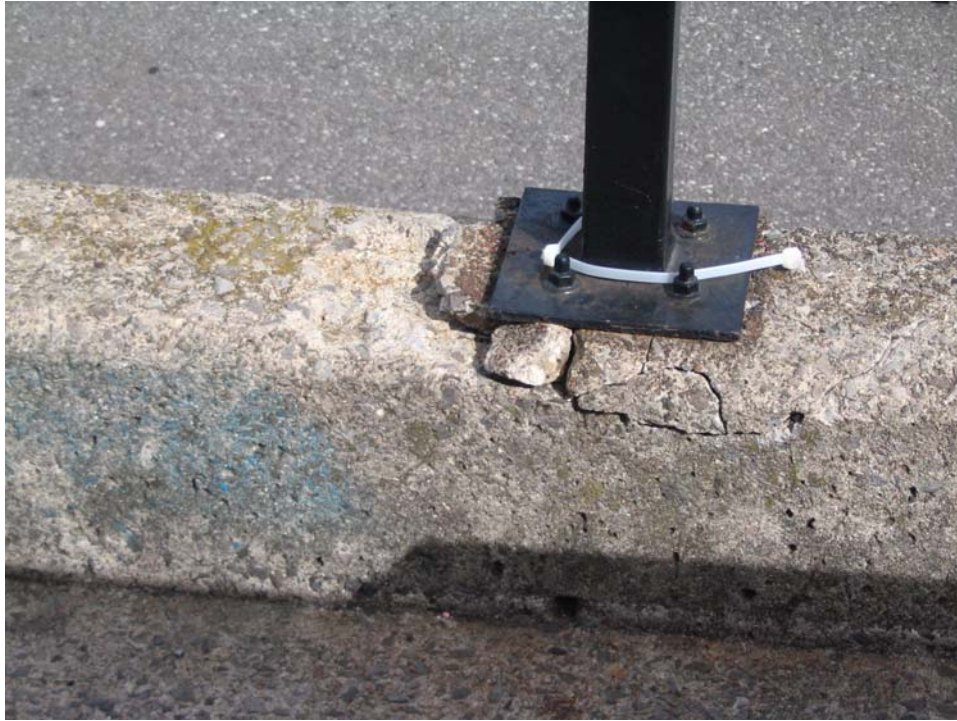
Photo 23 – Front Guard Rail: Deterioration base

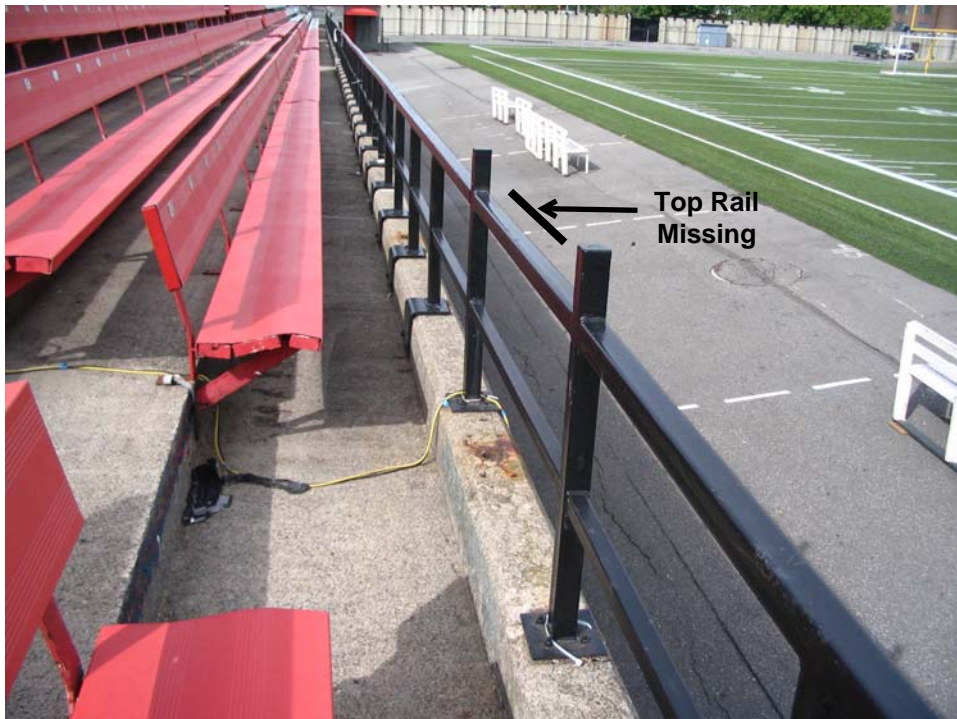
The front railing posts and horizontal rails were reconstructed in 1990 and currently have local deteriorated concrete at an anchor location and a section of upper rail is missing. The concrete supporting a post has delaminated as evident in Photo 23. The top railing at the front of the aisle is required to be higher than at the front of seating. It was noted that at one of the aisle locations, the verticals are in place without the top extension rail section, above the seating rail height, as evident in Photo 24.

Photo 24 – Front aisle guard rail: Top horizontal rail missing

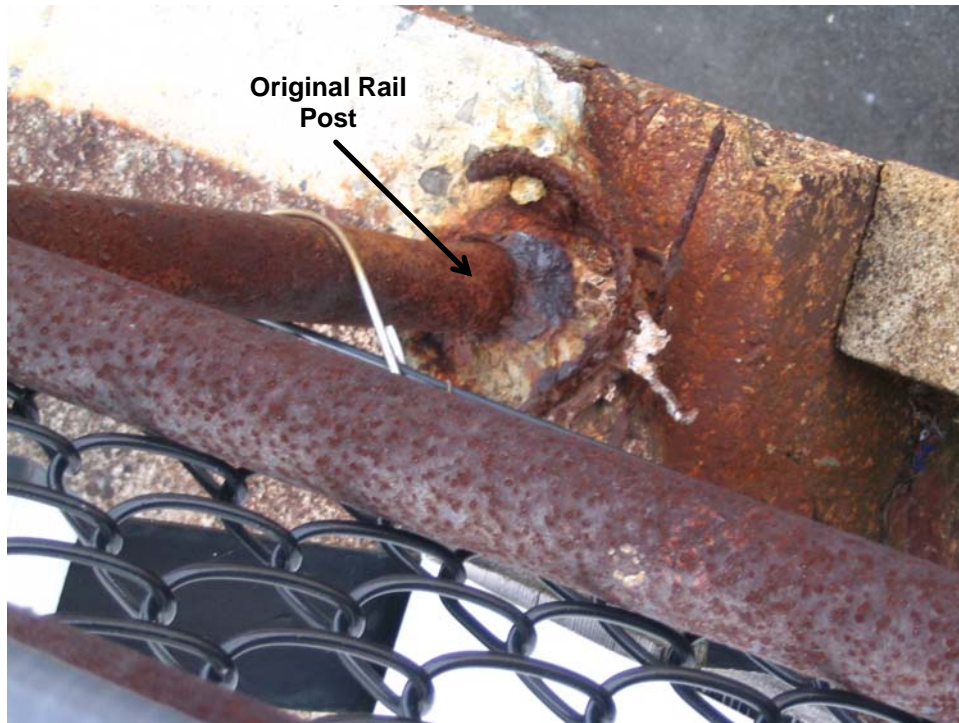
The original posts are currently deteriorated. See Photo 24. The railing replacement undertaken in 1990 was to reinforce the railing by adding new verticals to supplement the posts that have deteriorated.

Photo 25 – Side Guards: Corroded post; kick stop missing
