1. REHABILITATION OF POOLEY'S BRIDGE AND FIVE STONE ARCH BRIDGES -  
LEBRETON FLATS - PUBLIC HEARING

DATE                        19 March 1999

SUBJECT/OBJET           **REHABILITATION OF POOLEY'S BRIDGE AND FIVE STONE  
                                  ARCH BRIDGES - LEBRETON FLATS**

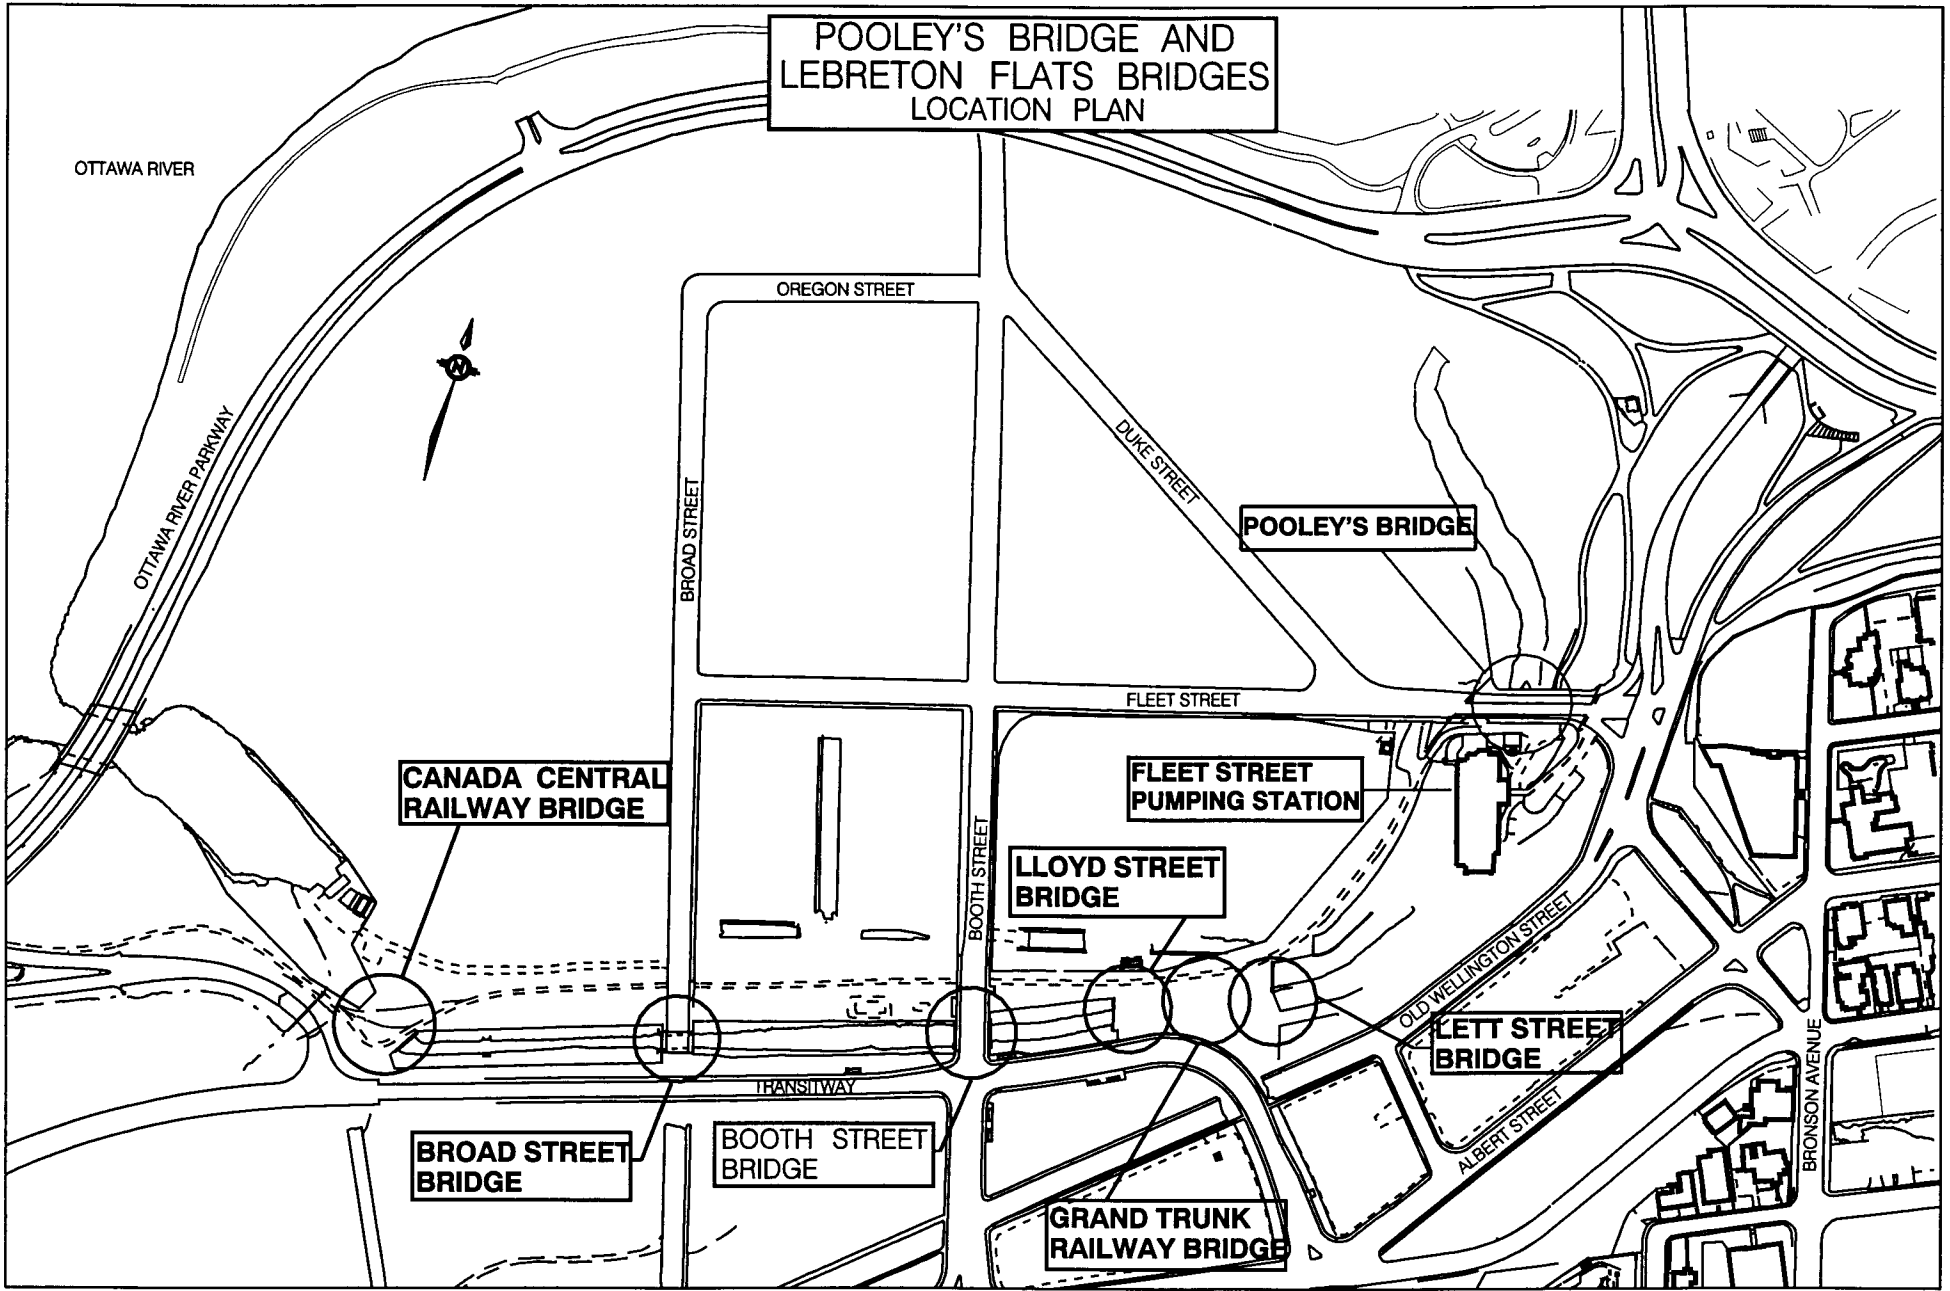
**FIG 1**

**POOLEY'S BRIDGE AND  
LEBRETON FLATS BRIDGES  
LOCATION PLAN**

On 04 August 1998, Corporate Services and Economic Development Committee approved the appointment of Stantec Consulting Group, with Barry Padolsky, Heritage Architect, as sub-consultant, to provide engineering services to reassess the condition and feasibility of rehabilitation of Pooley's Bridge as a pedestrian/bicycle facility. This reassessment was initiated due to heritage interest in the structure. The engineering reports completed in 1994 indicated that the structure could not be economically rehabilitated due to concerns relating to continuing disintegration of the existing stones. This appointment also included engineering services related to limited repairs to five single span stone arch bridges in the Lebreton Flats area. The locations of Pooley's Bridge and five Lebreton flats Bridges are illustrated in Figure 1.

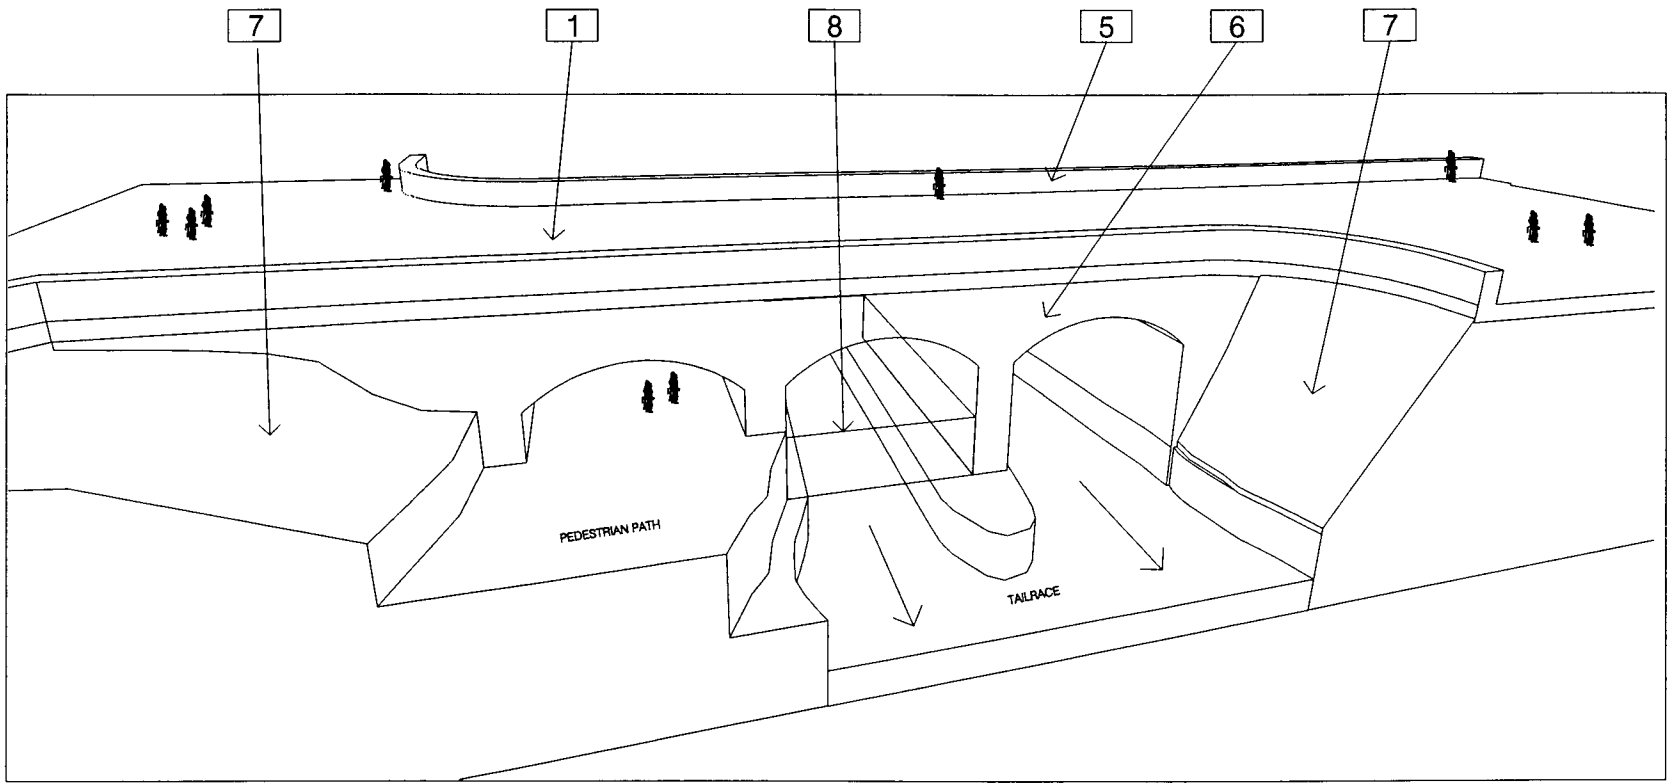
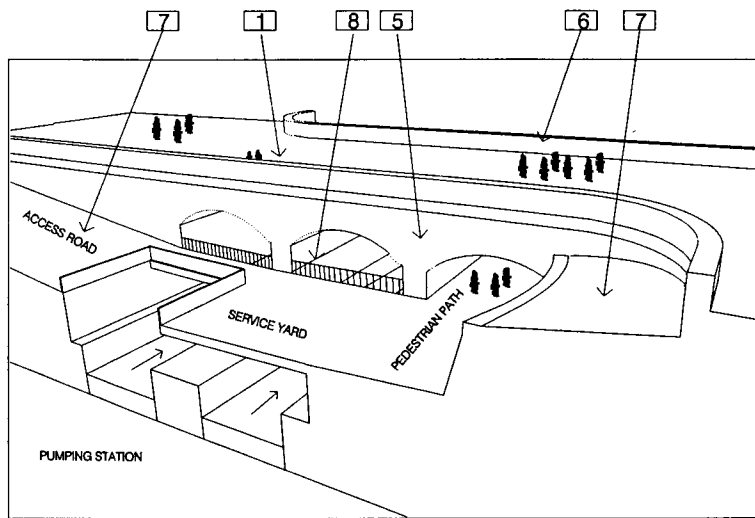
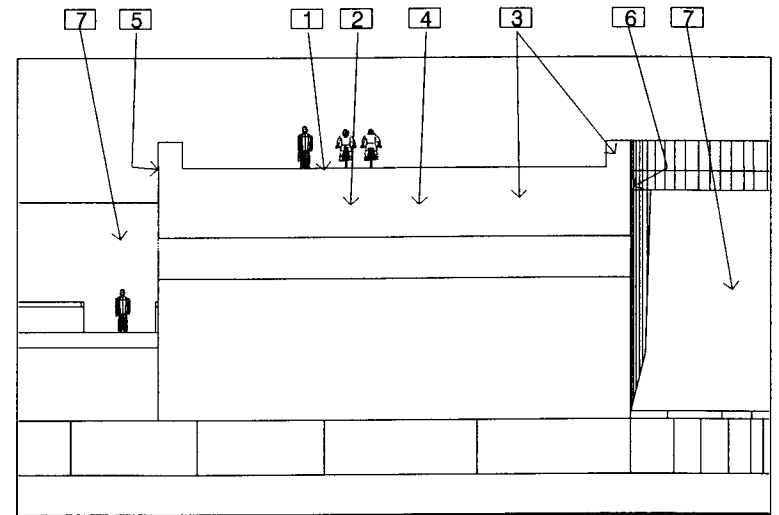
FIG 3

- 1. Rehabilitated bridge.
- 2. New concrete arches.
- 3. New concrete slab and upstand.
- 4. New fill.
- 5. Refaced stone south spandrel wall.
- 6. New stone north spandrel wall.
- 7. Landscaping to remain.
- 8. Remove existing timber cribwork.

POOLEY'S BRIDGE REHABILITATION ALT. 1

**Alternative 1:** Rehabilitation to existing width with new elements. (Fig. 3)

Apart from providing a 16 m. width, Alternative 1 would recreate the aesthetics of the original bridge with a substantial quantity of new stones using an inner concrete support structure. The historic character of the

Estimated cost of this alternative is \$4,350,000 with a 50 year service life, with a major rehabilitation in a 25 year timeframe.

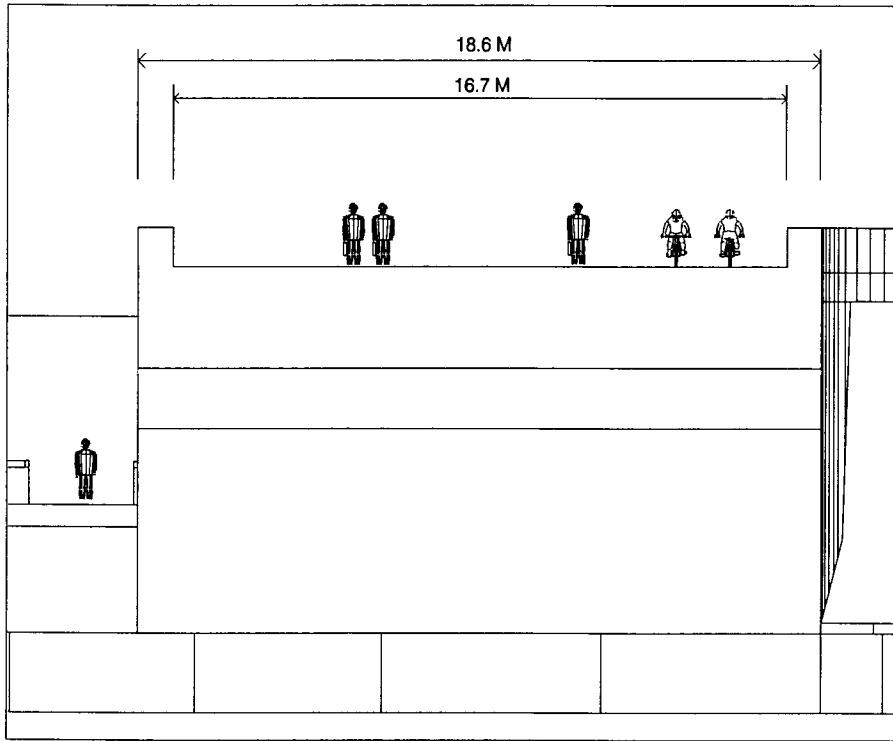
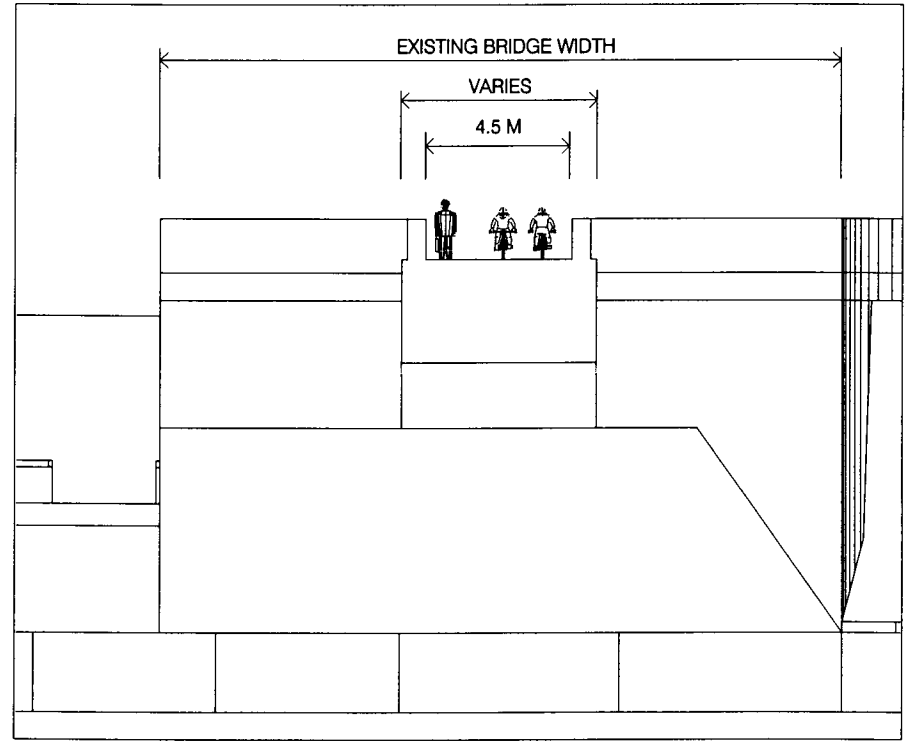
CROSS SECTION - ALTERNATIVE 1

CROSS SECTION - ALTERNATIVES 2 to 5

Alternative 1 is based on rehabilitation of the bridge to full width of the existing structure (18.0 metre total and 16.7 metre clear).

Alternatives in categories 2 to 5 were initially developed on the basis of a 5.0 metre wide structure with a 3.8 metre usable width and were presented as such at the Public Information Centre. These alternatives have since been revised to provide a 4.5 metre clear usable width. There is progressively lesser preservation of heritage elements from alternatives 2 to 5.

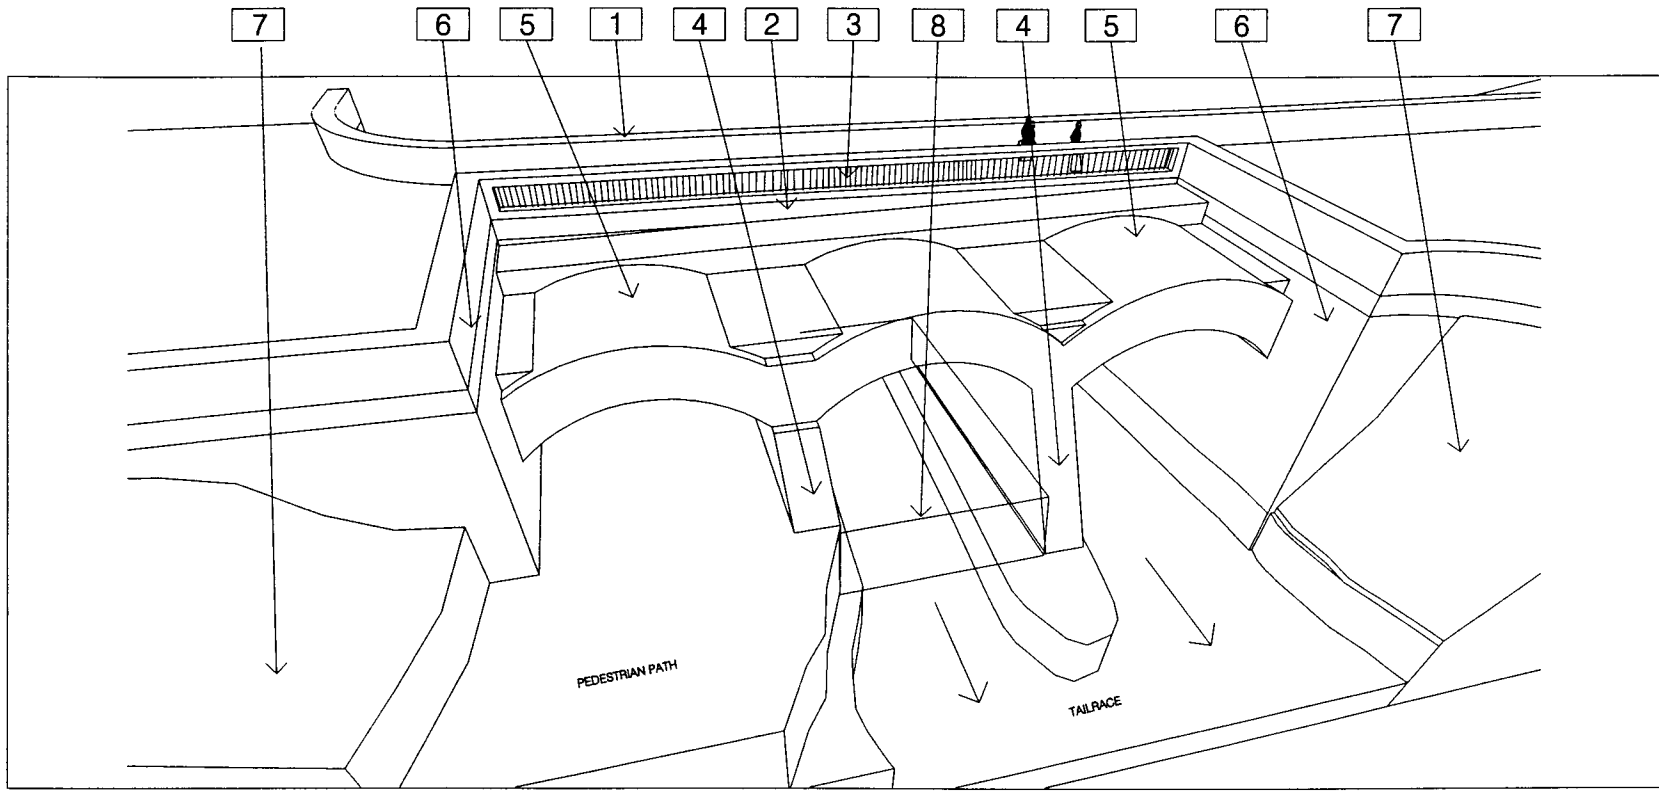
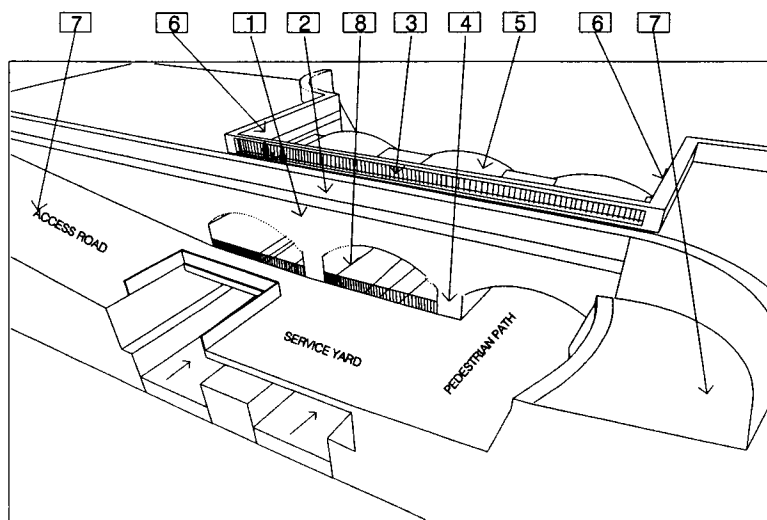
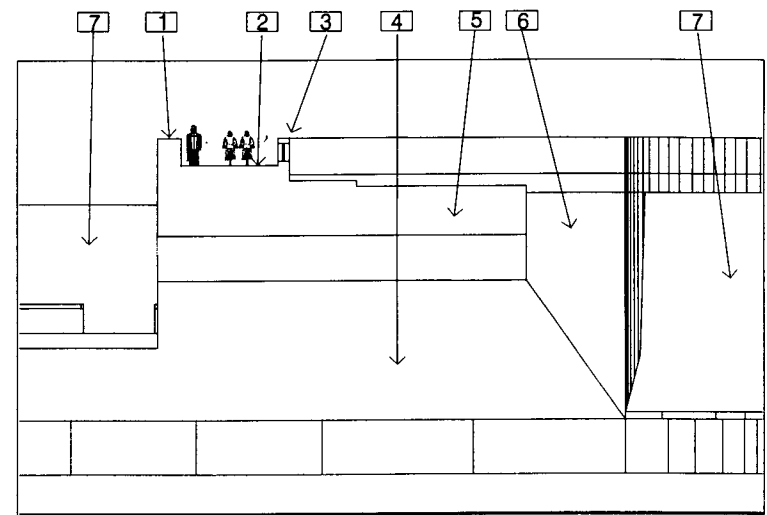
FIG 4

POOLEY'S BRIDGE REHABILITATION ALT. 2A

- 1. Retain and stabilize existing south stone spandrel wall.
- 2. New concrete pedestrian bridge structure (stone veneer).
- 3. New north railing (stone veneer w/ metal railing).
- 4. Retain and stabilize existing stone piers as "ruins".
- 5. Retain and stabilize existing arches as "ruin".
- 6. Retain and stabilize east and west abutments north of new pedestrian bridge.
- 7. Landscaping to remain.
- 8. Remove existing timber cribwork.

**Alternative 2A:** Rehabilitation to accommodate new bridge on south side and maximum retained ruin elsewhere. (Figs. 4 & 5)

Estimated cost of this alternative is \$1,600,000 with a 50 year service life.

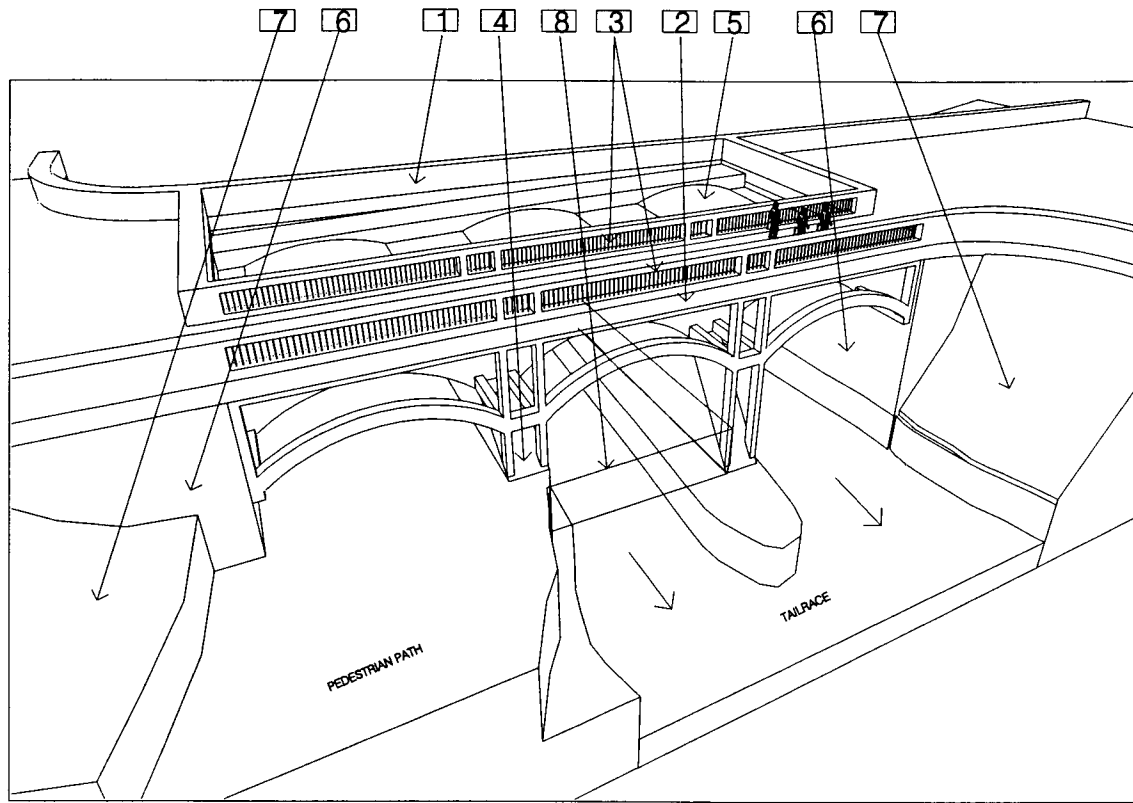
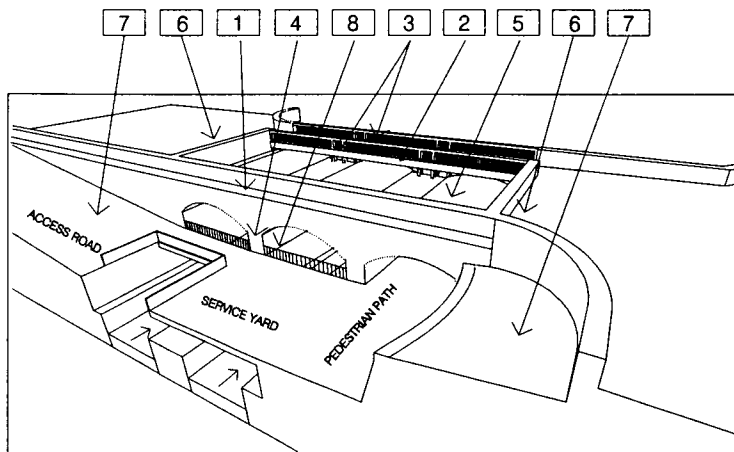
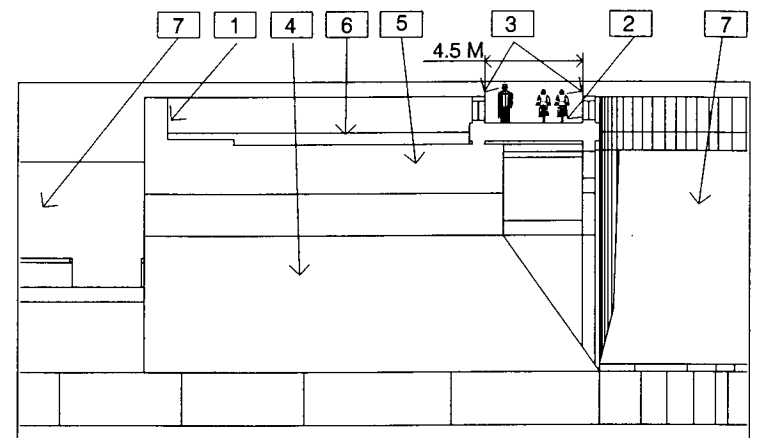
FIG 5

POOLEY'S BRIDGE REHABILITATION ALT. 2A

1. Retain and stabilize existing south stone spandrel wall.
2. New concrete or metal pedestrian bridge structure.
3. New railings.
4. Retain and stabilize existing stone piers as "ruins".
5. Retain and stabilize existing arches as "ruins".
6. Retain and stabilize east and west abutments south of new pedestrian bridge.
7. Landscaping to remain.
8. Remove existing timber cribwork.

**Alternative 2B:** Rehabilitation to accommodate new bridge on north side and maximum retained ruin elsewhere. (Fig. 6)

Estimated cost of this alternative is \$1,490,000 with a service life of 50 years.

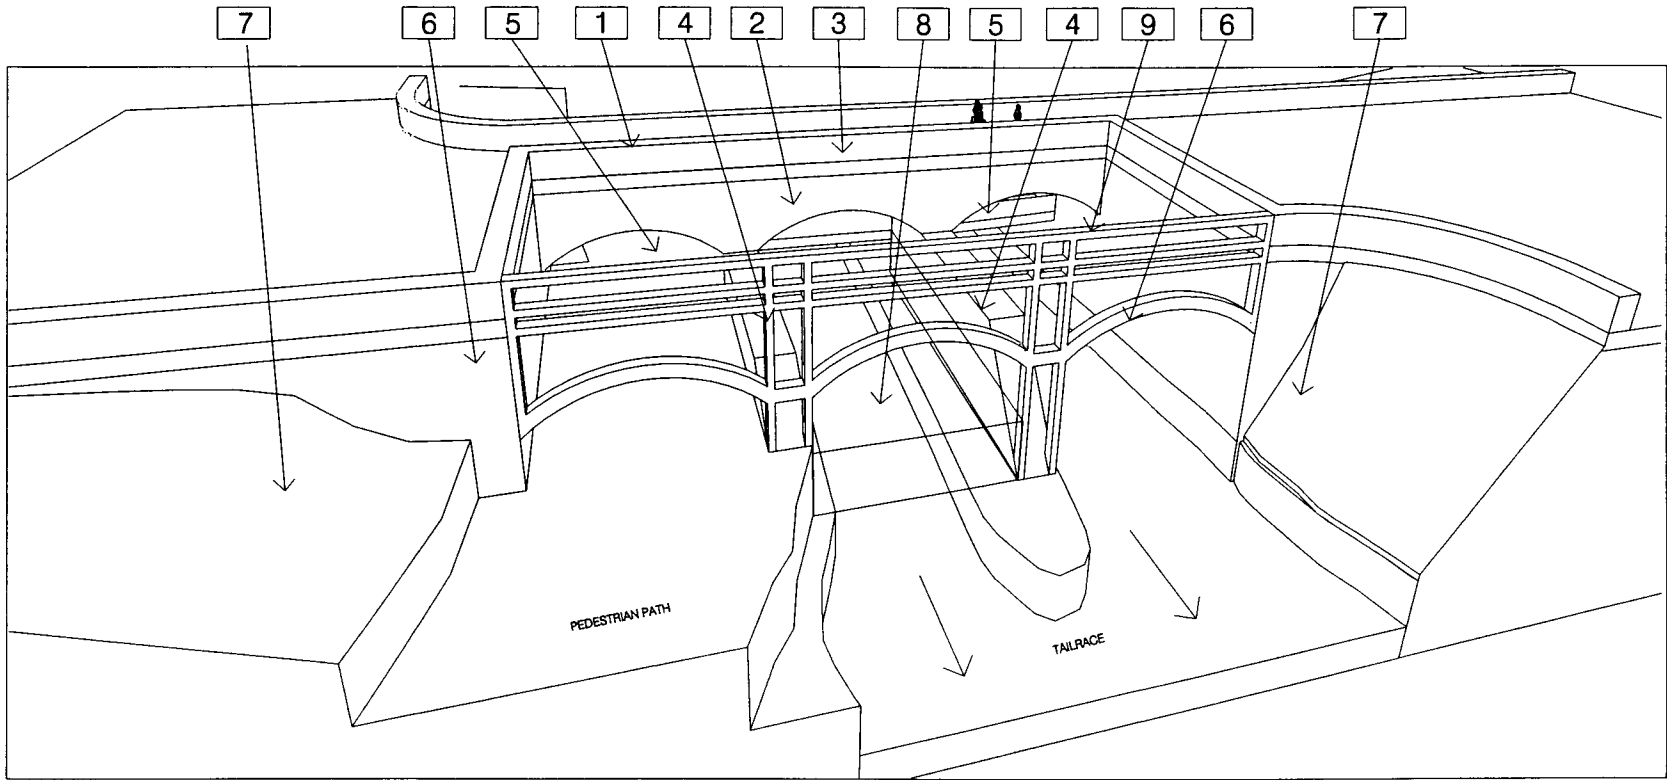
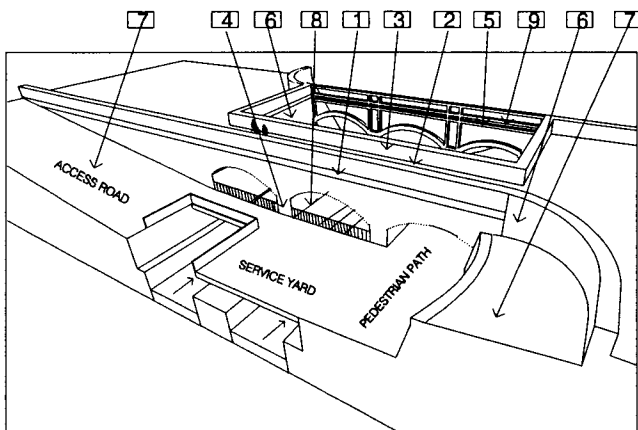
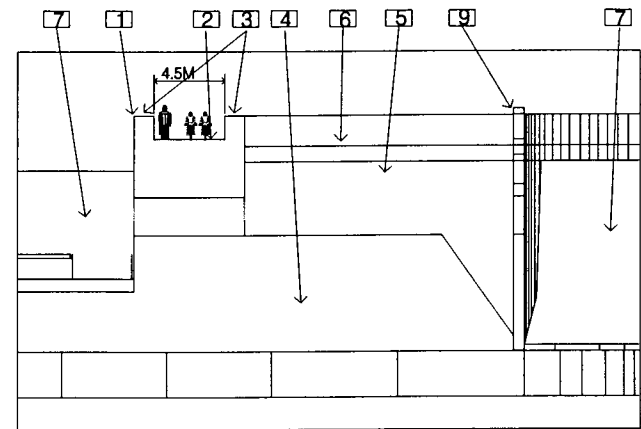
FIG 7

1. Retain and stabilize existing south stone spandrel wall.
2. New concrete pedestrian bridge structure (stone veneer).
3. New north railing (stone veneer).
4. Retain and stabilize existing stone piers as "ruins".
5. Remove existing arches.
6. Retain and stabilize east and west abutments north of new pedestrian bridge.
7. Landscaping to remain.
8. Remove existing timber cribwork.
9. Steel "Ghost" outline of original bridge structure.

POOLEY'S BRIDGE REHABILITATION ALT. 3A

**Alternative 3A:** Rehabilitation to accommodate a new concrete bridge on the south side and 'Ghosted' outline of south spandrel wall. (Fig. 7)

Estimated cost of this alternative is \$1,300,000 with a service life of 50 years.

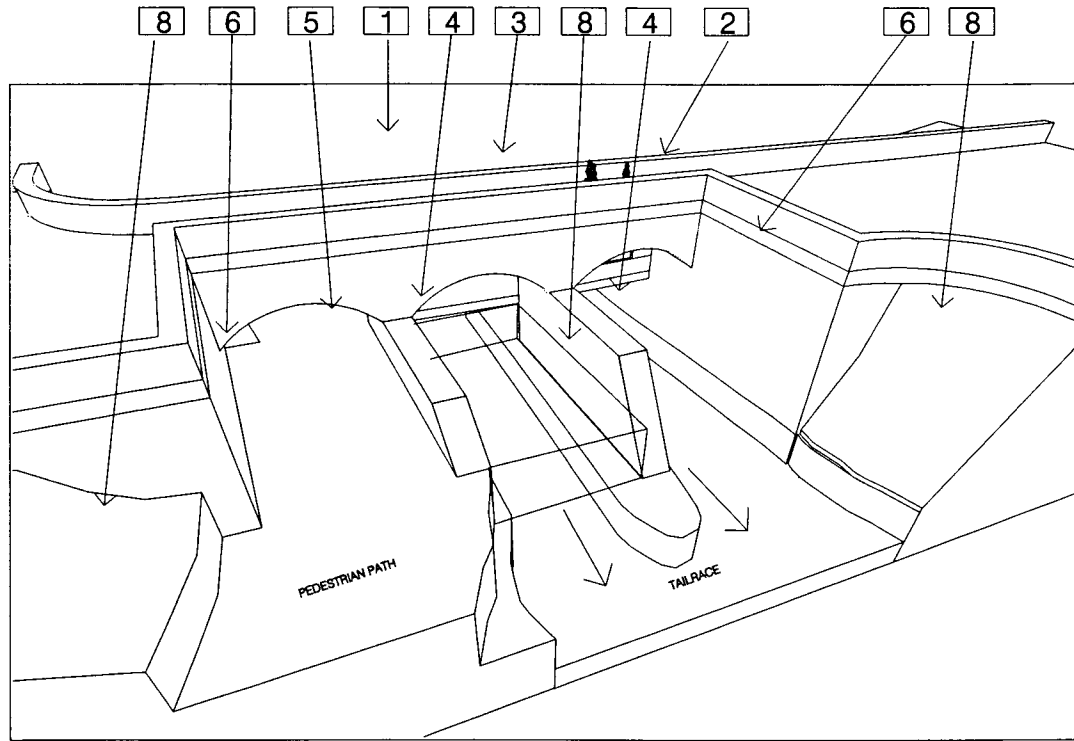
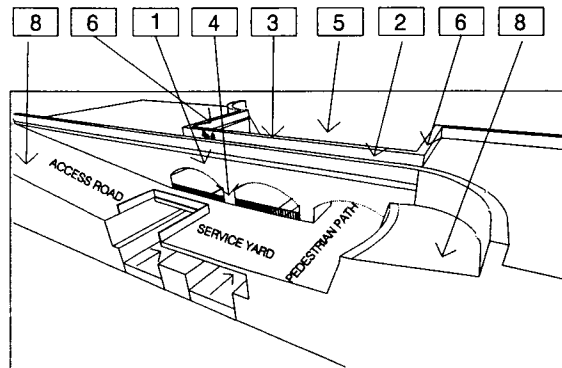
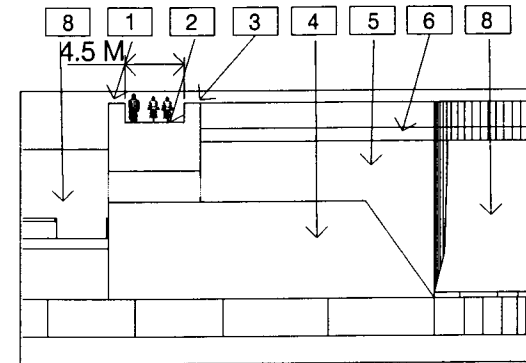
**FIG 8**

1. Retain and stabilize existing south stone spandrel wall.
2. New concrete pedestrian bridge structure (stone veneer).
3. New north railing (stone veneer).
4. Retain and stabilize existing stone piers as "ruins".
5. Remove existing arches.
6. Retain and stabilize east and west abutments north of new pedestrian bridge.
7. Remove east and west abutments north of new pedestrian bridge.
8. Landscaping to remain.
9. New site regrading and new landscaping for abutment replacement.
10. Remove existing timber cribwork.

**POOLEY'S BRIDGE REHABILITATION ALT. 3B  
(RECOMMENDED)**

**Alternative 3B:** Rehabilitation to accommodate a new concrete bridge on south side and preservation of substructure elements. (Fig. 8)

Estimated cost of this alternative is \$1,270,000 with a service life of 50 years.

Based on assessment of various alternatives developed, implementation of Alternative 3B is recommended. The main features of this alternative are as follows:

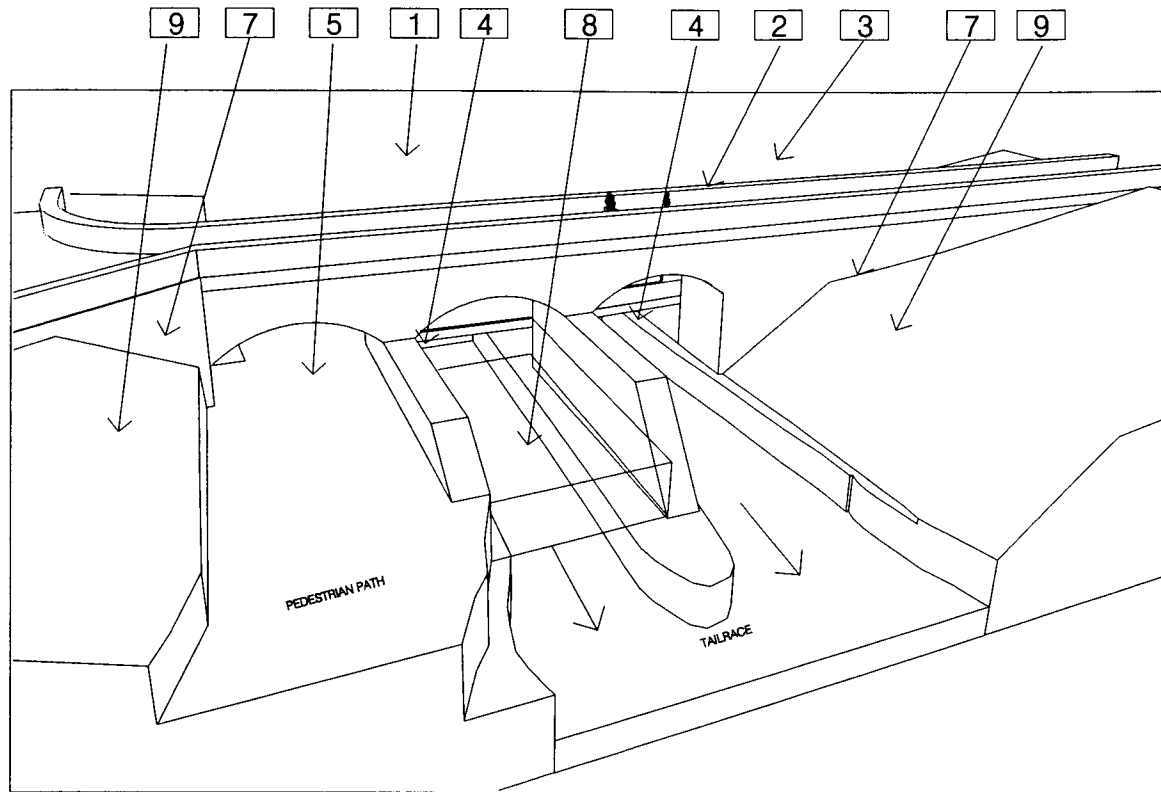
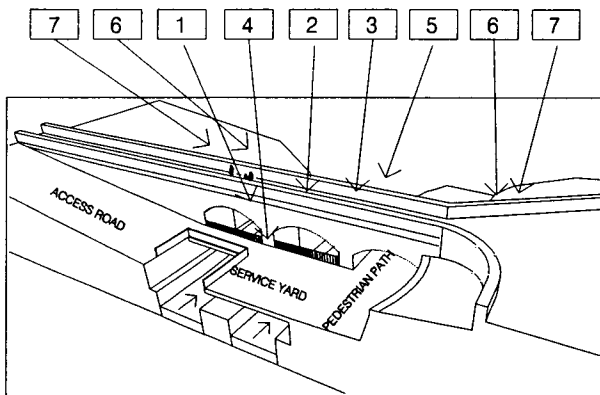
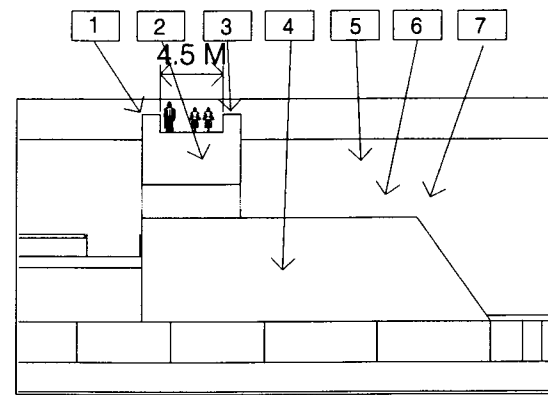
1. Retain and stabilize existing south stone spandrel wall.
2. New concrete pedestrian bridge structure (stone veneer).
3. New north railing (stone veneer).
4. Retain and stabilize existing stone piers as "ruins".
5. Remove existing arches.
6. Retain and stabilize east and west abutments north of new pedestrian bridge.
7. Remove east and west abutments north of new pedestrian bridge.
8. Landscaping to remain.
9. New site regrading and new landscaping for abutment replacement.
10. Remove existing timber cribwork.

**Alternative 3C:** Rehabilitation to accommodate a new bridge on south side and preserve pier elements. (Fig. 9)

Estimated cost of this alternative is \$1,280,000 with a service life of 50 years.

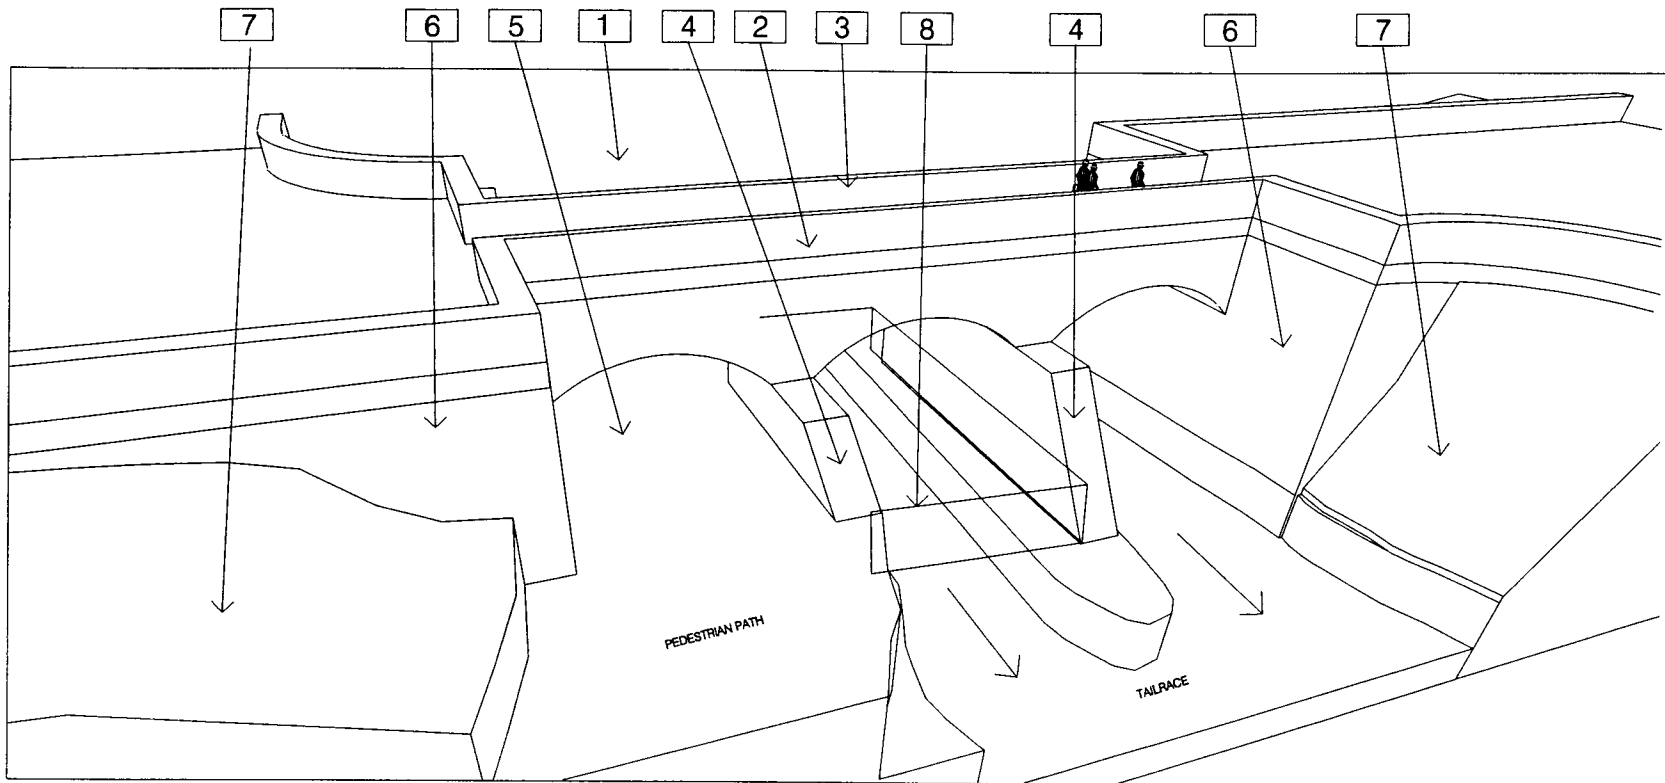
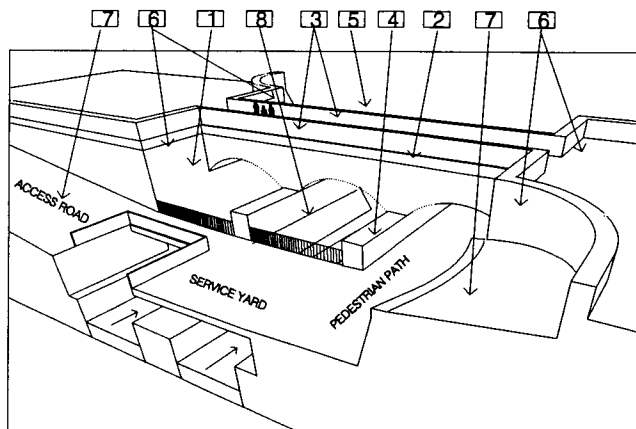
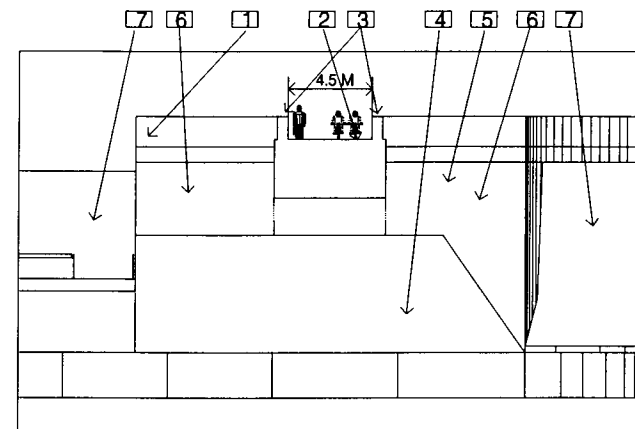
FIG 10

1. Remove existing south stone spandrel wall between abutments. Restore the rest of the wall.
2. New pedestrian bridge structure (concrete clad with stone veneer).
3. Concrete clad with stone veneer railing.
4. Retain and stabilize existing stone piers.
5. Remove deteriorated portion of bridge.
6. Retain and stabilize east and west abutments on both sides of new pedestrian bridge.
7. Landscaping to remain.
8. Remove existing timber cribwork.

POOLEY'S BRIDGE REHABILITATION ALT. 4A

**Alternative 4A:** New 3 span concrete arch bridge (centred) on existing substructure. (Fig. 10)

Estimated cost of this alternative is \$1,300,000 with a service life of 50 years.

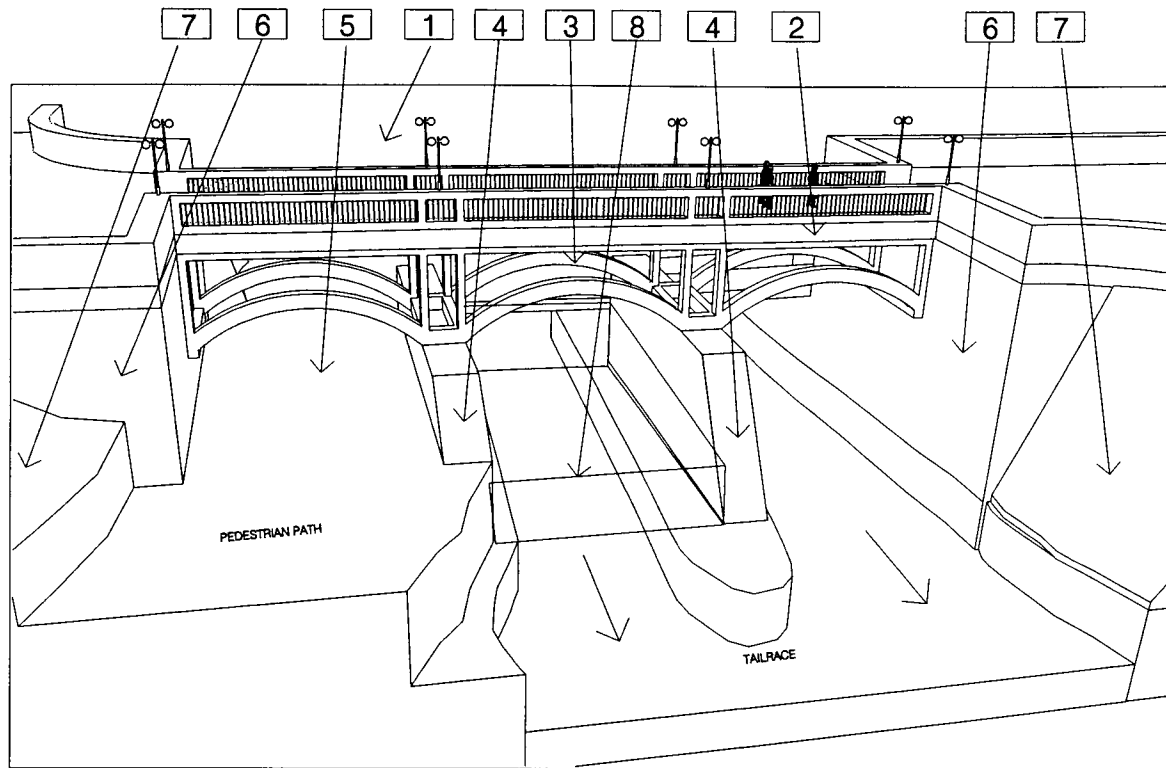
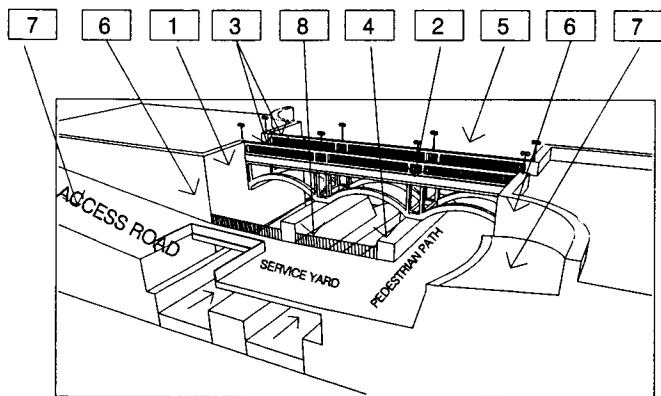
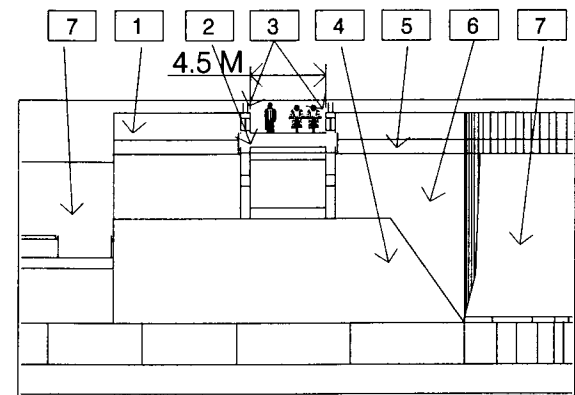
1. Remove existing south stone spandrel wall between abutments. Restore the rest of the wall.
2. New pedestrian bridge structure (precast/concrete/steel).
3. Precast concrete and/or steel railing.
4. Retain and stabilize existing stone piers as "ruins".
5. Remove deteriorated portion of bridge.
6. Retain and stabilize east and west abutments on both sides of new pedestrian bridge.
7. Landscaping to remain.
8. Remove existing timber cribwork.

**Alternative 4B:** New 3 span steel arch bridge (centred) on existing substructure width. (Fig. 11)

Estimated cost of this alternative is \$1,050,000 with a service life of 50 years.

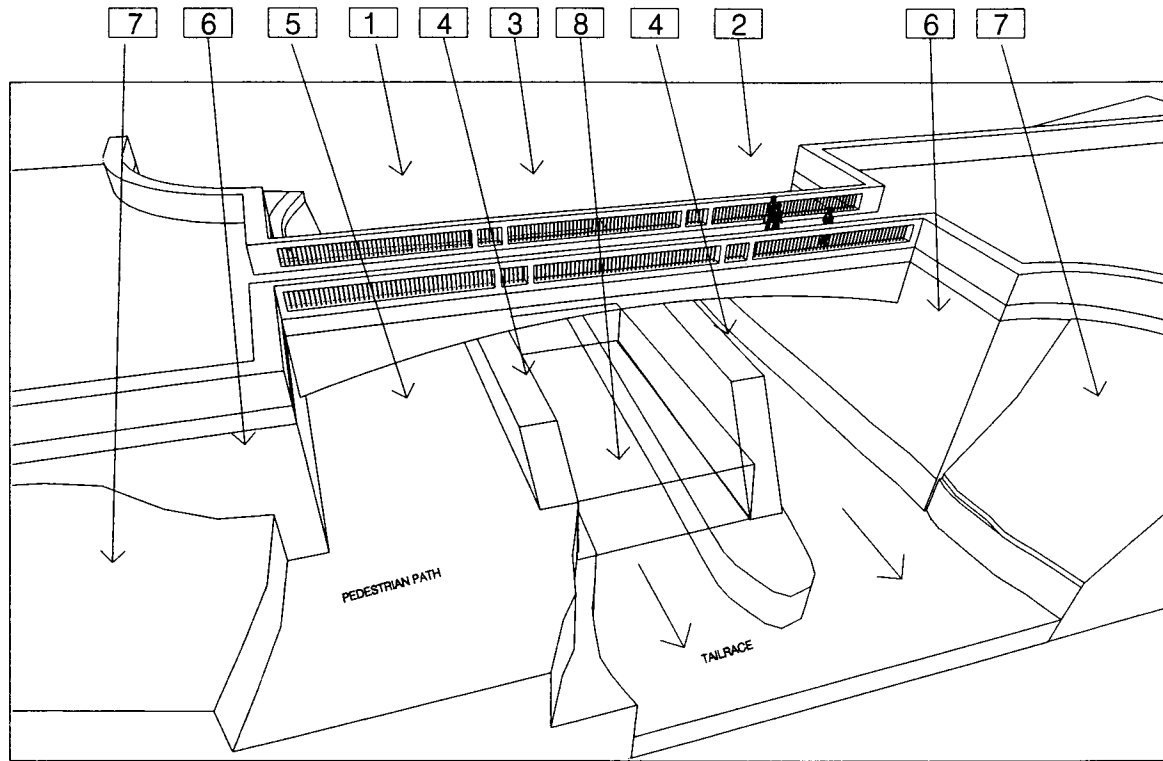
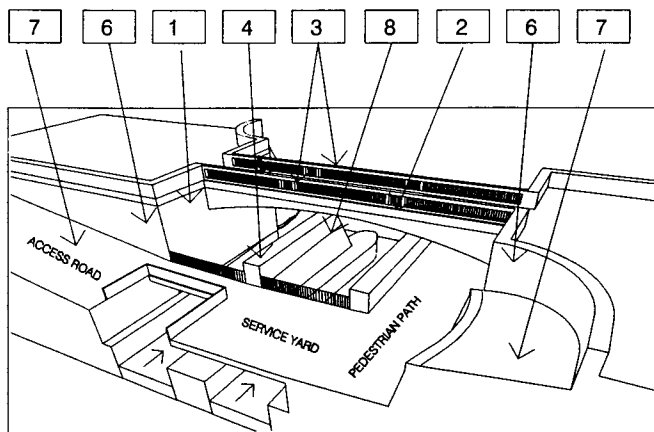
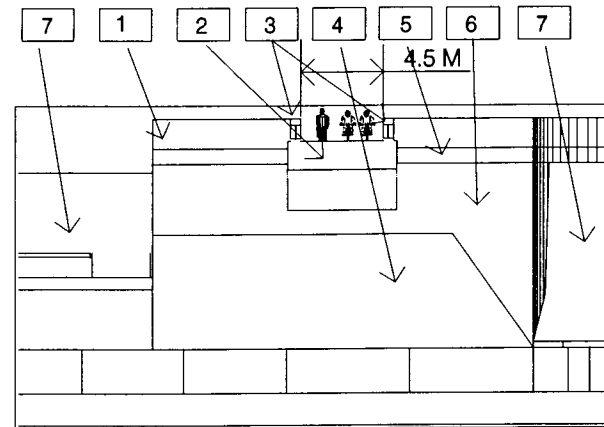
1. Remove existing south stone spandrel wall between abutments. Restore the rest of the wall.
2. New pedestrian bridge structure (precast/concrete/steel).
3. Precast concrete and/or steel railing.
4. Retain and stabilize existing stone piers as "ruins".
5. Remove deteriorated portion of bridge.
6. Retain and stabilize east and west abutments on both sides of new pedestrian bridge.
7. Landscaping to remain.
8. Remove existing timber cribwork.

**Alternative 4C:** New single span concrete arch structure (centred) on existing substructure. (Fig. 12)

Estimated cost of this alternative is \$1,025,000 with a service life of 50 years.

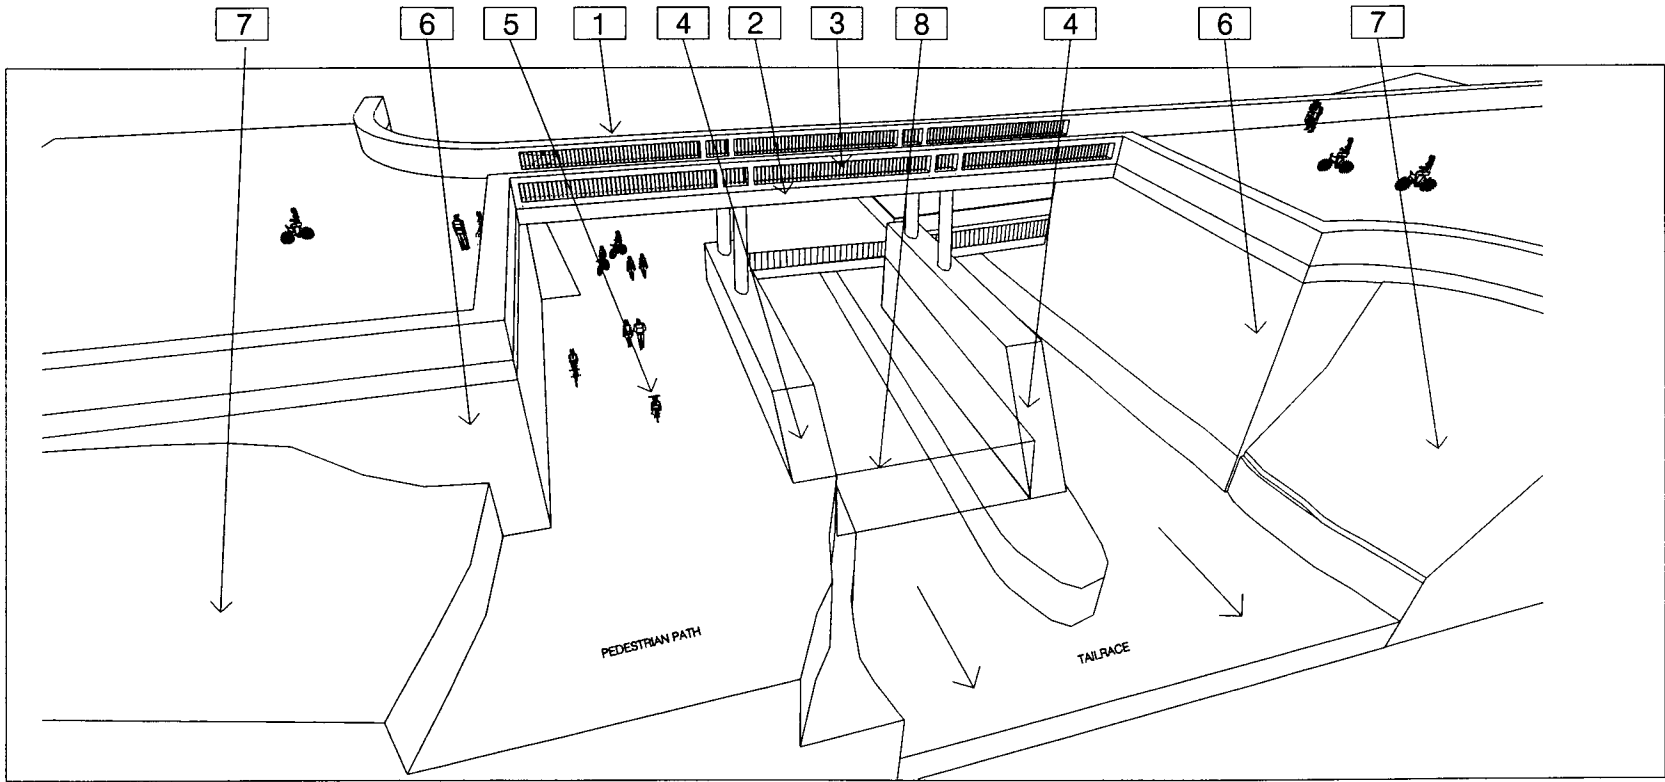
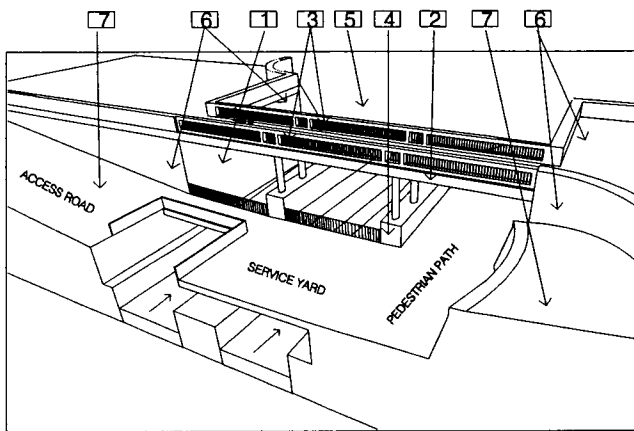
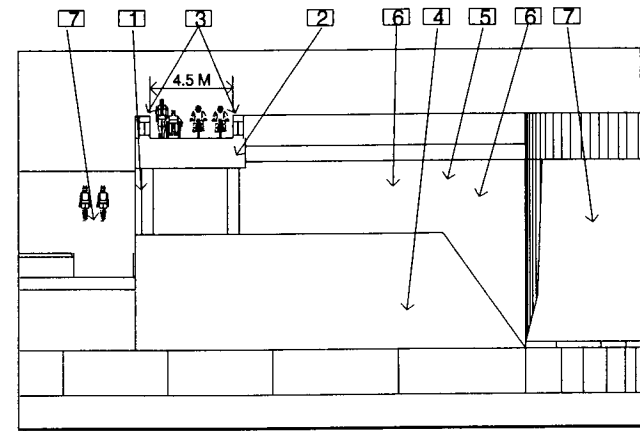
**FIG 13**

1. Remove existing south stone spandrel wall between embankments. Restore the rest of the wall.
2. New pedestrian bridge structure (steel).
3. Steel railings.
4. Retain and stabilize existing stone piers as "ruins".
5. Remove deteriorated portion of bridge.
6. Retain and stabilize east and west abutments north of new pedestrian bridge.
7. Landscaping to remain.
8. Remove existing timber cribwork.

**POOLEY'S BRIDGE REHABILITATION ALT. 5A**

**Alternative 5A:** New 3 span contrasting bridge. (Fig. 13)

Estimated cost of this alternative is \$1,010,000 with a service life of 50 years.
