1. REHABILITATION OF POOLEY'S BRIDGE AND FIVE STONE ARCH BRIDGES -  
LEBRETON FLATS - PUBLIC HEARING

DATE                        19 March 1999

SUBJECT/OBJET           **REHABILITATION OF POOLEY'S BRIDGE AND FIVE STONE  
                                  ARCH BRIDGES - LEBRETON FLATS**

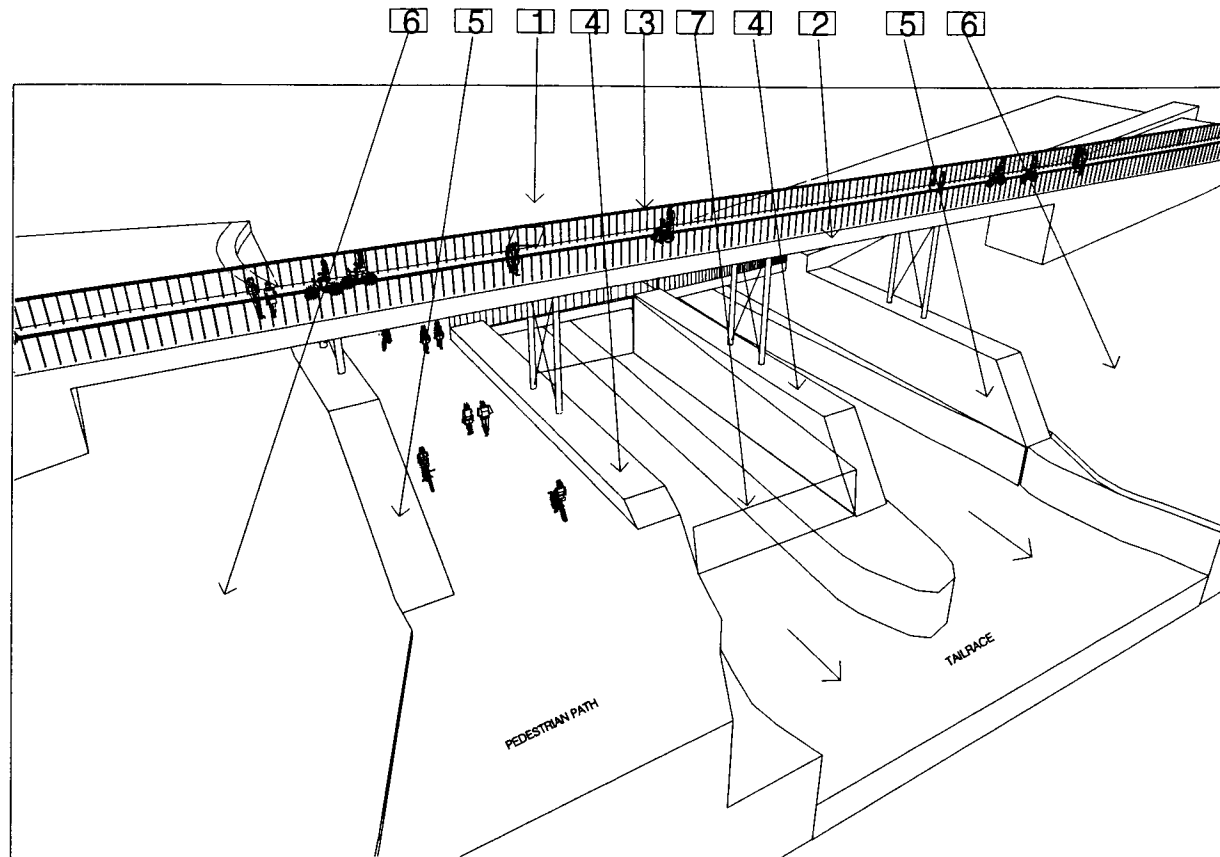
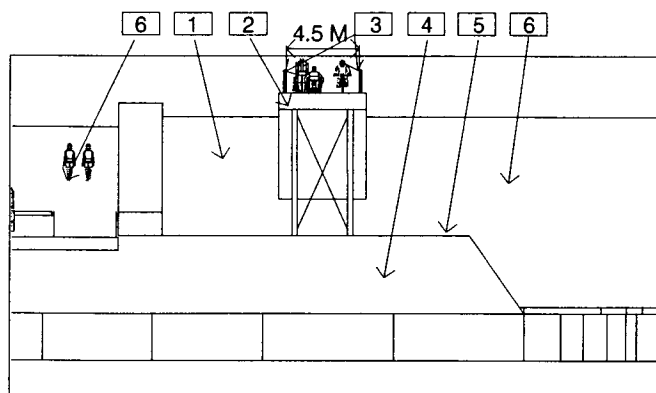
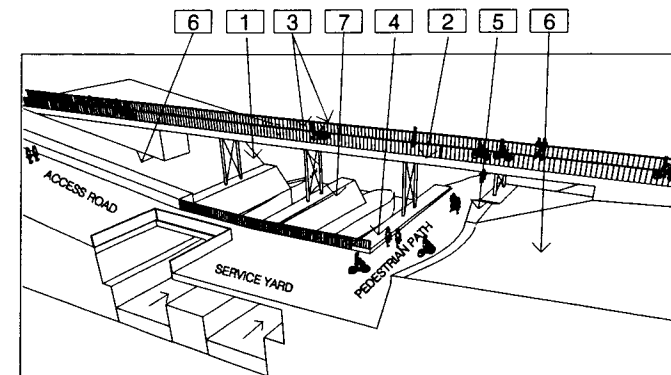
1. Remove existing bridge.
2. New pedestrian bridge structure (steel).
3. Steel railings.
4. Lower and stabilize existing stone piers.
5. Lower and stabilize east and west abutments.
6. Re-grade and new landscaping for abutment replacement.
7. Remove existing timber cribwork.

**Alternative 5B:** New 5 span steel bridge. (Fig. 14)

Estimated cost of this alternative is \$700,000 with a service life of 50 years.

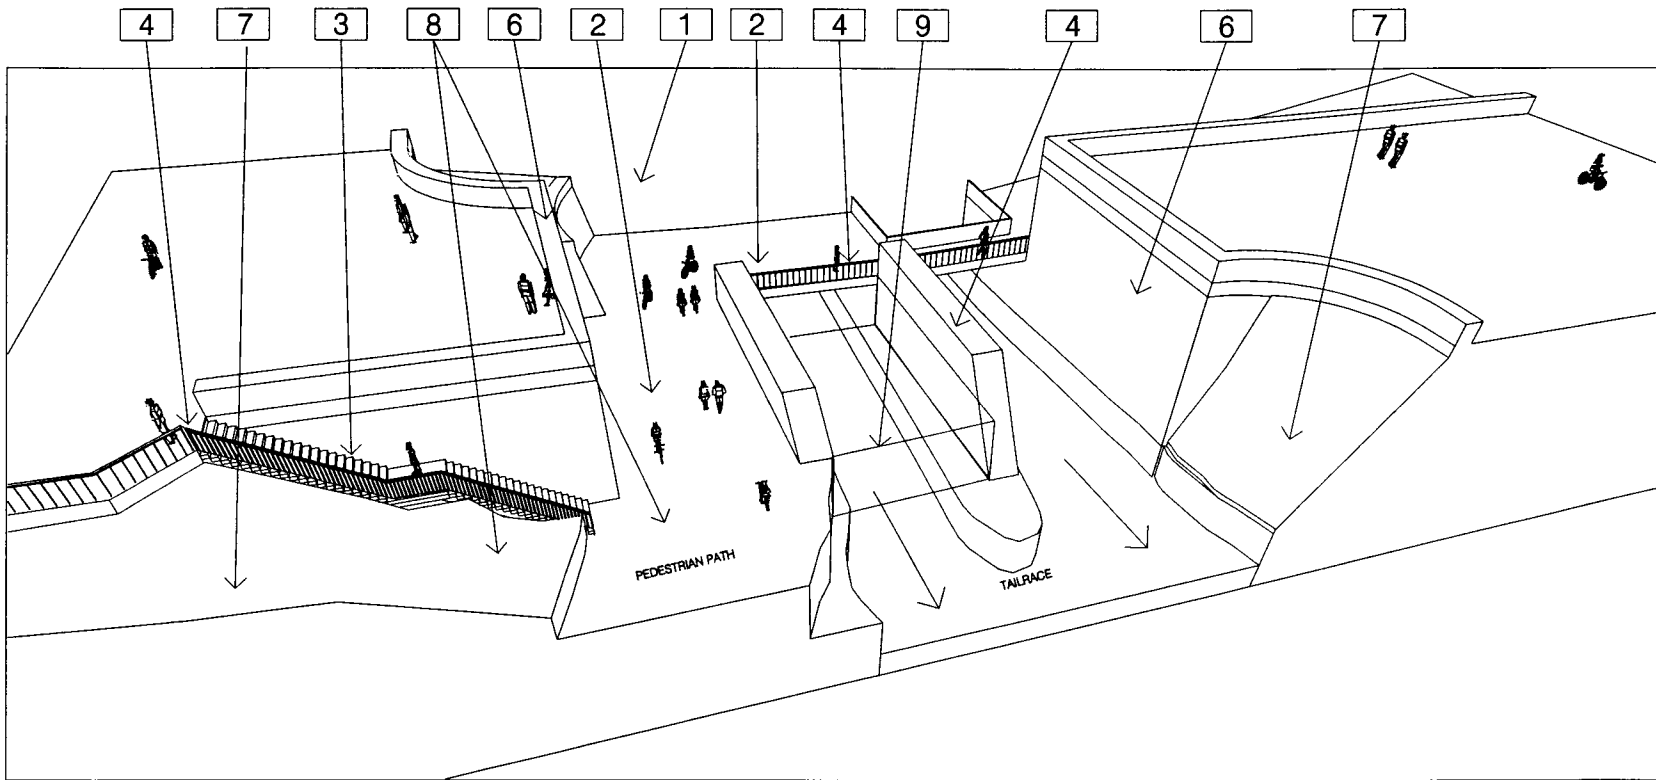
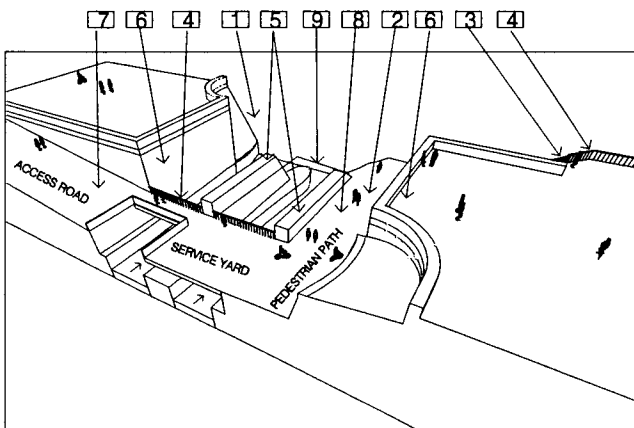
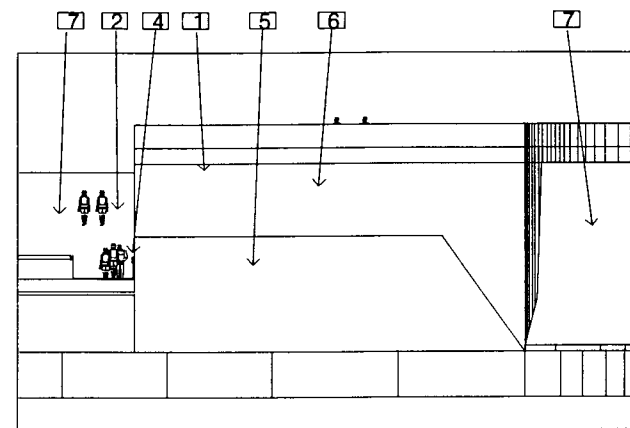
1. Remove existing bridge.
2. Existing pedestrian path.
3. New stairs.
4. Steel railings.
5. Retain and stabilize existing stone piers as "ruins".
6. Retain and stabilize east and west abutments.
7. Landscaping to remain.
8. New regrading and landscaping for pedestrian path and stair.
9. Remove existing timber cribwork.

**POOLEY'S BRIDGE REHABILITATION ALT. 6**

**Alternative 6:** Remove structure including piers, preserve existing substructure as ruins and use lower access road. (Fig. 15)

This alternative provides a lower level linkage only, with a concrete staircase at the northeast corner of the existing structure. Existing bridge level access is eliminated. This alternative takes the users closer to the tailrace level and the Fleet Street Pumping Station. Due to the removal of the bridge, the sight distances at pathway under the east arch are improved. However, the grades at the west end of the lower pathway are steep and it will be necessary to provide alternate access for those physically challenged. Also there are safety and security concerns of users due to the pathway being hidden from view.
