REGION OF OTTAWA-CARLETON
 RÉGION D'OTTAWA-CARLETON

REPORT
 RAPPORT

DATE 19 March 1999

SUBJECT/OBJET **REHABILITATION OF POOLEY'S BRIDGE AND FIVE STONE
 ARCH BRIDGES - LEBRETON FLATS**

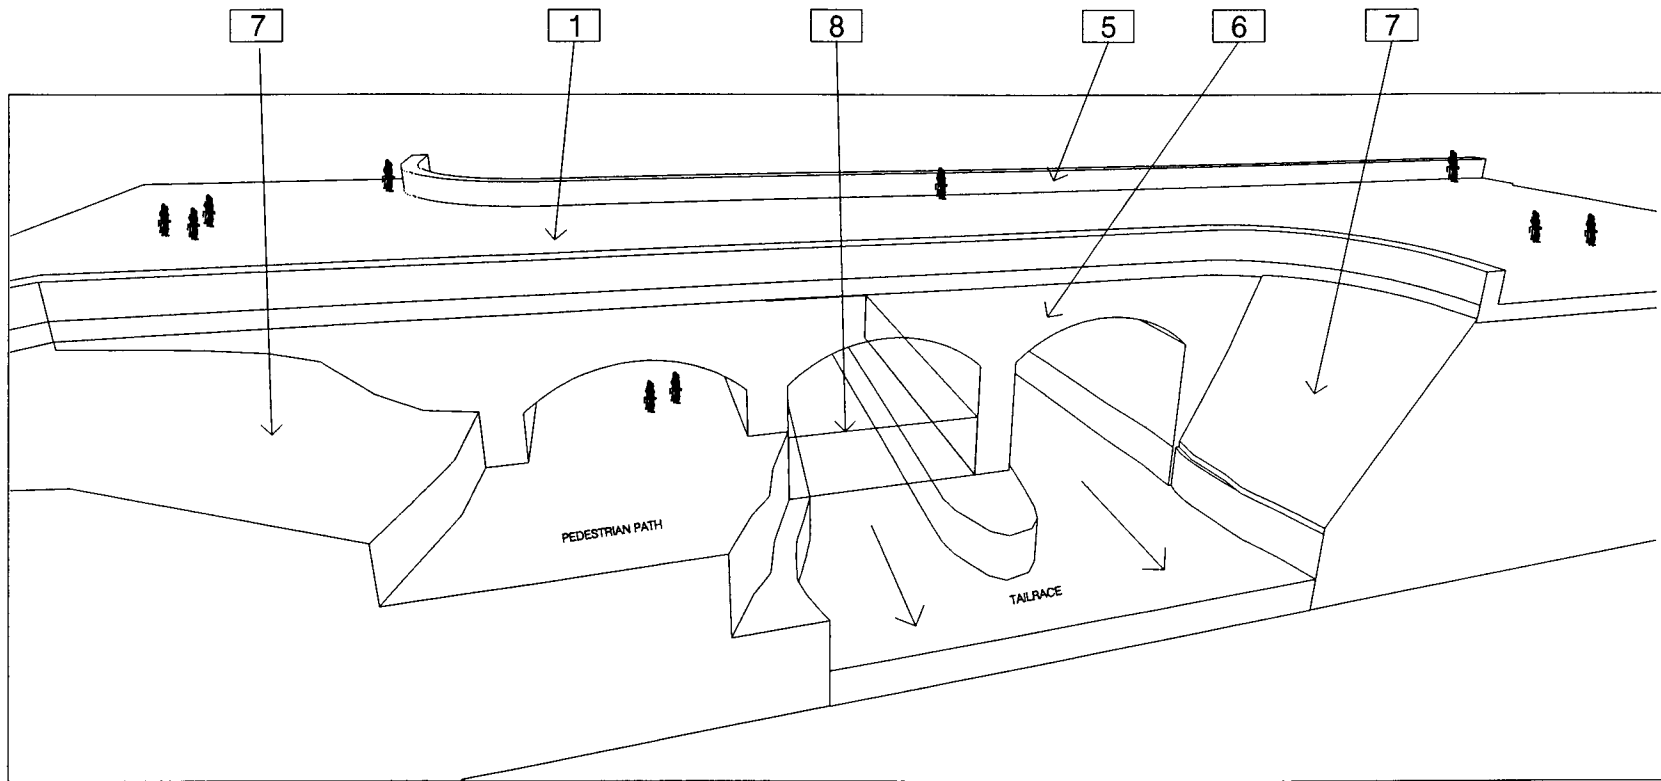
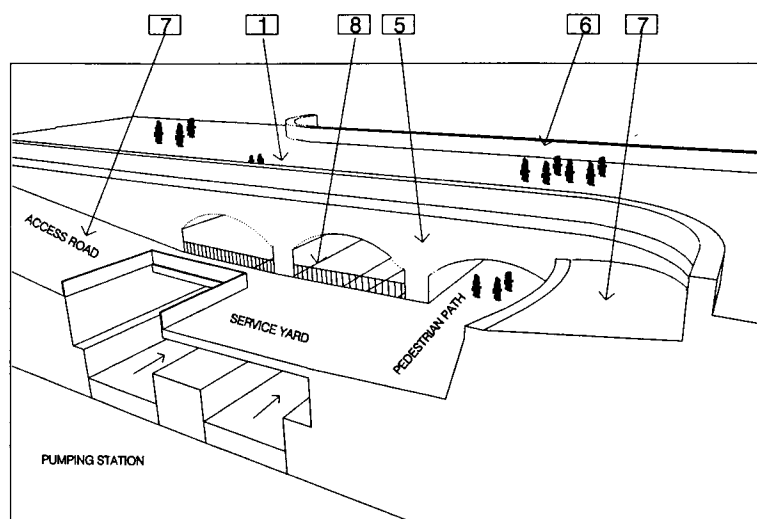
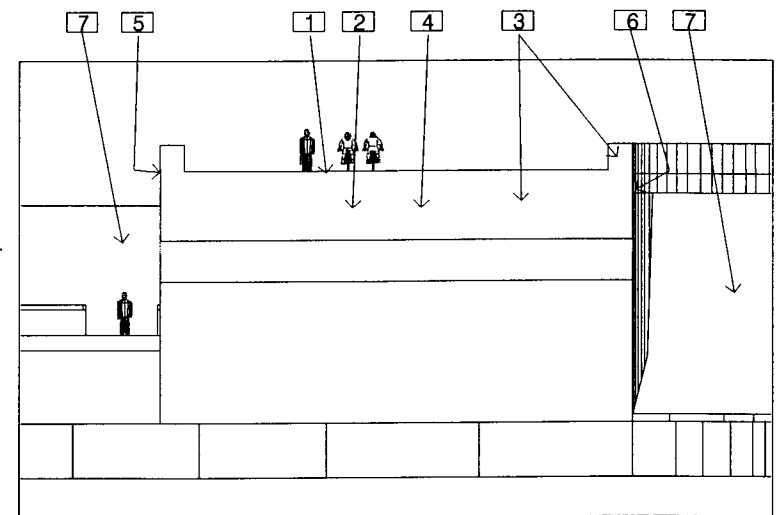
FIG 3

1. Rehabilitated bridge.
2. New concrete arches.
3. New concrete slab and upstand.
4. New fill.
5. Refaced stone south spandrel wall.
6. New stone north spandrel wall.
7. Landscaping to remain.
8. Remove existing timber cribwork.

POOLEY'S BRIDGE REHABILITATION ALT. 1

Alternative 1: Rehabilitation to existing width with new elements. (Fig. 3)

Apart from providing a 16 m. width, Alternative 1 would recreate the aesthetics of the original bridge with a substantial quantity of new stones using an inner concrete support structure. The historic character of the

pump house forecourt as well as the completeness of the original aqueduct/waterworks infrastructure, are retained.

On the negative side, there is high initial capital cost as well as high maintenance costs due to safety concerns resulting from continued scaling of retained stones from original construction.

Estimated cost of this alternative is \$4,350,000 with a 50 year service life, with a major rehabilitation in a 25 year timeframe.

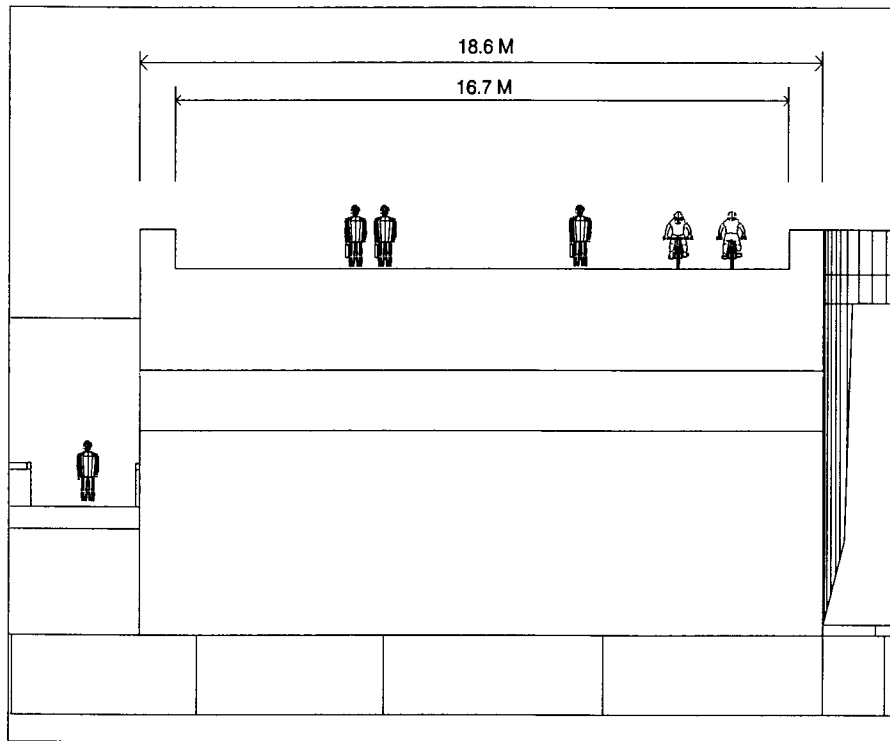
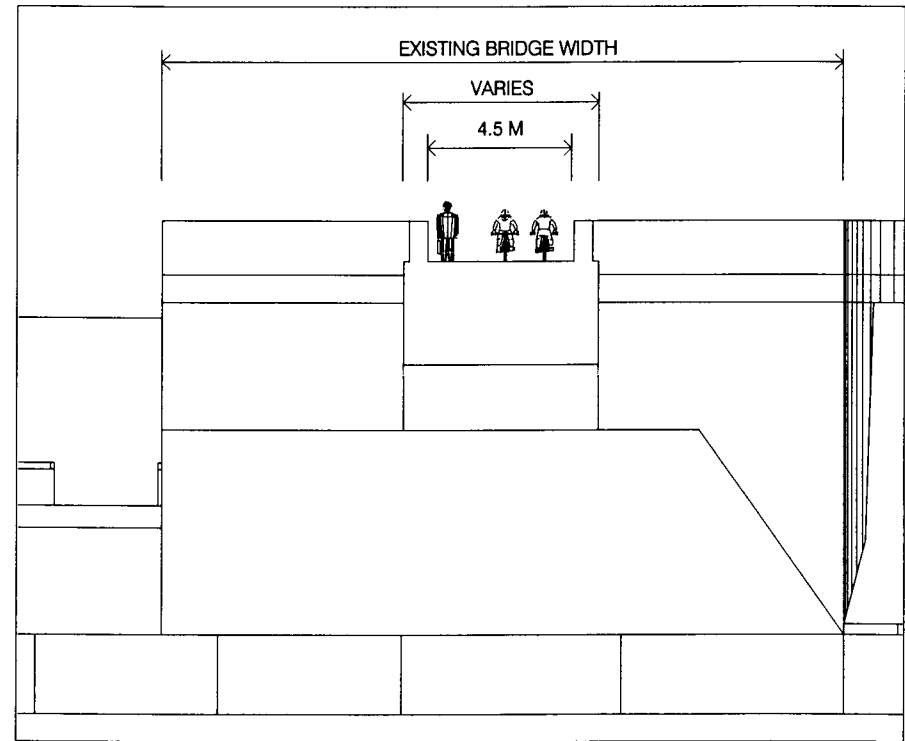
FIG 4

CROSS SECTION - ALTERNATIVE 1

CROSS SECTION - ALTERNATIVES 2 to 5

BRIDGE DIMENSIONS

Alternative 1 is based on rehabilitation of the bridge to full width of the existing structure (18.0 metre total and 16.7 metre clear).

Alternatives in categories 2 to 5 were initially developed on the basis of a 5.0 metre wide structure with a 3.8 metre usable width and were presented as such at the Public Information Centre. These alternatives have since been revised to provide a 4.5 metre clear usable width. There is progressively lesser preservation of heritage elements from alternatives 2 to 5.

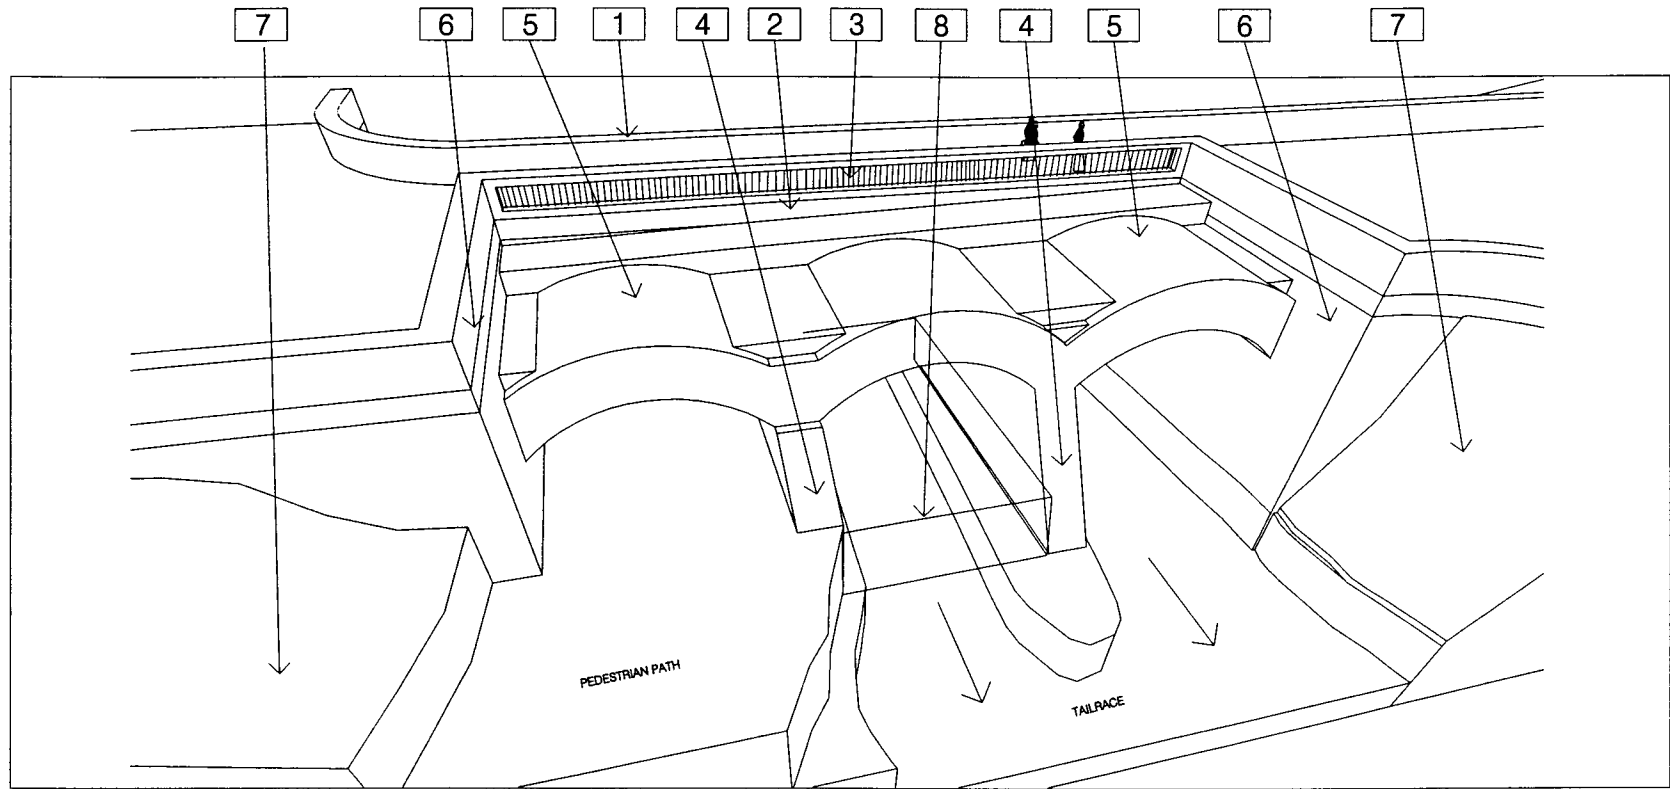
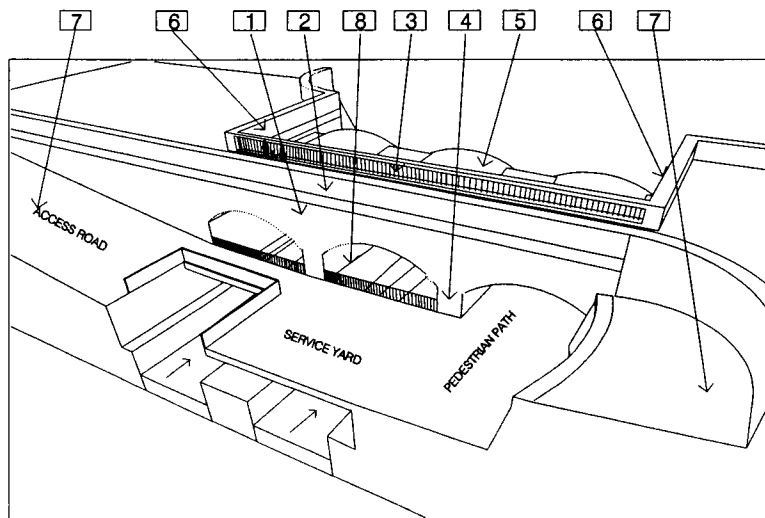
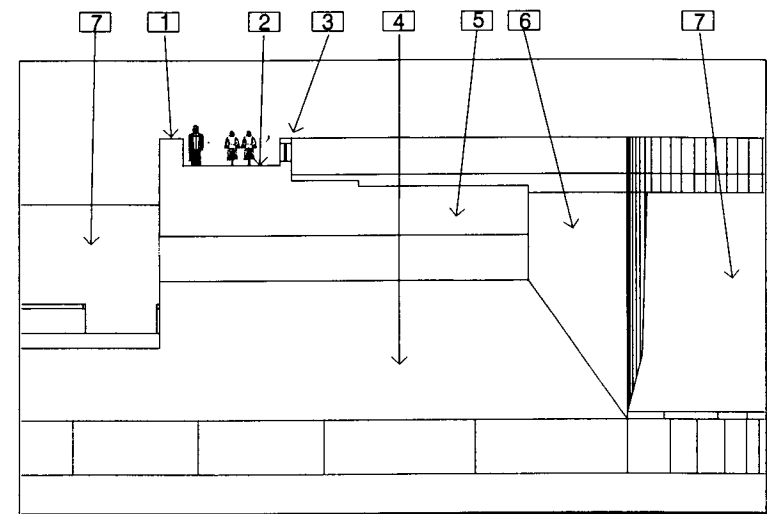
FIG 5

1. Retain and stabilize existing south stone spandrel wall.
2. New concrete pedestrian bridge structure (stone veneer).
3. New north railing (stone veneer w/ metal railing).
4. Retain and stabilize existing stone piers as "ruins".
5. Retain and stabilize existing arches as "ruin".
6. Retain and stabilize east and west abutments north of new pedestrian bridge.
7. Landscaping to remain.
8. Remove existing timber cribwork.

POOLEY'S BRIDGE REHABILITATION ALT. 2A

Alternative 2A: Rehabilitation to accommodate new bridge on south side and maximum retained ruin elsewhere. (Figs. 4 & 5)

Estimated cost of this alternative is \$1,600,000 with a 50 year service life.

Category 2 alternatives retain a significant part of the existing historic fabric as a functional component or ruin. Also, the historic character of the pump house forecourt is retained. As well, the original aqueduct/waterworks infrastructure is retained though to a lesser extent than in Alternative 1. Under Alternative 2A, the south face is restored to original aesthetics.

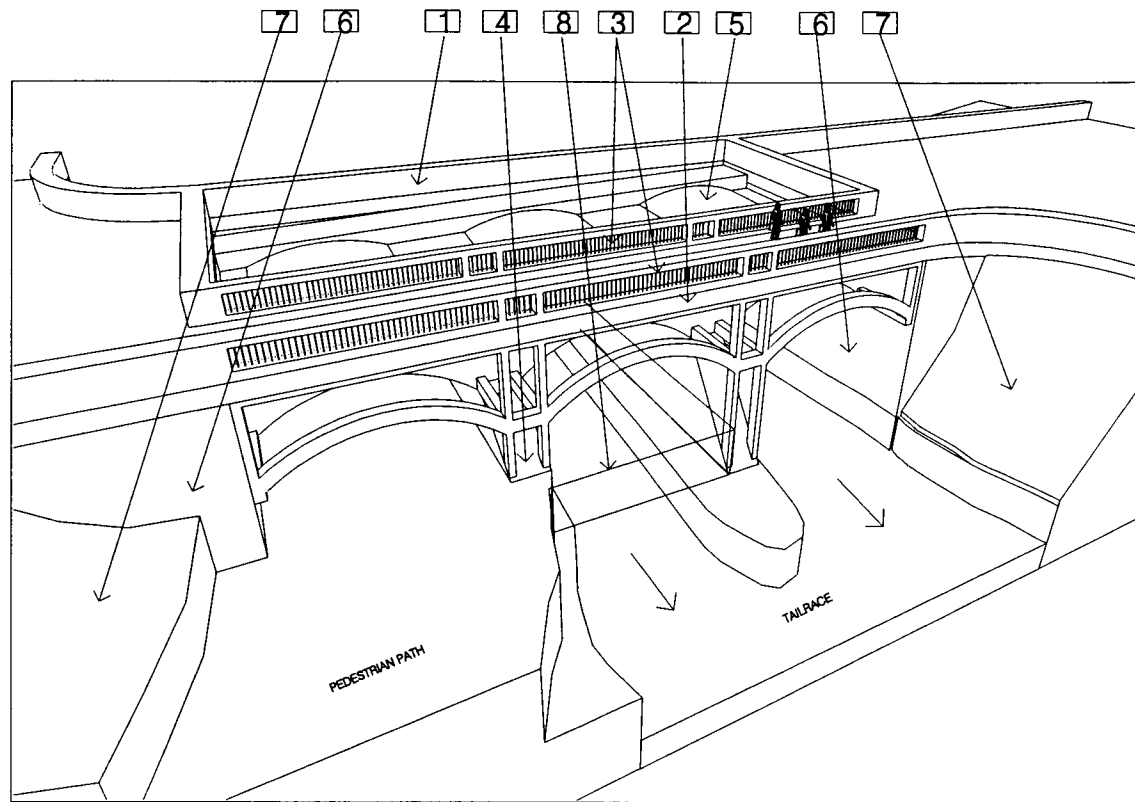
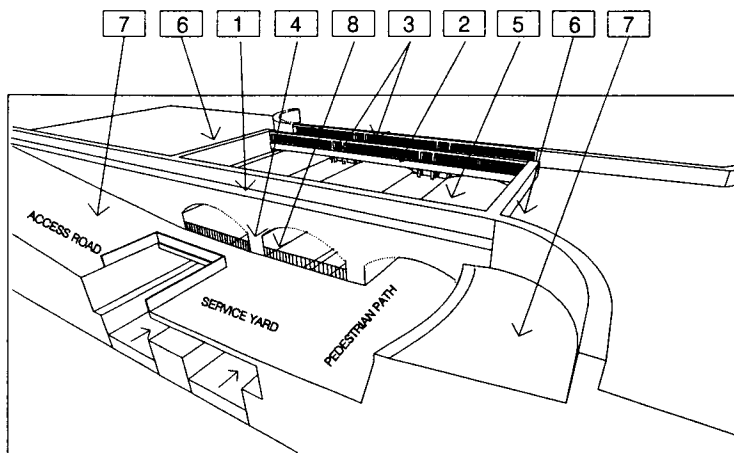
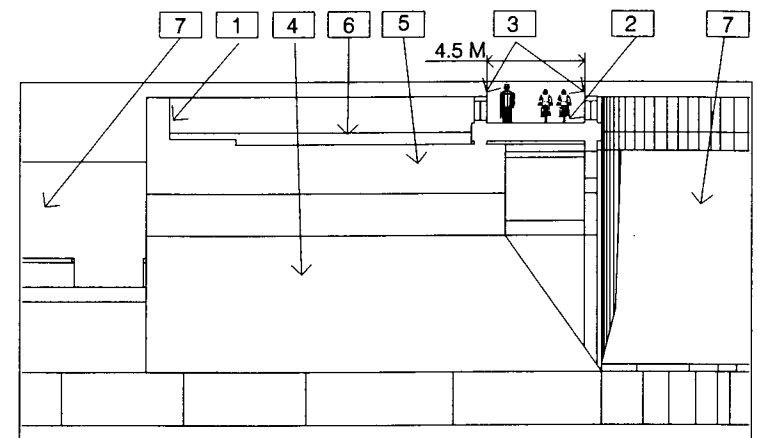
1. Retain and stabilize existing south stone spandrel wall.
2. New concrete or metal pedestrian bridge structure.
3. New railings.
4. Retain and stabilize existing stone piers as "ruins".
5. Retain and stabilize existing arches as "ruins".
6. Retain and stabilize east and west abutments south of new pedestrian bridge.
7. Landscaping to remain.
8. Remove existing timber cribwork.

Alternative 2B: Rehabilitation to accommodate new bridge on north side and maximum retained ruin elsewhere. (Fig. 6)

Estimated cost of this alternative is \$1,490,000 with a service life of 50 years.

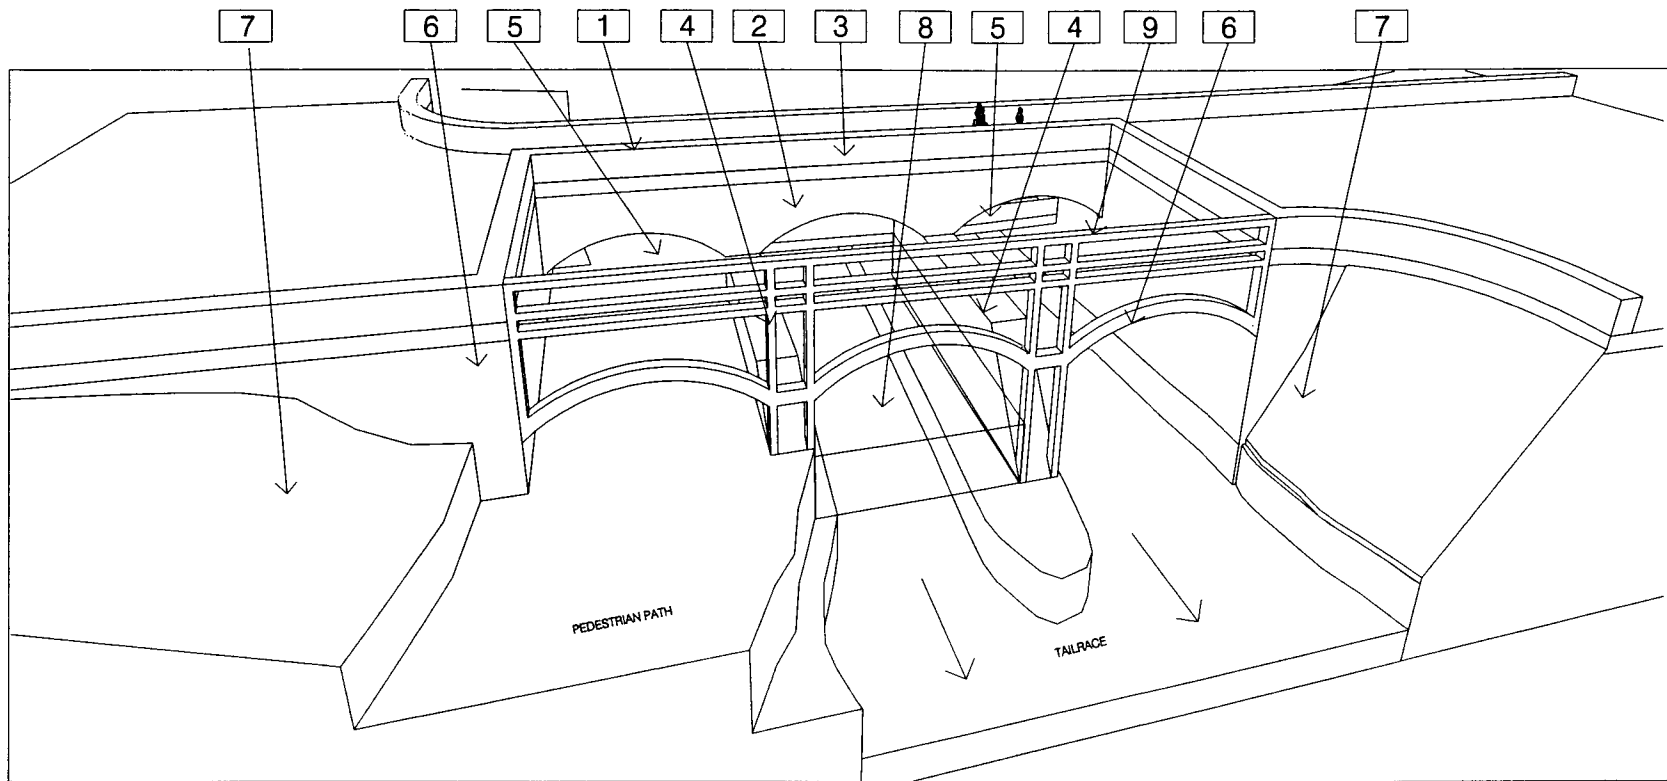
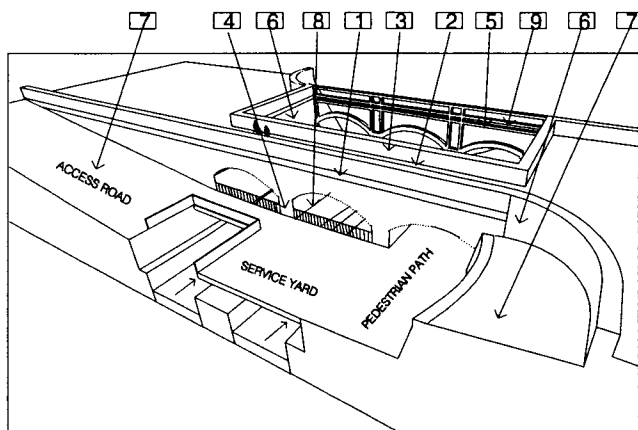
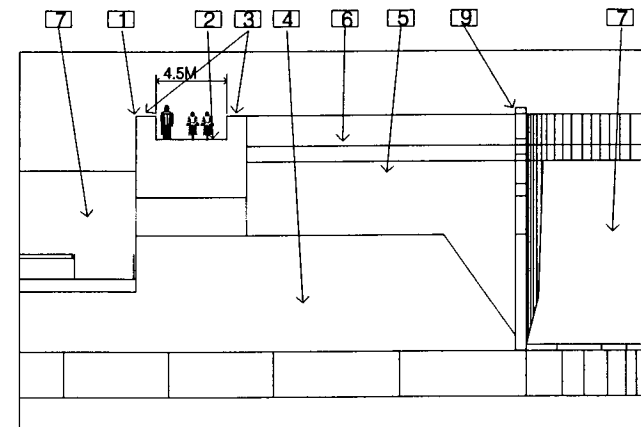
FIG 7

1. Retain and stabilize existing south stone spandrel wall.
2. New concrete pedestrian bridge structure (stone veneer).
3. New north railing (stone veneer).
4. Retain and stabilize existing stone piers as 'ruins'.
5. Remove existing arches.
6. Retain and stabilize east and west abutments north of new pedestrian bridge.
7. Landscaping to remain.
8. Remove existing timber cribwork.
9. Steel "Ghost" outline of original bridge structure.

POOLEY'S BRIDGE REHABILITATION ALT. 3A

Alternative 3A: Rehabilitation to accommodate a new concrete bridge on the south side and 'Ghosted' outline of south spandrel wall. (Fig. 7)

Estimated cost of this alternative is \$1,300,000 with a service life of 50 years.

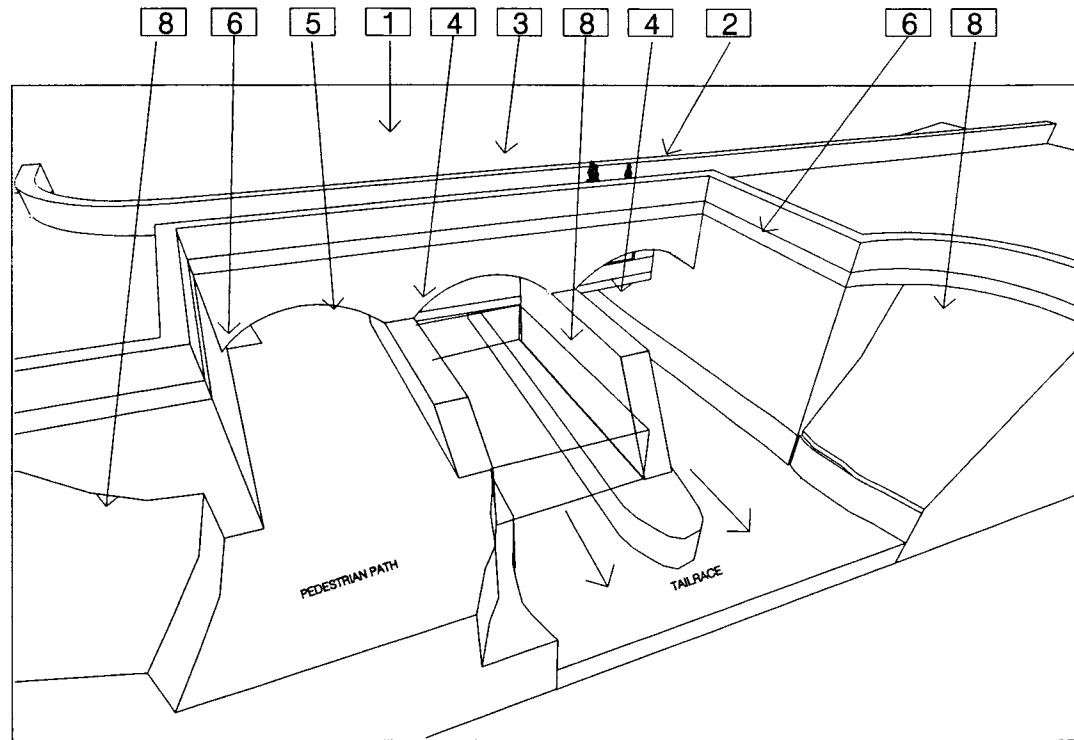
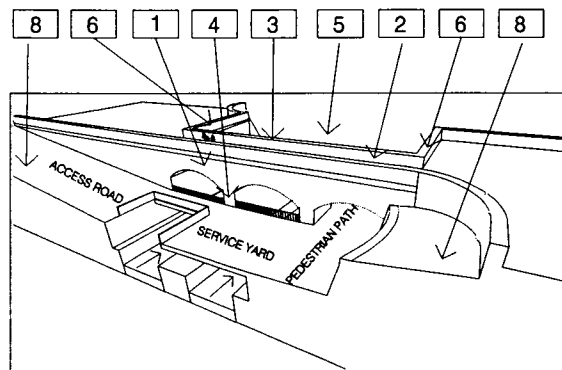
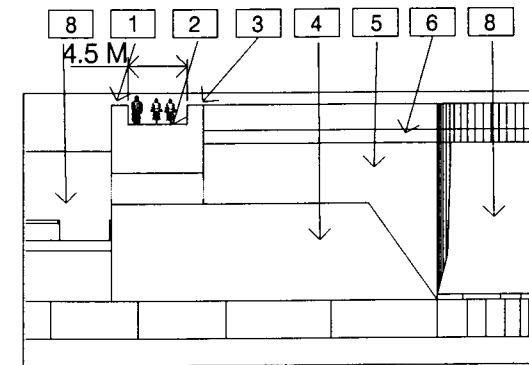
FIG 8

1. Retain and stabilize existing south stone spandrel wall.
2. New concrete pedestrian bridge structure (stone veneer).
3. New north railing (stone veneer).
4. Retain and stabilize existing stone piers as "ruins".
5. Remove existing arches.
6. Retain and stabilize east and west abutments north of new pedestrian bridge.
7. Remove east and west abutments north of new pedestrian bridge.
8. Landscaping to remain.
9. New site regrading and new landscaping for abutment replacement.
10. Remove existing timber cribwork.

**POOLEY'S BRIDGE REHABILITATION ALT. 3B
(RECOMMENDED)**

Alternative 3B: Rehabilitation to accommodate a new concrete bridge on south side and preservation of substructure elements. (Fig. 8)

Estimated cost of this alternative is \$1,270,000 with a service life of 50 years.

Based on assessment of various alternatives developed, implementation of Alternative 3B is recommended. The main features of this alternative are as follows:

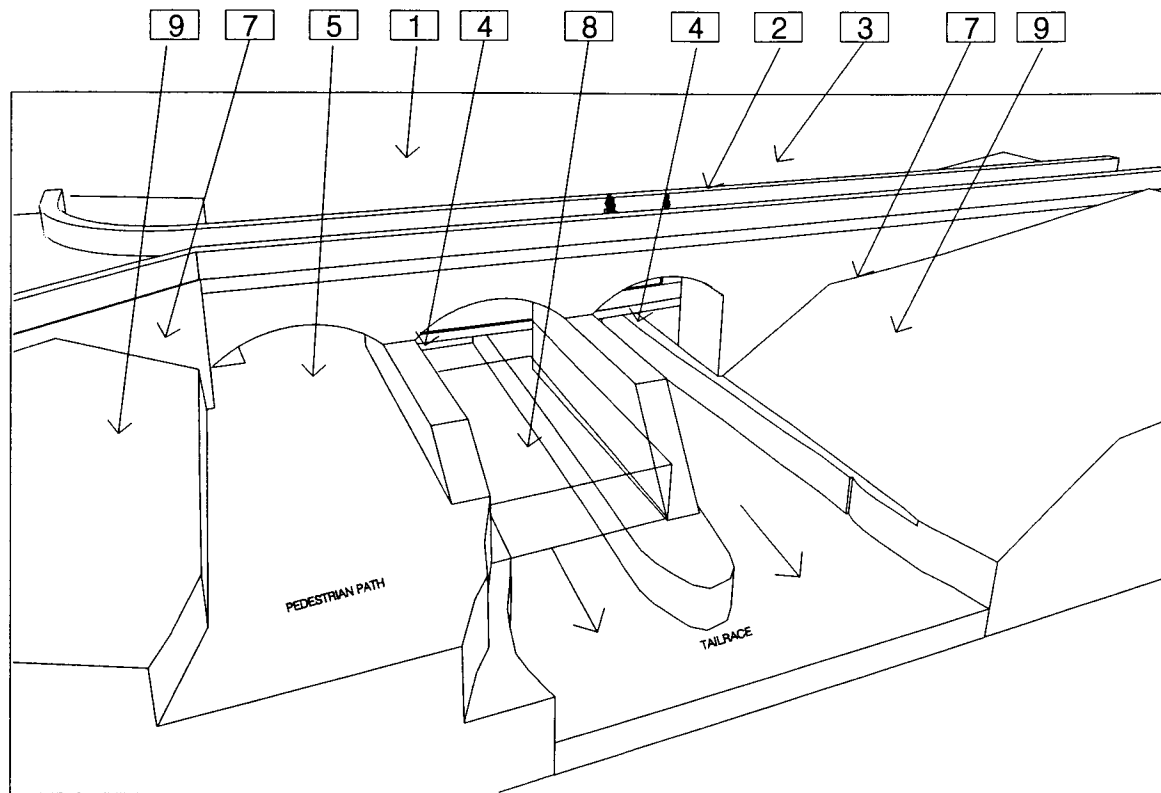
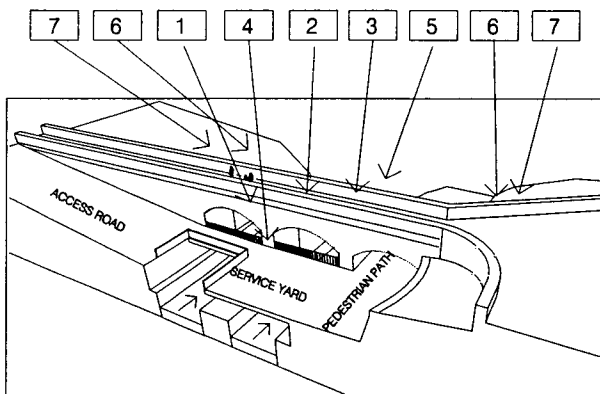
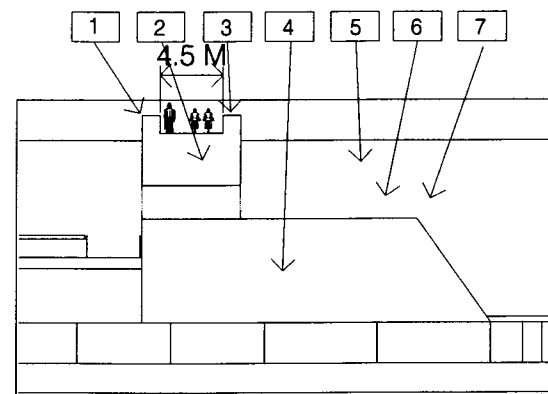
1. Retain and stabilize existing south stone spandrel wall.
2. New concrete pedestrian bridge structure (stone veneer).
3. New north railing (stone veneer).
4. Retain and stabilize existing stone piers as "ruins".
5. Remove existing arches.
6. Retain and stabilize east and west abutments north of new pedestrian bridge.
7. Remove east and west abutments north of new pedestrian bridge.
8. Landscaping to remain.
9. New site regrading and new landscaping for abutment replacement.
10. Remove existing timber cribwork.

Alternative 3C: Rehabilitation to accommodate a new bridge on south side and preserve pier elements. (Fig. 9)

Estimated cost of this alternative is \$1,280,000 with a service life of 50 years.

Under alternatives in this category, all but south five meters of the arches are removed but the piers are retained as supports for the new bridge or are preserved as ruins outside the five meter limit.

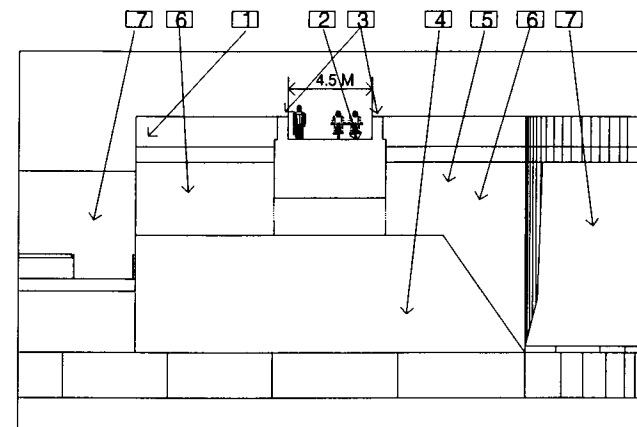
FIG 10

1. Remove existing south stone spandrel wall between abutments. Restore the rest of the wall.
2. New pedestrian bridge structure (concrete clad with stone veneer).
3. Concrete clad with stone veneer railing.
4. Retain and stabilize existing stone piers.
5. Remove deteriorated portion of bridge.
6. Retain and stabilize east and west abutments on both sides of new pedestrian bridge.
7. Landscaping to remain.
8. Remove existing timber cribwork.

POOLEY'S BRIDGE REHABILITATION ALT. 4A

Alternative 4A: New 3 span concrete arch bridge (centred) on existing substructure. (Fig. 10)

Estimated cost of this alternative is \$1,300,000 with a service life of 50 years.

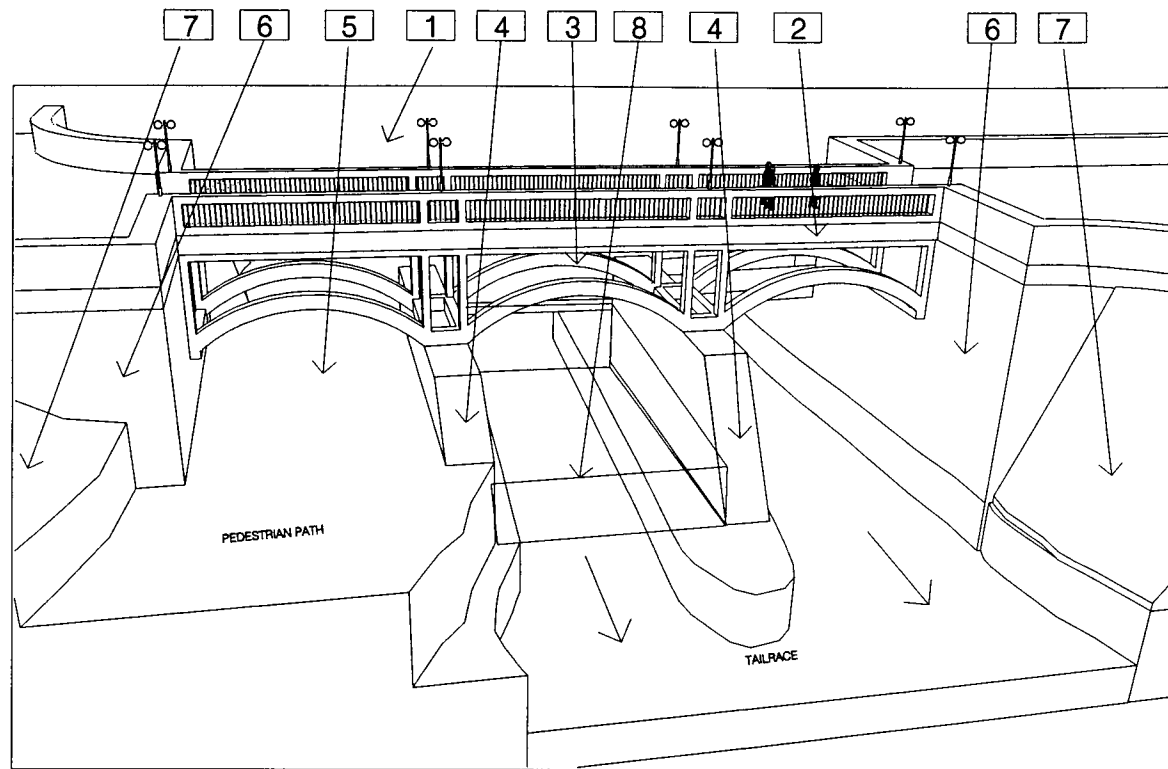
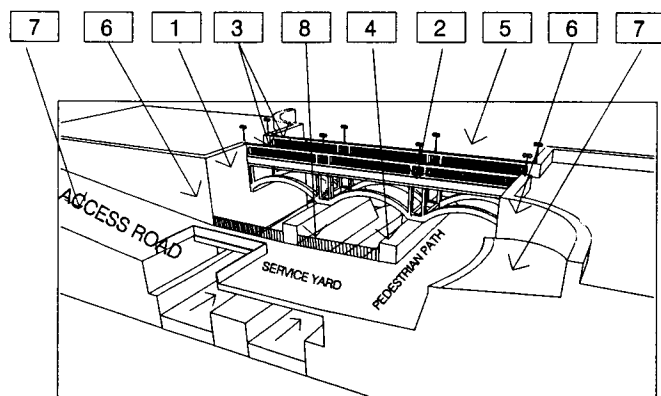
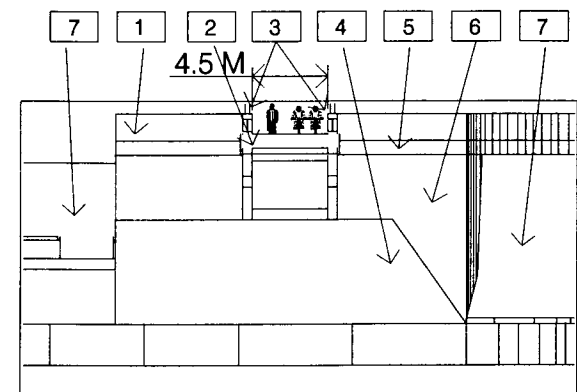
FIG 11

1. Remove existing south stone spandrel wall between abutments. Restore the rest of the wall.
2. New pedestrian bridge structure (precast/concrete/steel).
3. Precast concrete and/or steel railing.
4. Retain and stabilize existing stone piers as "ruins".
5. Remove deteriorated portion of bridge.
6. Retain and stabilize east and west abutments on both sides of new pedestrian bridge.
7. Landscaping to remain.
8. Remove existing timber cribwork.

POOLEY'S BRIDGE REHABILITATION ALT. 4B

Alternative 4B: New 3 span steel arch bridge (centred) on existing substructure width. (Fig. 11)

Estimated cost of this alternative is \$1,050,000 with a service life of 50 years.

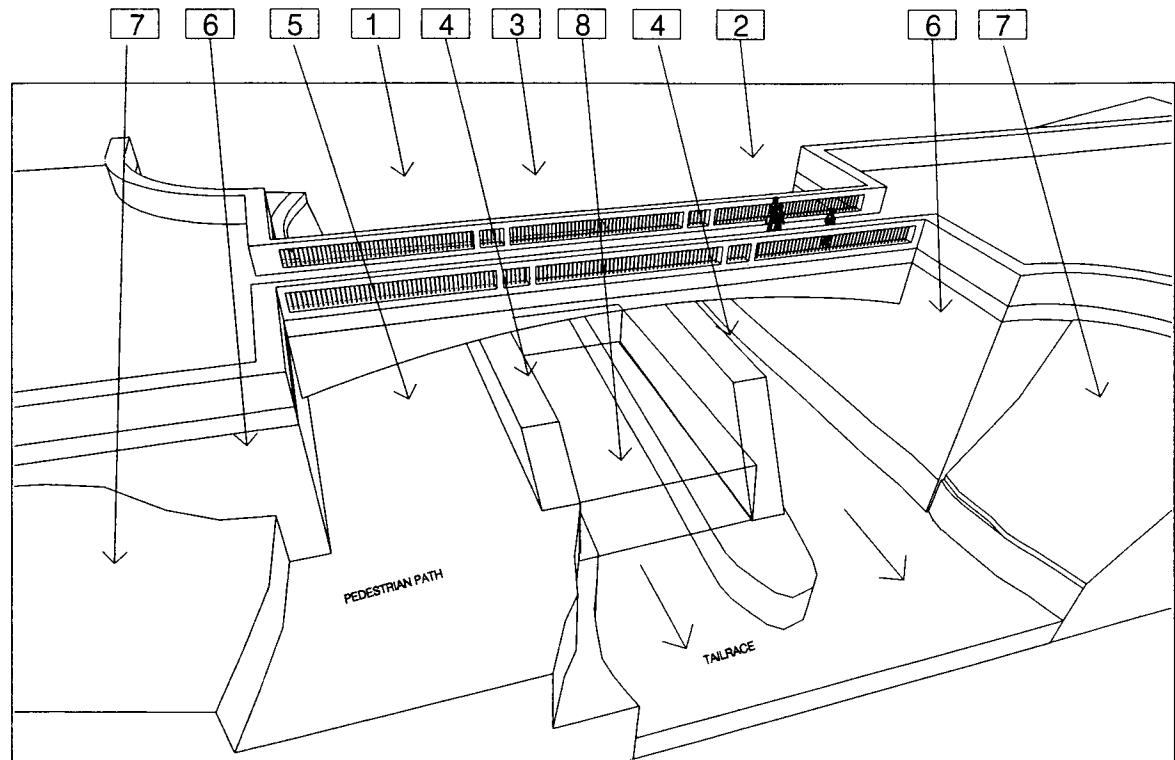
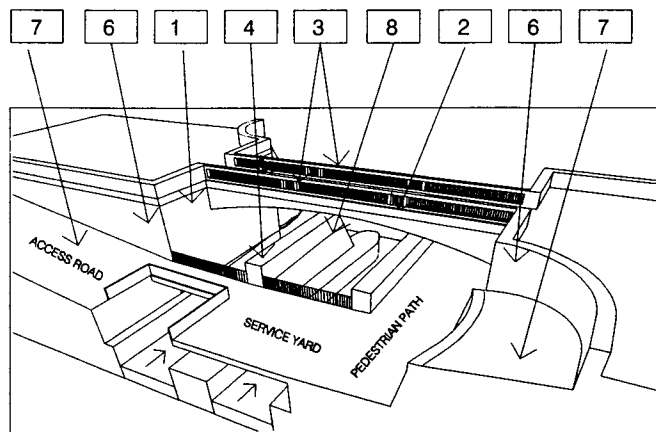
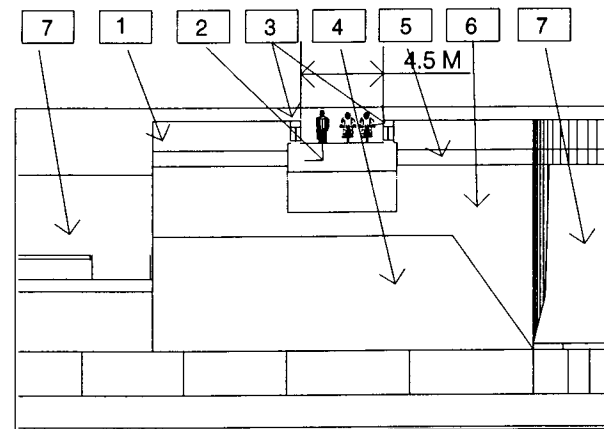
1. Remove existing south stone spandrel wall between abutments. Restore the rest of the wall.
2. New pedestrian bridge structure (precast/concrete/steel).
3. Precast concrete and/or steel railing.
4. Retain and stabilize existing stone piers as "ruins".
5. Remove deteriorated portion of bridge.
6. Retain and stabilize east and west abutments on both sides of new pedestrian bridge.
7. Landscaping to remain.
8. Remove existing timber cribwork.

Alternative 4C: New single span concrete arch structure (centred) on existing substructure. (Fig. 12)

Estimated cost of this alternative is \$1,025,000 with a service life of 50 years.

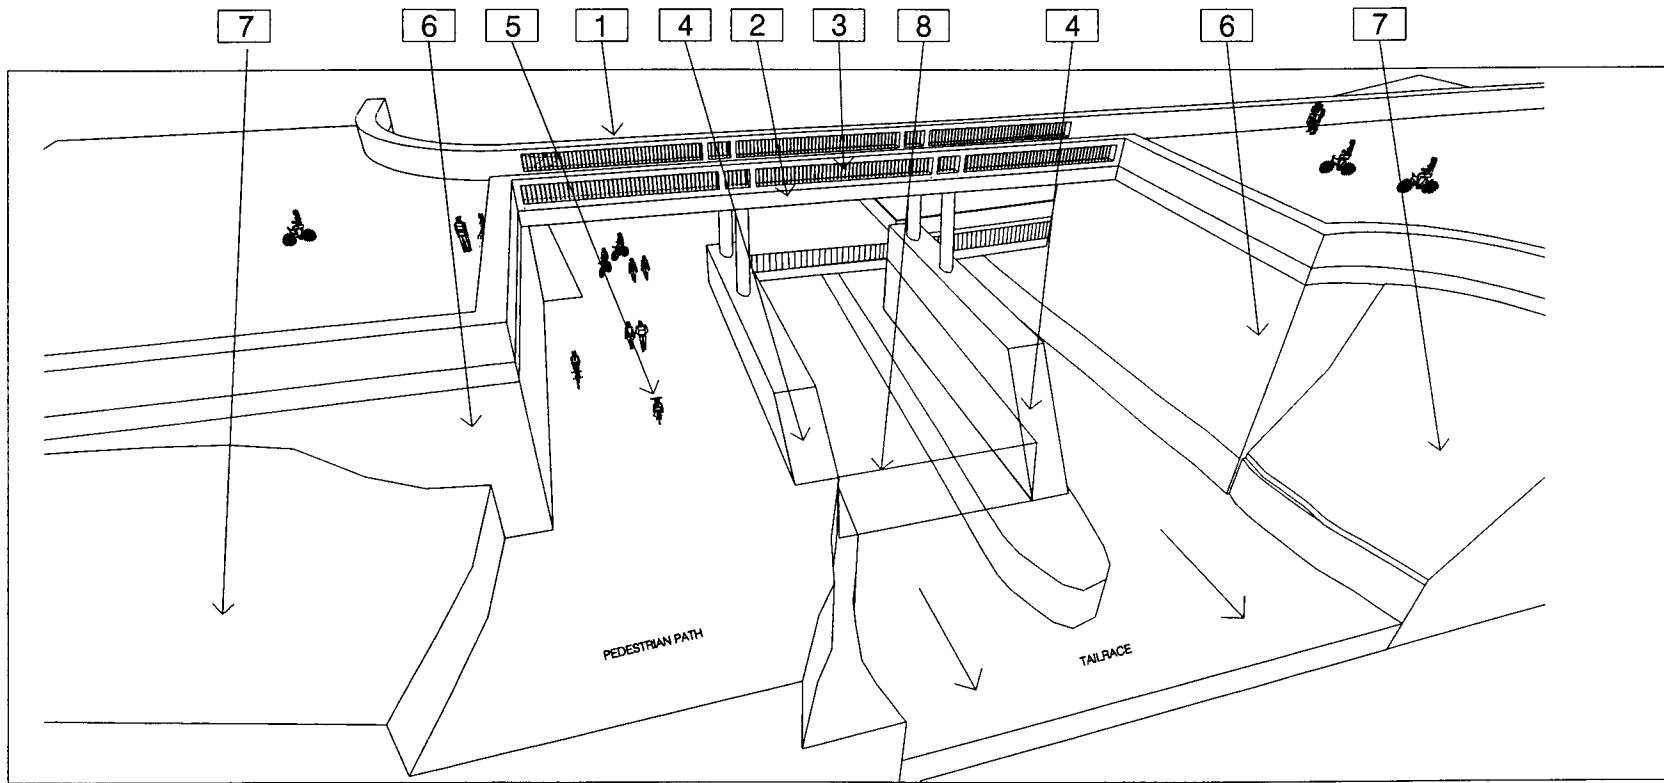
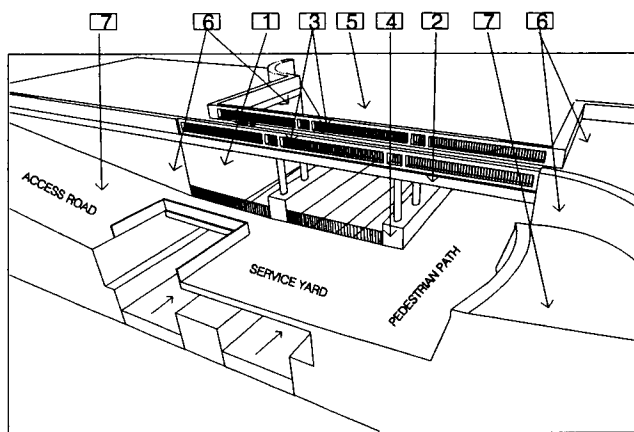
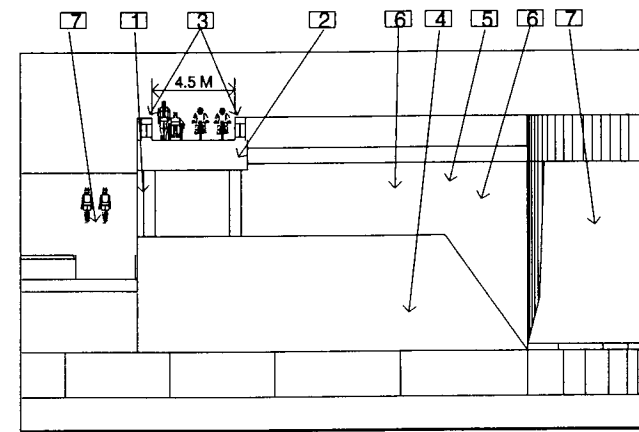
FIG 13

1. Remove existing south stone spandrel wall between embankments. Restore the rest of the wall.
2. New pedestrian bridge structure (steel).
3. Steel railings.
4. Retain and stabilize existing stone piers as "ruins".
5. Remove deteriorated portion of bridge.
6. Retain and stabilize east and west abutments north of new pedestrian bridge.
7. Landscaping to remain.
8. Remove existing timber cribwork.

POOLEY'S BRIDGE REHABILITATION ALT. 5A

Alternative 5A: New 3 span contrasting bridge. (Fig. 13)

Estimated cost of this alternative is \$1,010,000 with a service life of 50 years.

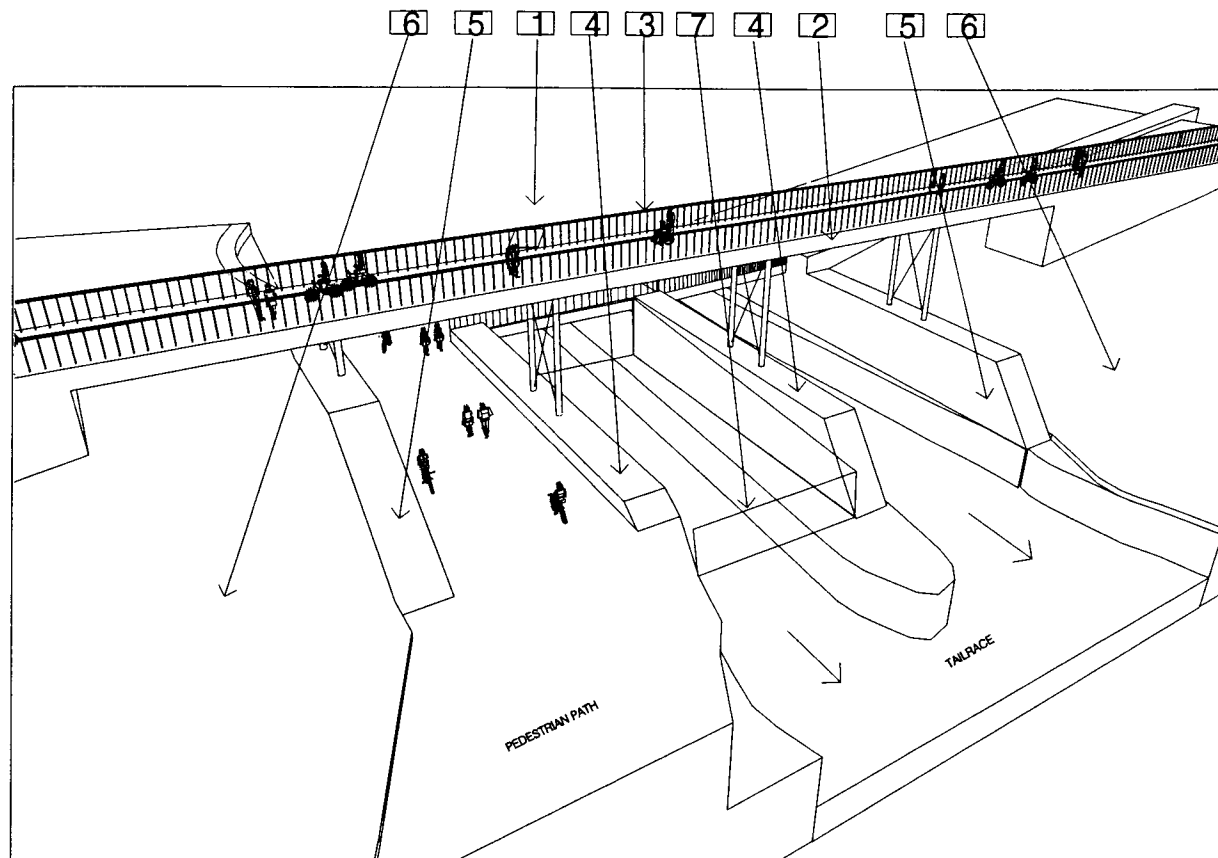
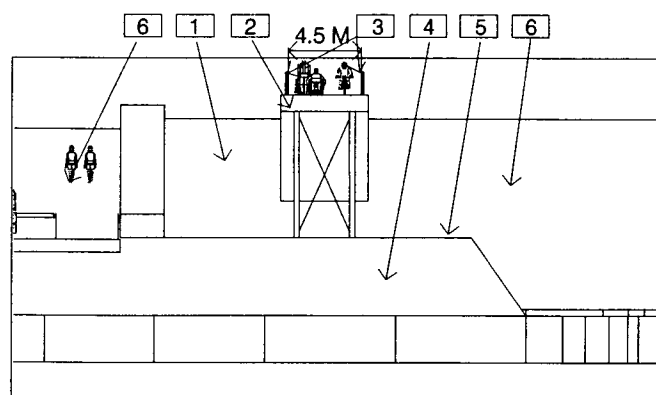
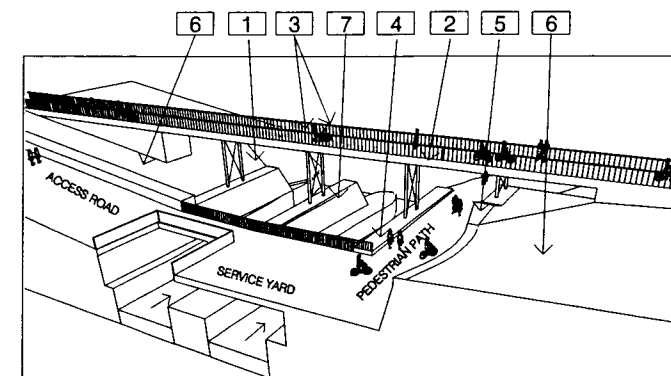
FIG 14

1. Remove existing bridge.
2. New pedestrian bridge structure (steel).
3. Steel railings.
4. Lower and stabilize existing stone piers.
5. Lower and stabilize east and west abutments.
6. Re-grade and new landscaping for abutment replacement.
7. Remove existing timber cribwork.

POOLEY'S BRIDGE REHABILITATION ALT. 5B

Alternative 5B: New 5 span steel bridge. (Fig. 14)

Estimated cost of this alternative is \$700,000 with a service life of 50 years.

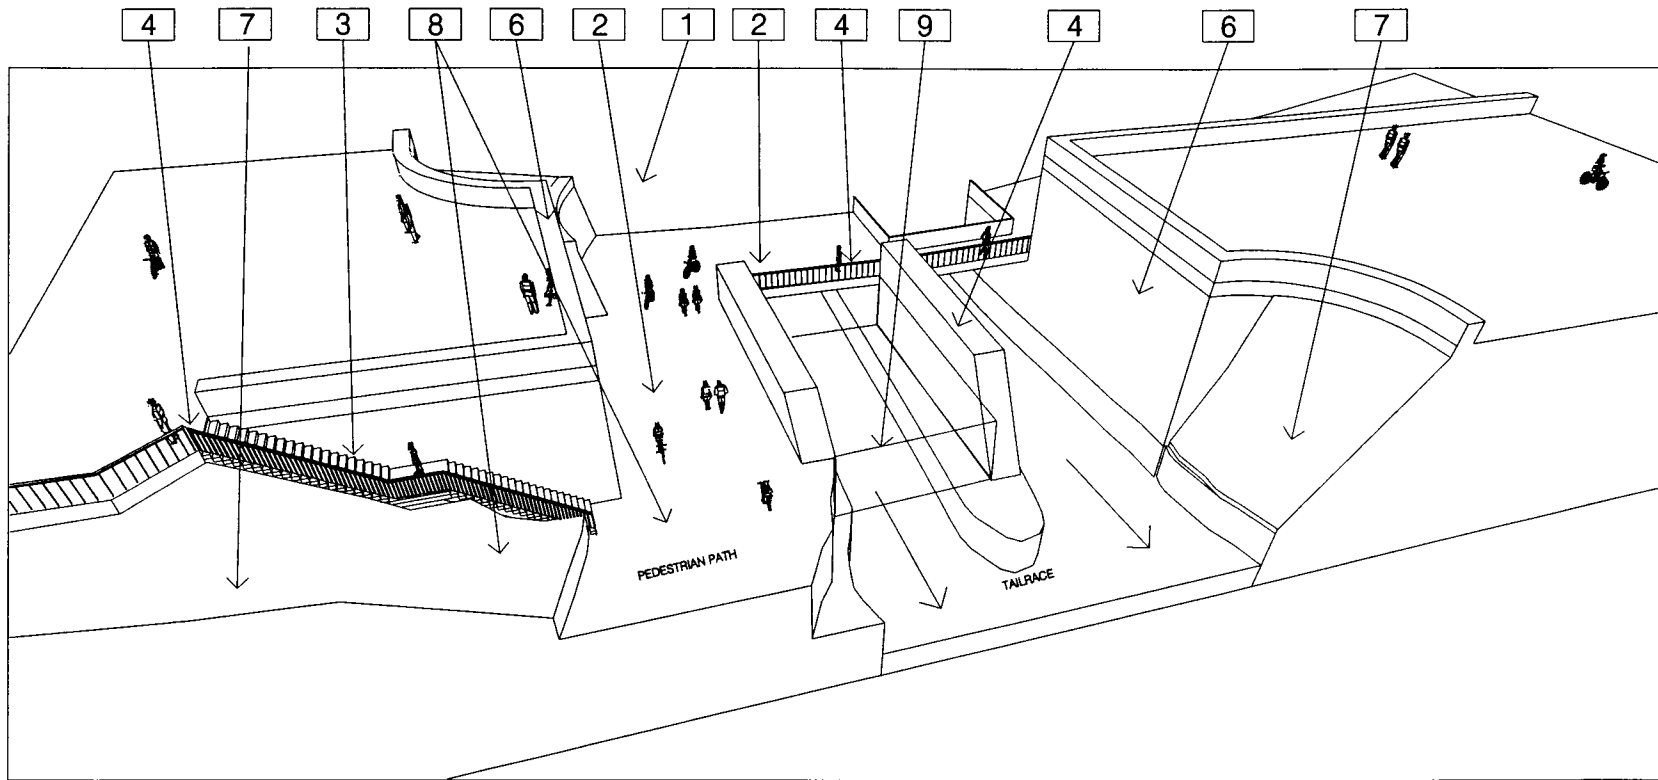
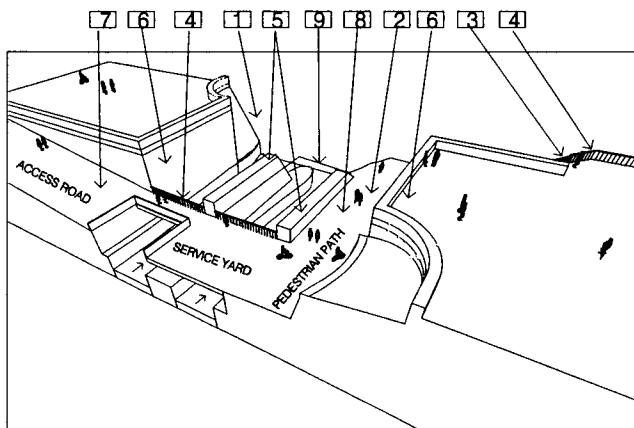
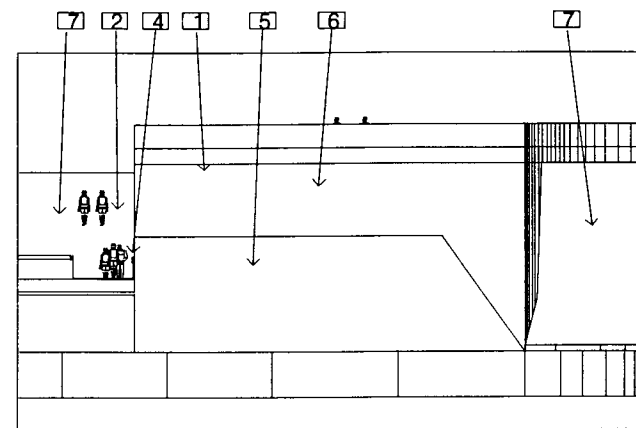
1. Remove existing bridge.
2. Existing pedestrian path.
3. New stairs.
4. Steel railings.
5. Retain and stabilize existing stone piers as "ruins".
6. Retain and stabilize east and west abutments.
7. Landscaping to remain.
8. New regrading and landscaping for pedestrian path and stair.
9. Remove existing timber cribwork.

POOLEY'S BRIDGE REHABILITATION ALT. 6

Alternative 6: Remove structure including piers, preserve existing substructure as ruins and use lower access road. (Fig. 15)

This alternative provides a lower level linkage only, with a concrete staircase at the northeast corner of the existing structure. Existing bridge level access is eliminated. This alternative takes the users closer to the tailrace level and the Fleet Street Pumping Station. Due to the removal of the bridge, the sight distances at pathway under the east arch are improved. However, the grades at the west end of the lower pathway are steep and it will be necessary to provide alternate access for those physically challenged. Also there are safety and security concerns of users due to the pathway being hidden from view.

Estimated cost of this alternative is \$670,000.
