APPENDIX H

**West Transitway Extension
Bayshore Station to Moodie Drive**

**Preliminary Characterization of
Existing Natural Environmental
Conditions**

September 2009

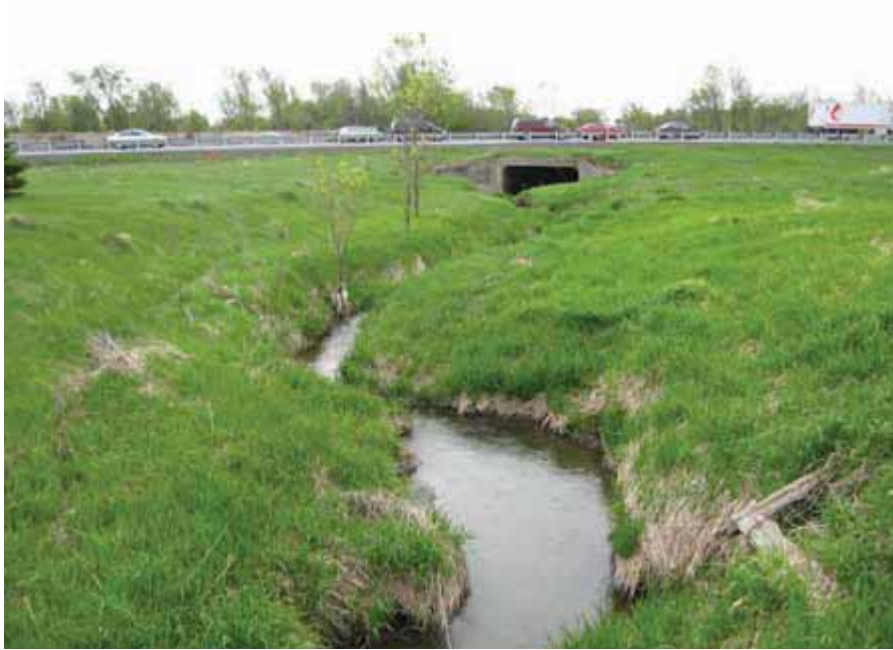
C#1 – Stillwater Creek west of Moodie Drive

Figure 1. Photograph taken looking upstream at general channel characteristics between Highway 417 ROW and Corkstown Road.

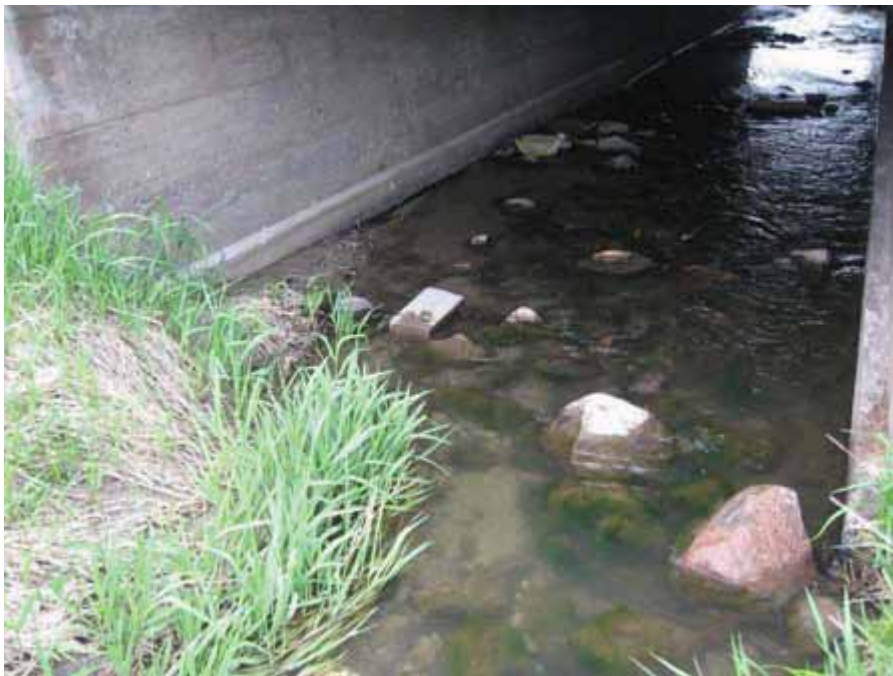
Figure 2. Photograph taken looking downstream at the Corkstown Road culvert and the substrate.

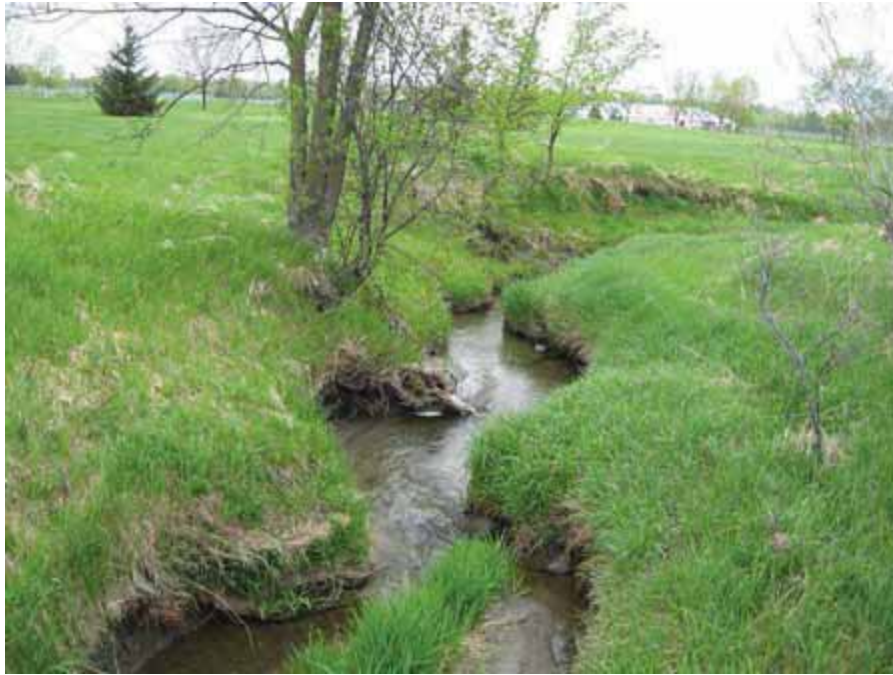
Figure 3. Photograph taken looking downstream from Corkstown Road Culvert at the general channel characteristics downstream.

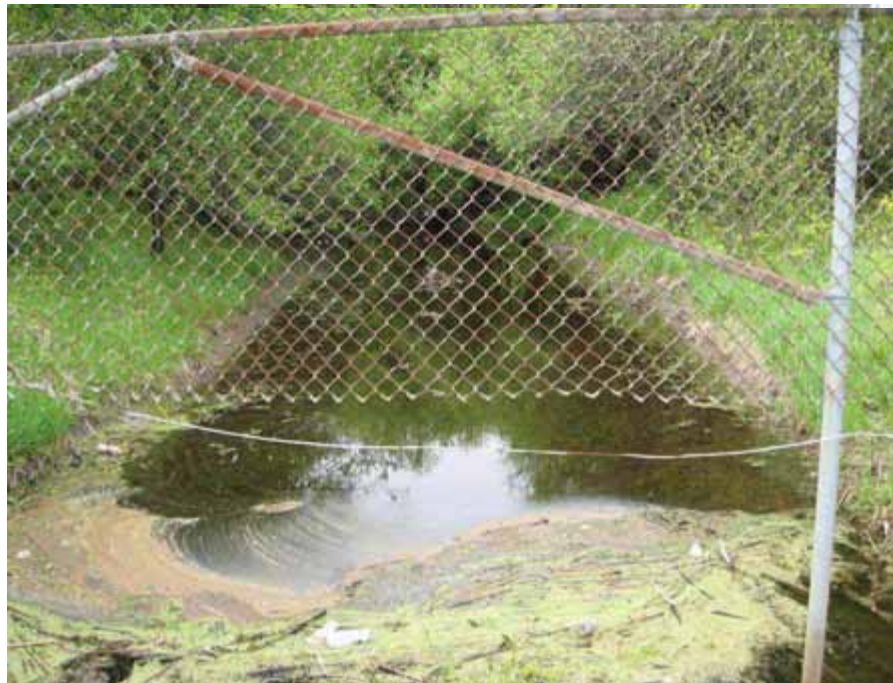
C#2 – Stillwater Creek at Corkstown Road (east of Moodie Drive)

Figure 4. Photograph taken looking upstream from Corkstown Road at general characteristics of Stillwater Creek upstream of road crossing.

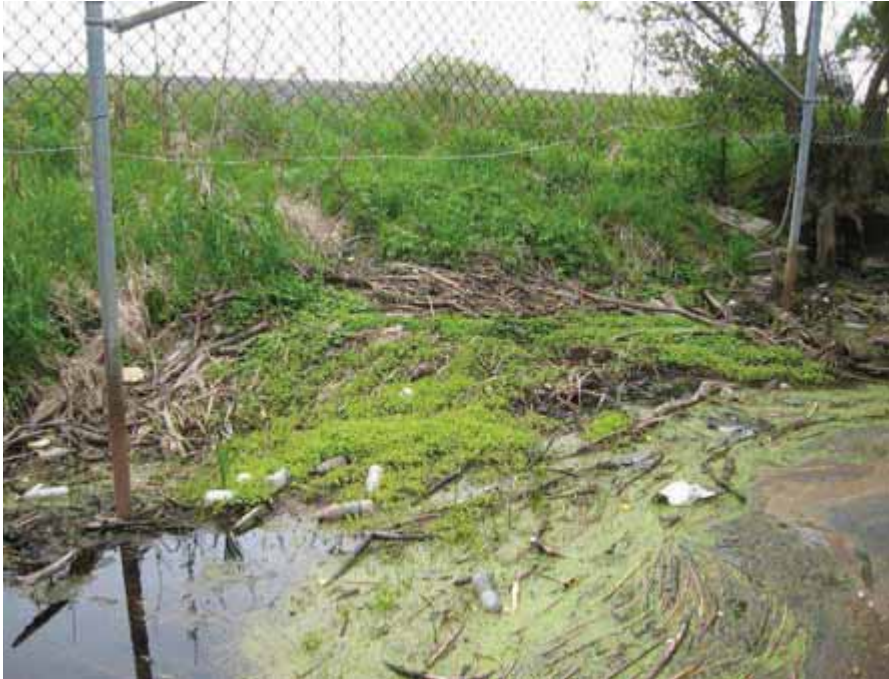
This channel forms part of the main branch of Stillwater Creek that flows from west to southeast around the Moodie Drive/ Highway 417 interchange, and along the north side of Highway 417. Flow appears permanent, however, the Corkstown Road culverts are blocked by woody debris and sediment at the upstream end and a collapsed retaining wall at the downstream end, creating barriers to upstream fish movement. A breached beaver dam was observed approximately 10 m downstream of Corkstown Road which may also act as a seasonal barrier to fish movement.

Figure 5. Photograph taken looking downstream at the general location of Corkstown Road crossing, and the debris burying the inlet.

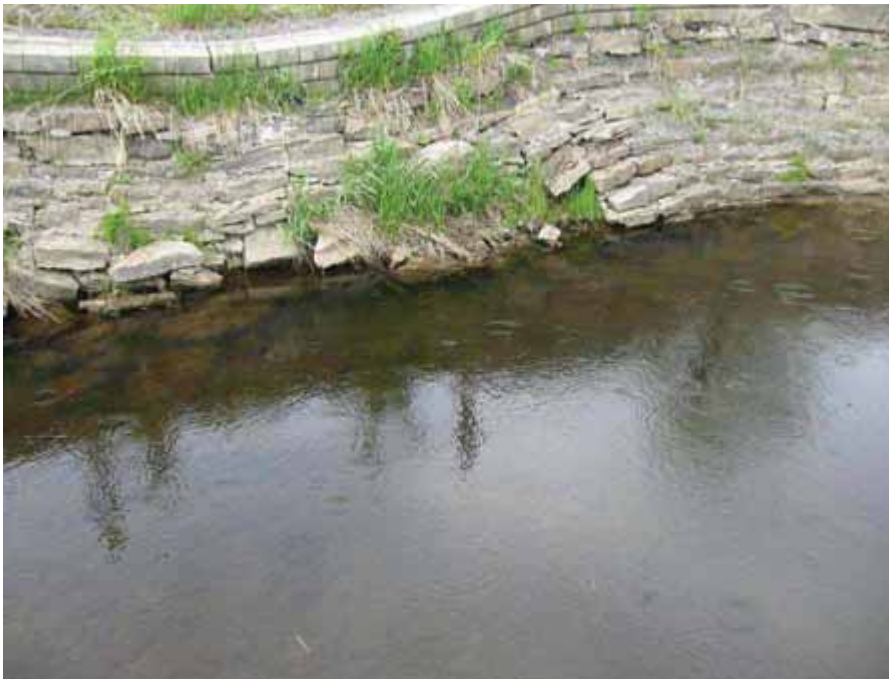
Figure 6. Photograph taken looking upstream at the outlet of the Corkstown Road crossing and failing retaining wall.

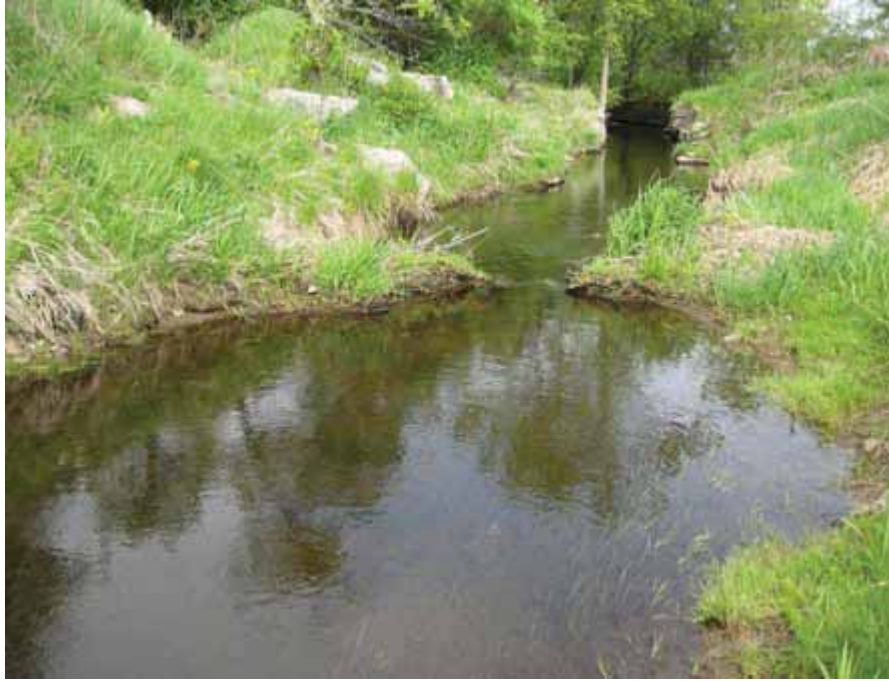
At the time of the field investigations, the Watts Creek Pathway crossing culvert was observed to be collapsed (submerged) with erosion noted on the banks. Despite these issues, the culvert did not appear to present a barrier to fish movement. The downstream portion of the channel is confined within vertical bedrock walls. Stream morphology is dominated by 'flats' with occasional pools present throughout the reach. In many cases the pools contain submergent vegetation and abundant baitfish were observed. A large, wide scour pool is located immediately downstream of the Corkstown Road crossing.

Figure 7. Photograph taken looking downstream at scour pool and small beaver dam in Stillwater Creek downstream of Corkstown Road crossing.

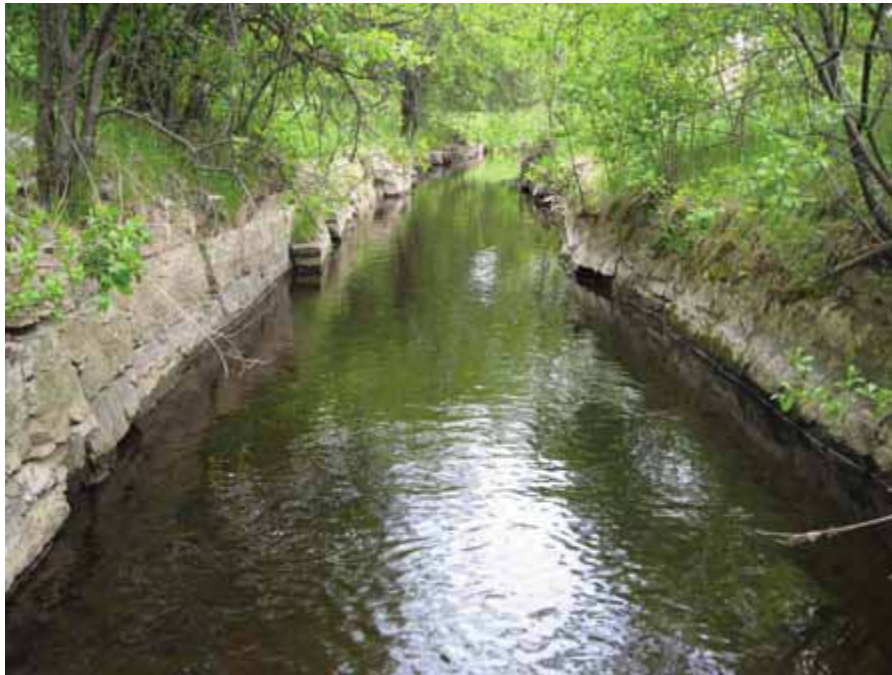
Figure 8. Photograph taken looking downstream at general channel characteristics of Stillwater Creek where it is confined within the bedrock walls, between Corkstown Road and the recreational trail.

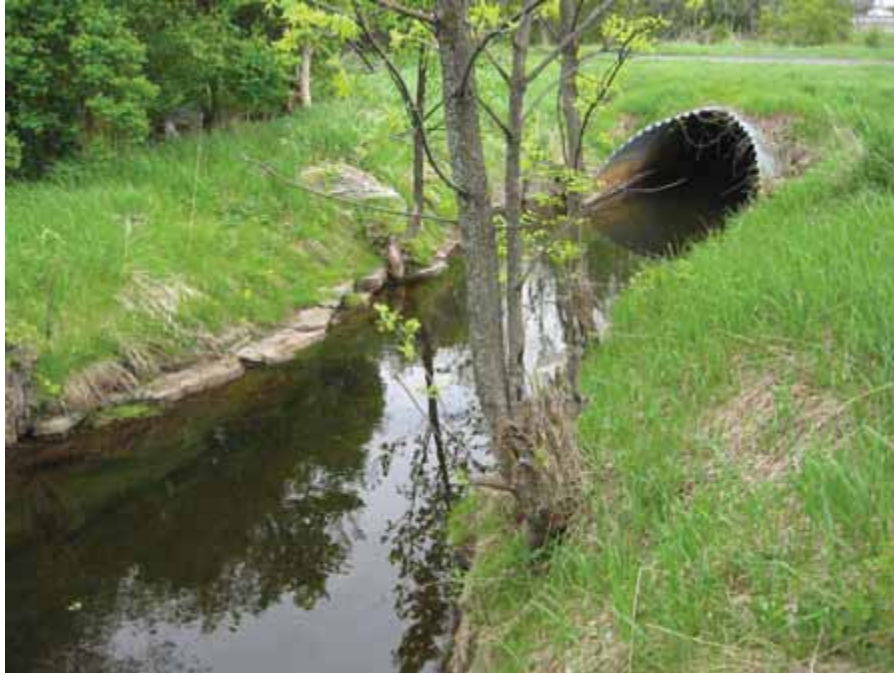
Figure 9. Photograph taken looking downstream at inlet of culvert at recreational trail.

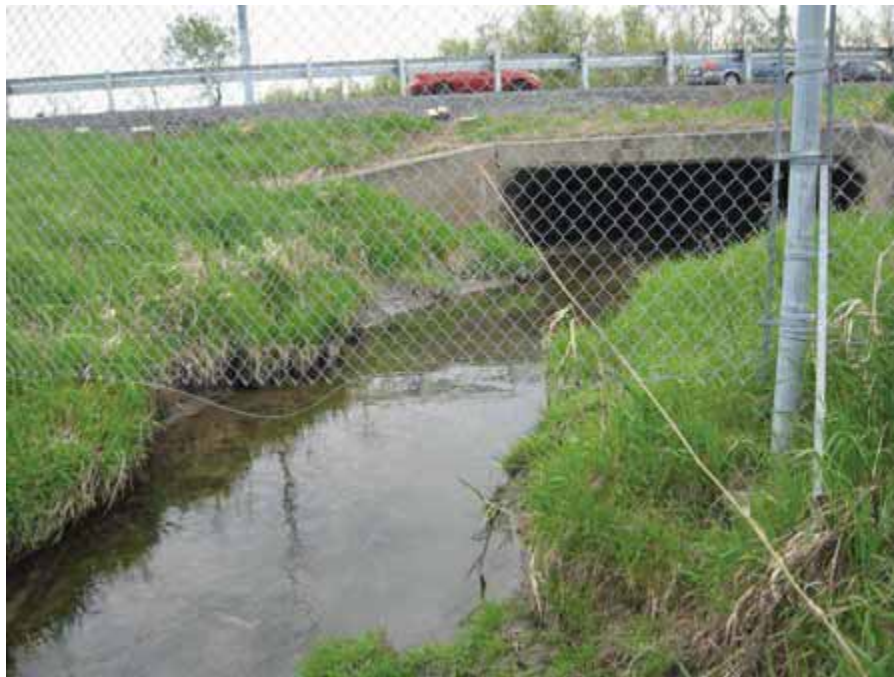
C#3 – Tributary A of Stillwater Creek at Highway 417, west of Moodie Drive

Figure 10. Photograph taken looking upstream at Highway 417 culvert for Tributary A and the general channel characteristics of this watercourse.

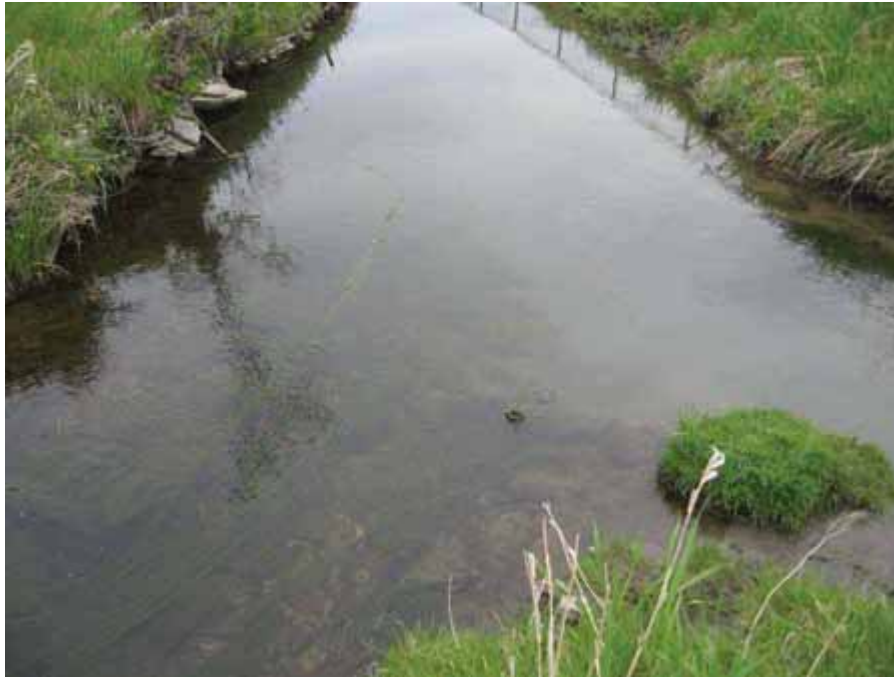
Figure 11. Photograph taken looking downstream at the outlet of the tributary into the main branch of Stillwater Creek.

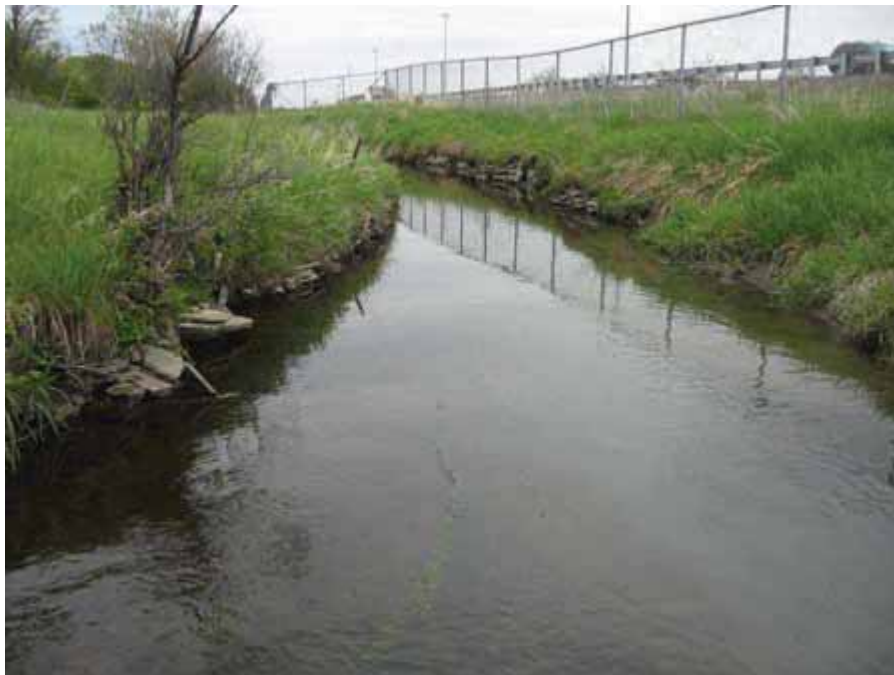
Figure 12. Photograph taken looking downstream of the tributary outlet on Stillwater Creek at the general channel characteristics.

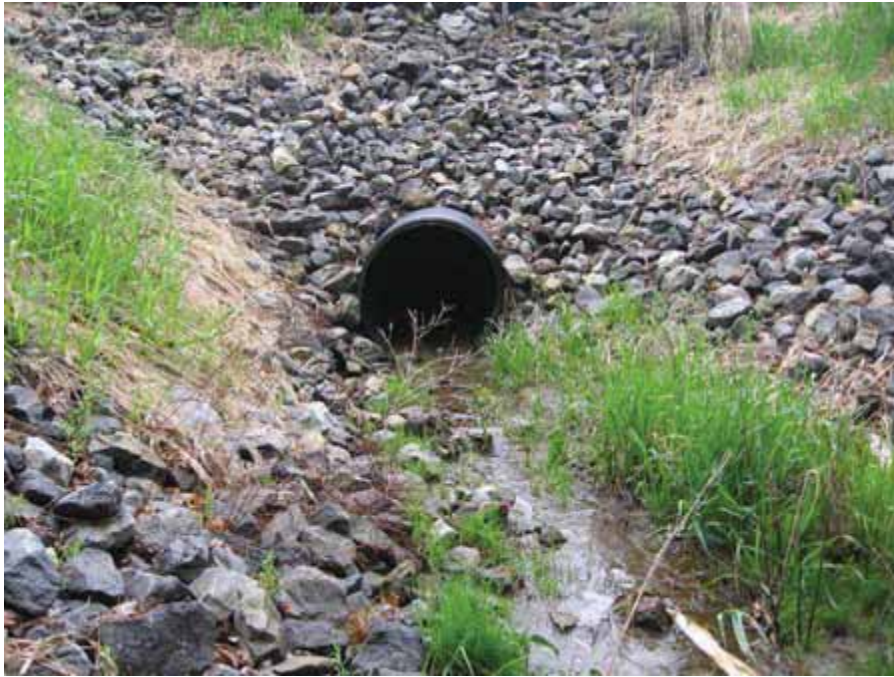
C#4 – Tributary B of Stillwater Creek – draining agricultural fields through Highway 417 ROW

Figure 13. Photograph taken looking upstream at the culvert under Highway 417 for this tributary.

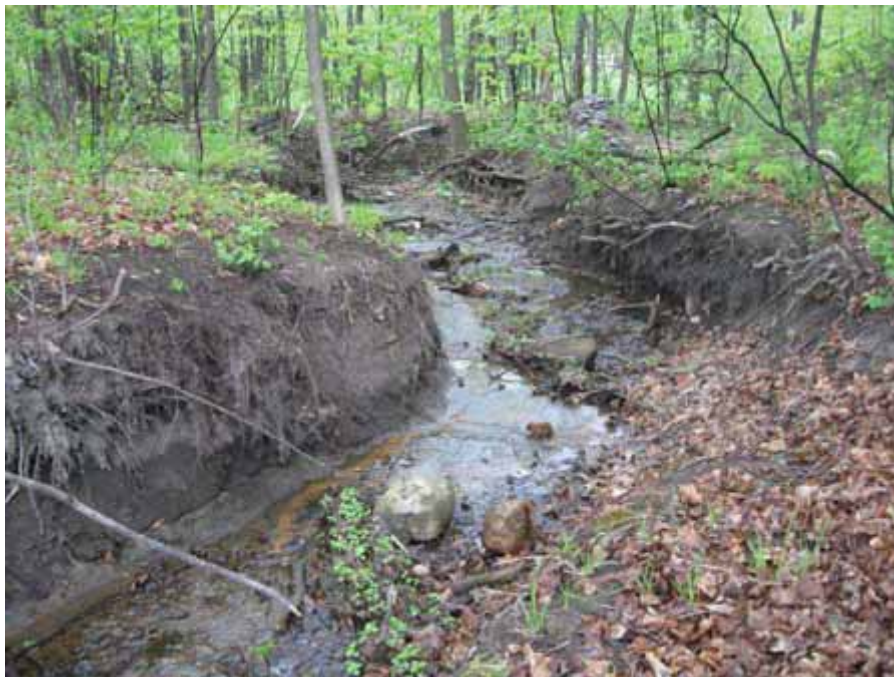
Figure 14. Photograph taken looking downstream at general channel characteristics within the reach.

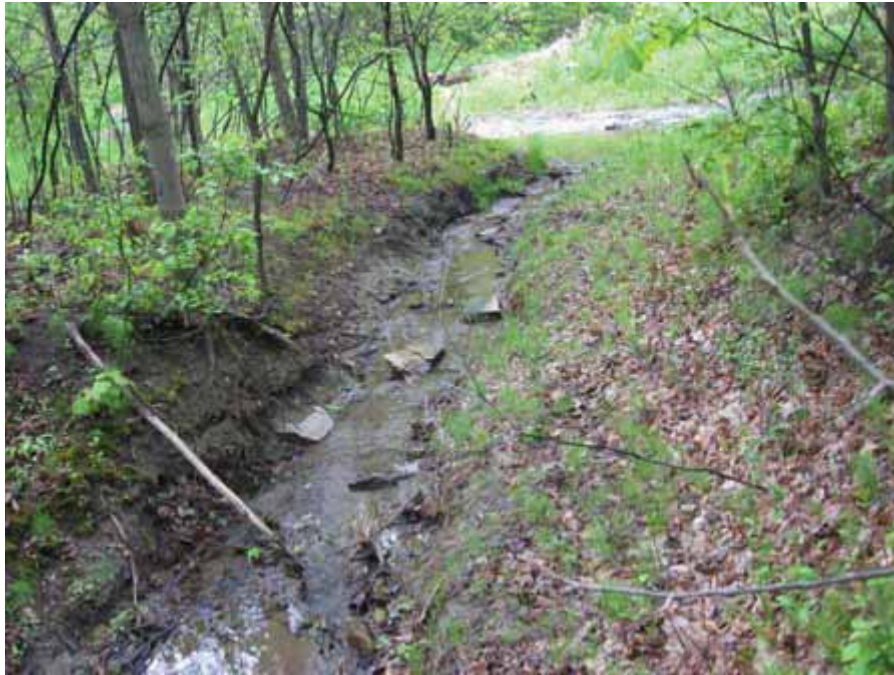
Figure 15. Photograph taken looking downstream along the reach at the outfall of the tributary to Stillwater Creek in the background.

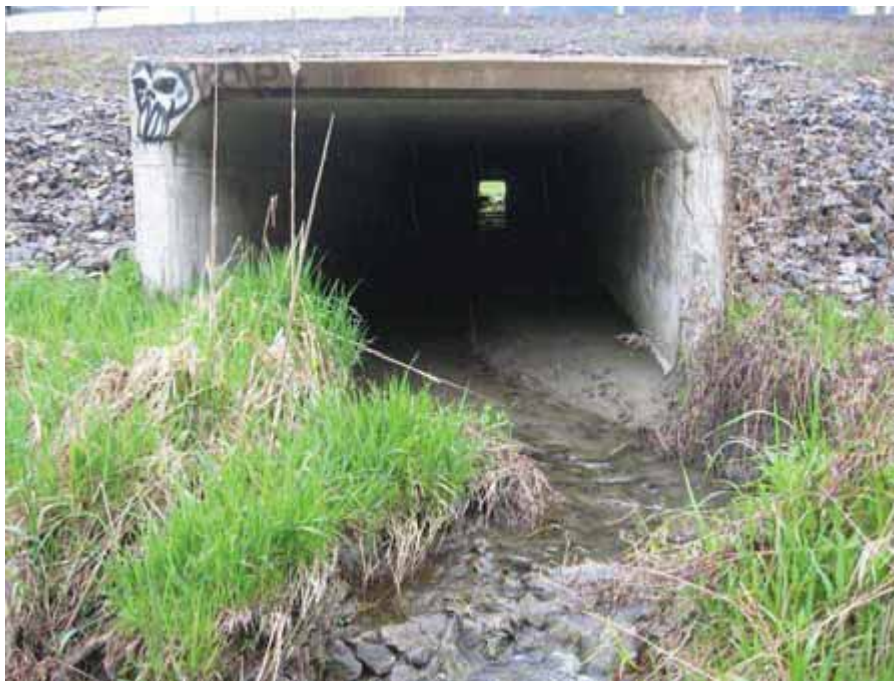
C#5 – Tributary C of Stillwater Creek - west of Highway 417/416 Interchange

Figure 16. Photograph taken looking upstream at the box culvert for this tributary under Highway 417.

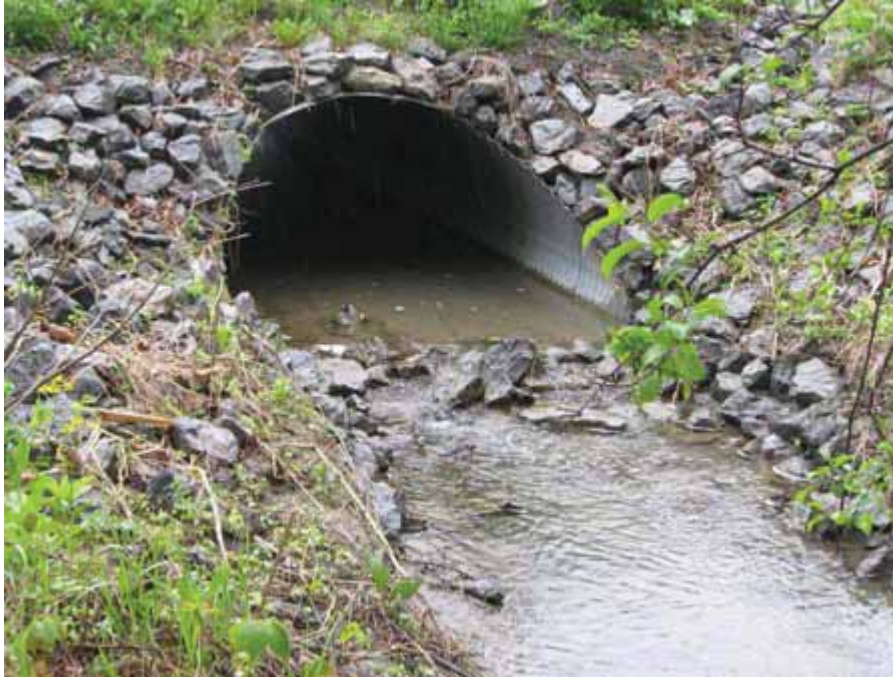
Figure 17. Photograph looking upstream at the culvert installed at the recreational trail and the rip rap bank protection and rocky ramp.

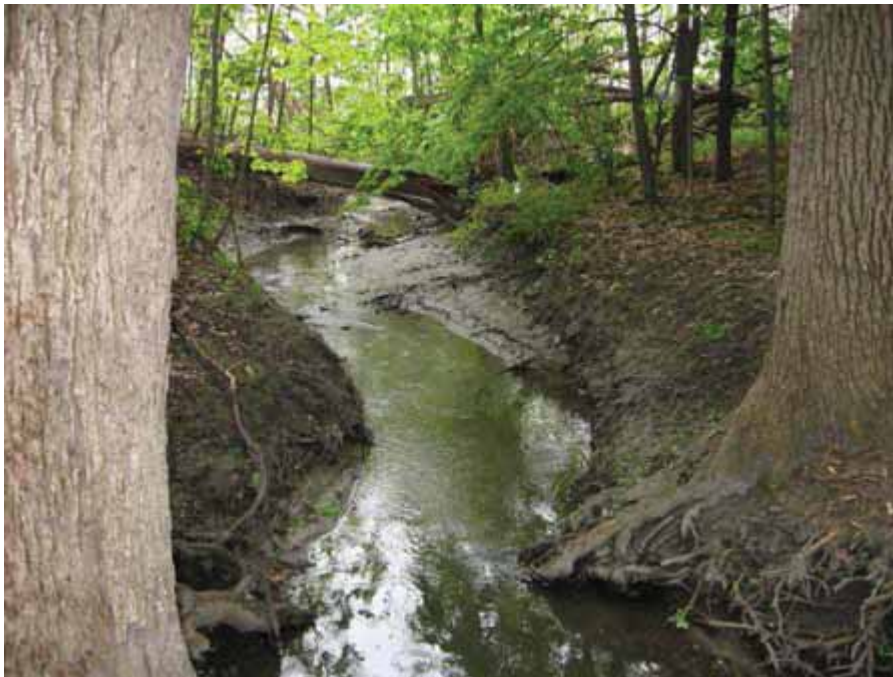
Figure 18. Photograph taken looking upstream at the confined section of reach in the mixed forest area.

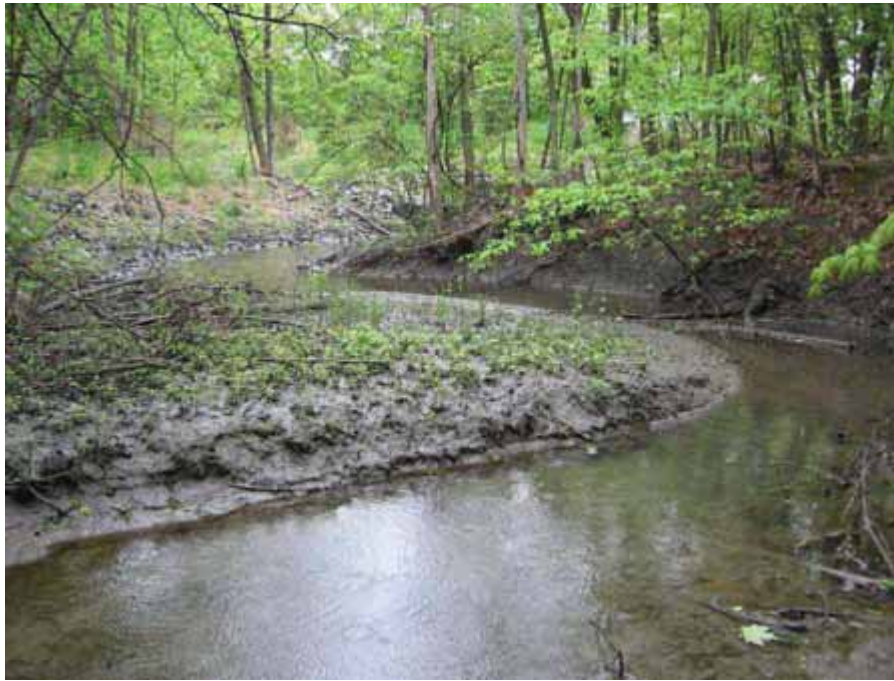
Figure 19. Photograph taken looking downstream at the general channel characteristics in the low lying forested area immediately upstream of the residential lands.

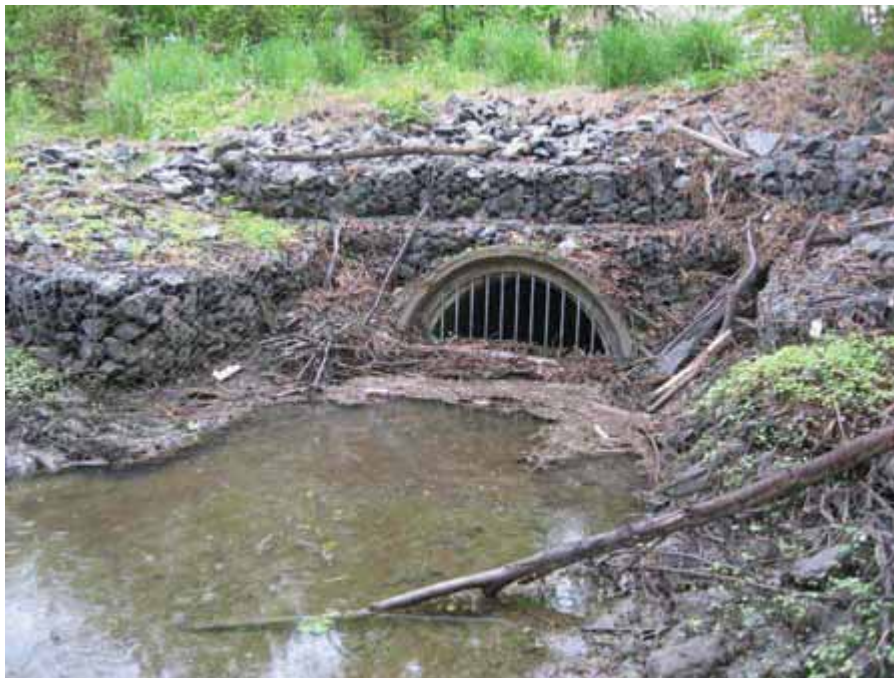
Figure 20. Photograph taken looking downstream at the culvert leading into the storm sewers and the woody debris accumulation on banks and in front of the grated culvert.

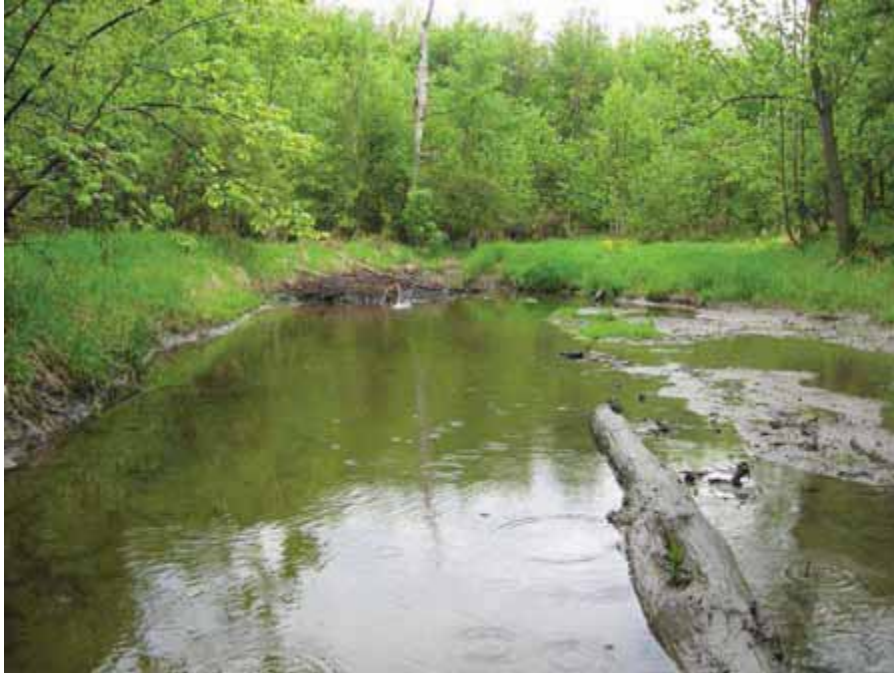
C#6 – Main Stillwater Creek at Hydro Corridor

Figure 21. Photograph taken looking upstream from the Hydro Corridor on Stillwater Creek, upstream of the residential lands.

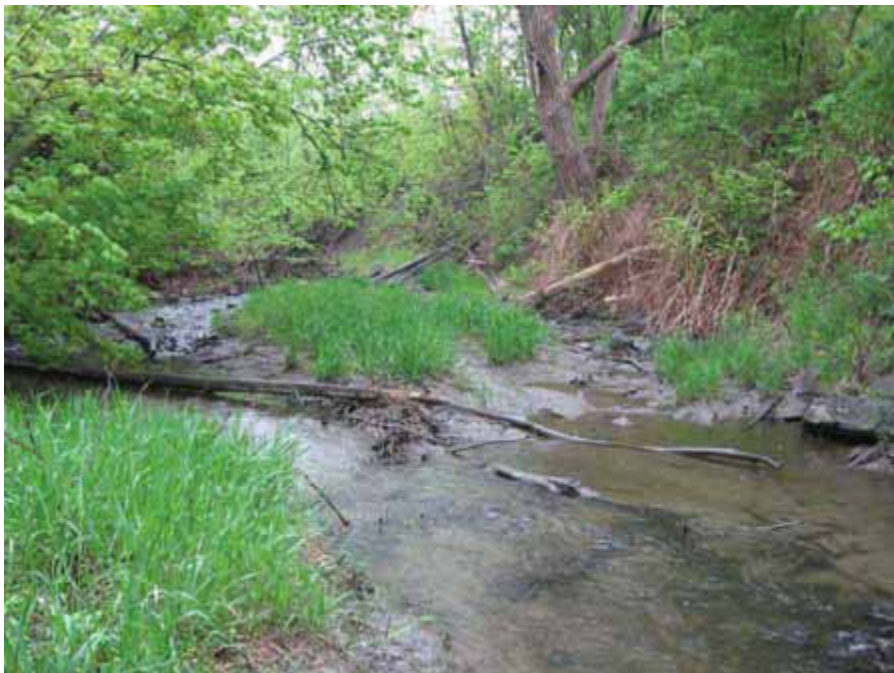
Figure 22. Photograph taken looking upstream at potential ROW (yellow corridor) at island formation and valley wall embankment.

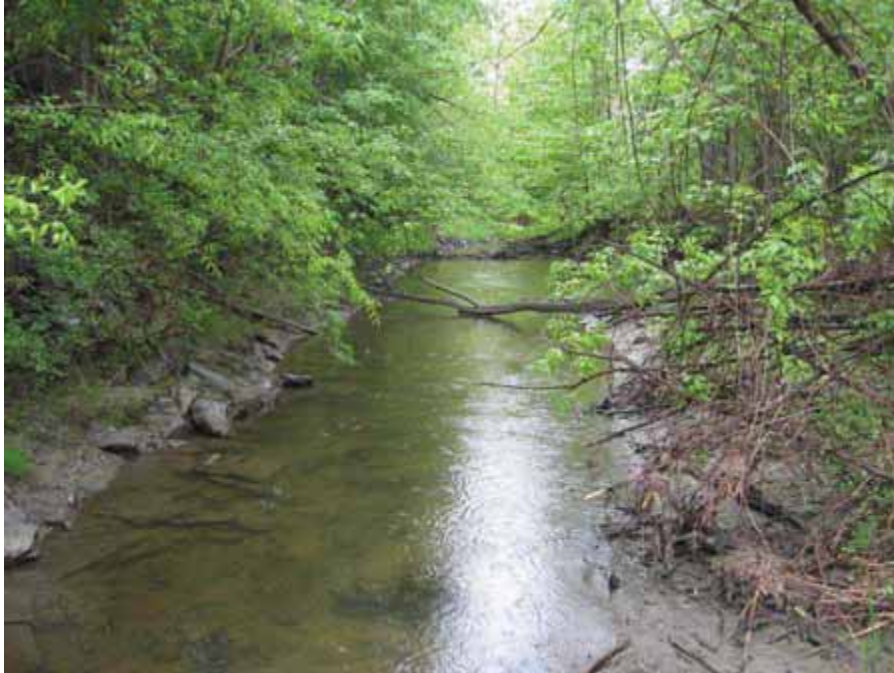
Figure 23. Photograph taken looking downstream from the potential ROW (yellow corridor) at general channel characteristics.

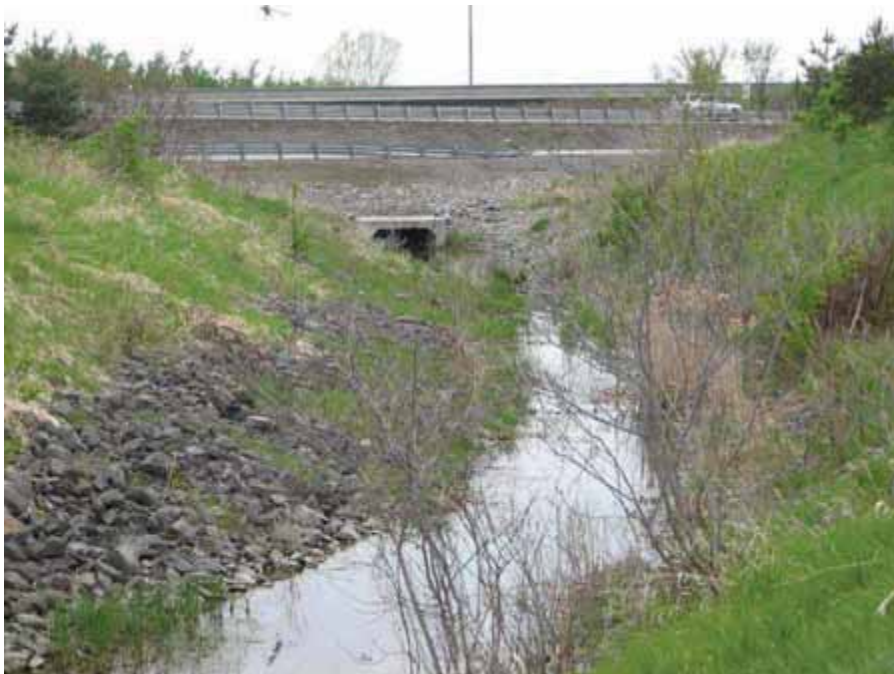
C#7 – Tributary A of Graham Creek

Figure 24. Photograph taken looking upstream at the culvert under Highway 417 for this tributary.

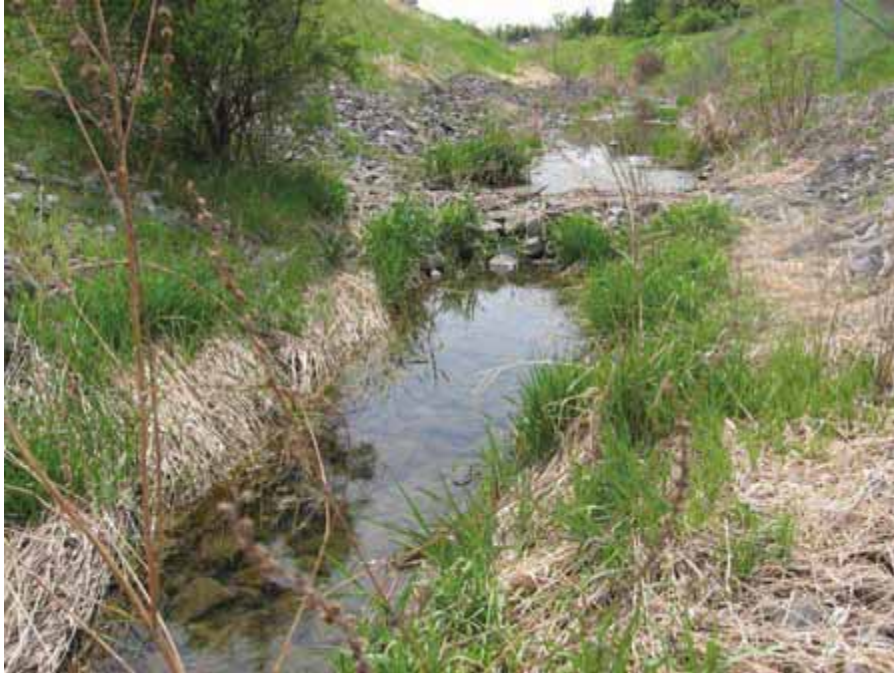
Figure 25. Photograph taken looking upstream through potential ROW (all corridors) at rock check dam and general bank vegetation.

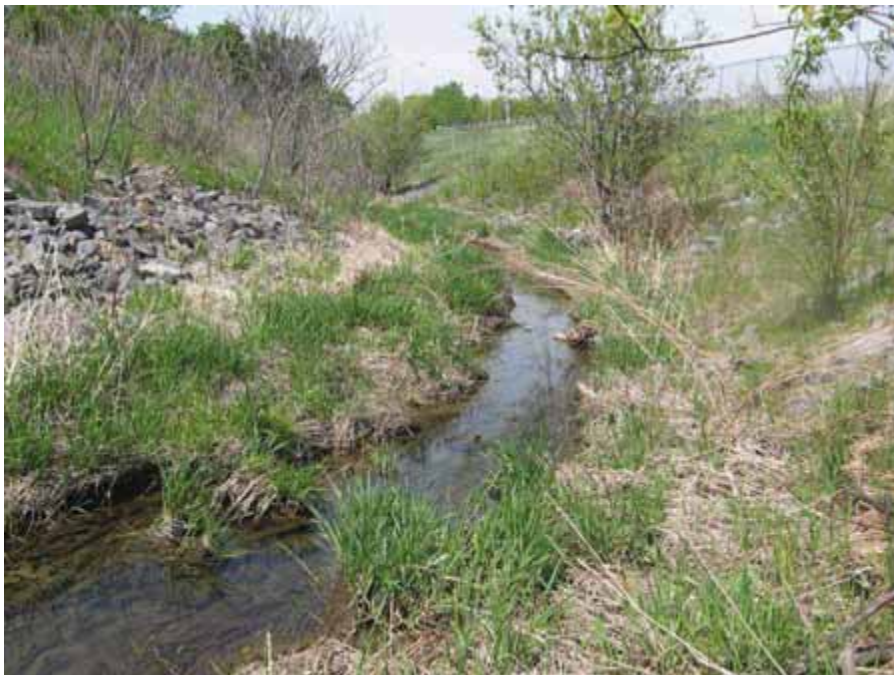
Figure 26. Photograph taken looking downstream at the general channel characteristics downstream of the potential ROW.

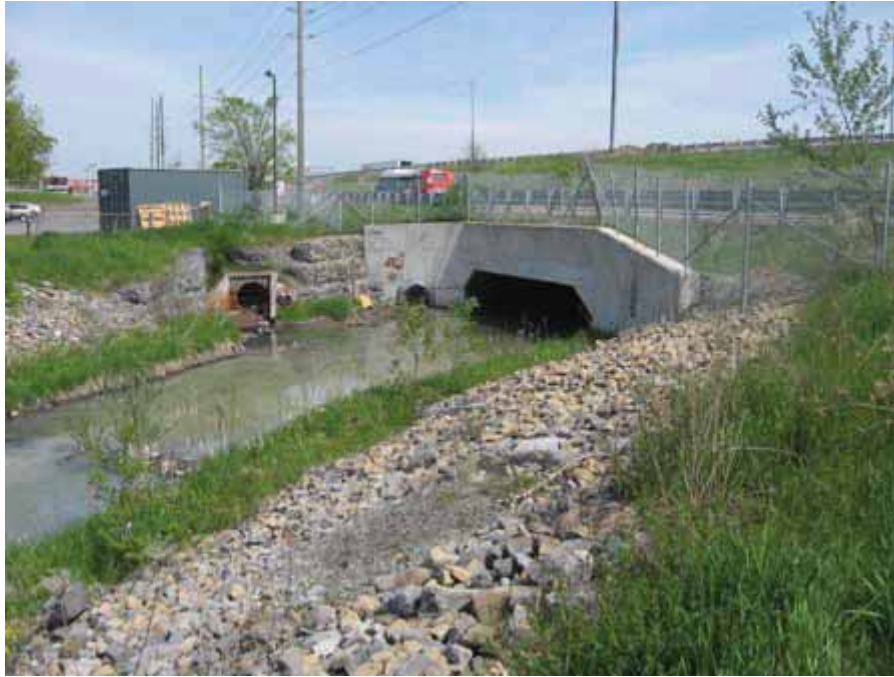
C#8–Graham Creek – East of Holly Acres Road

Figure 27. Photograph taken looking upstream at the bridge over Graham Creek for Highway 417.

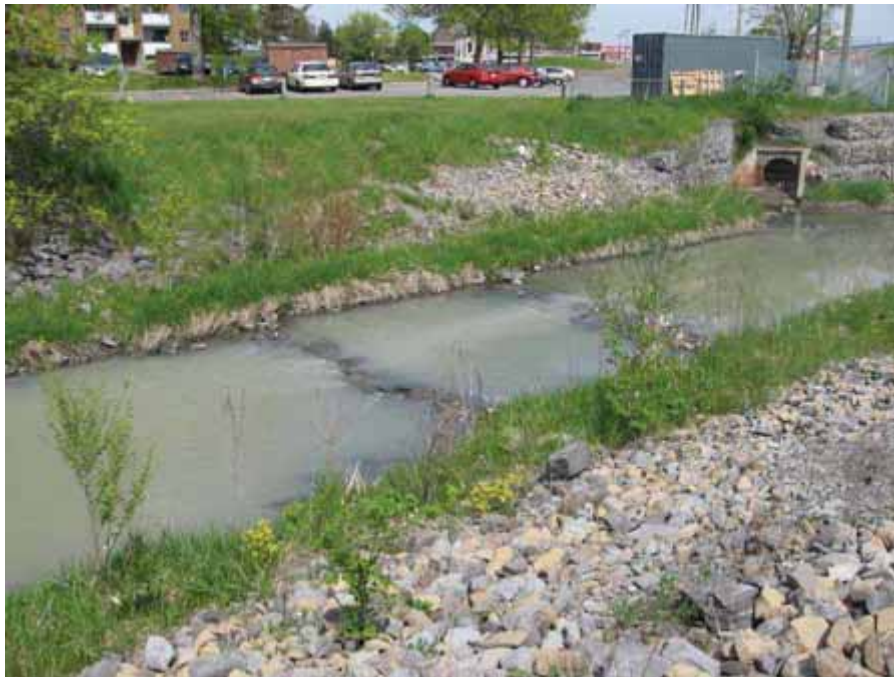
Abundant organic debris and leaf litter was observed on the streambed, covering some of the finer substrates, and offering some instream cover for baitfish. Water clarity was poor and flow was turbid during the 2009 field investigation. No sensitive habitat features (e.g. spawning, nursery habitat) were observed during the field visit and no fish were captured. In 2001, the RVCA reported the capture of baitfish at their sampling locations located approximately 670m downstream of the highway ROW, and approximately 750m upstream of the highway. Species captured included: White Sucker, Longnose Dace, Creek Chub, Johnny Darter and sculpin species. American Eel (*Anguilla rostrata*), designated by COSEWIC as *Special Concern*, by MNR as *Endangered* (although Ontario general status is *Secure*) has been captured near the mouth of Graham Creek approximately 670m downstream of the study area. This species has not been recorded within the study area.

Figure 28. Photograph taken looking across channel from western bank at the manmade riffle features and turbid (grey-water) observed during the 2009 field investigation.

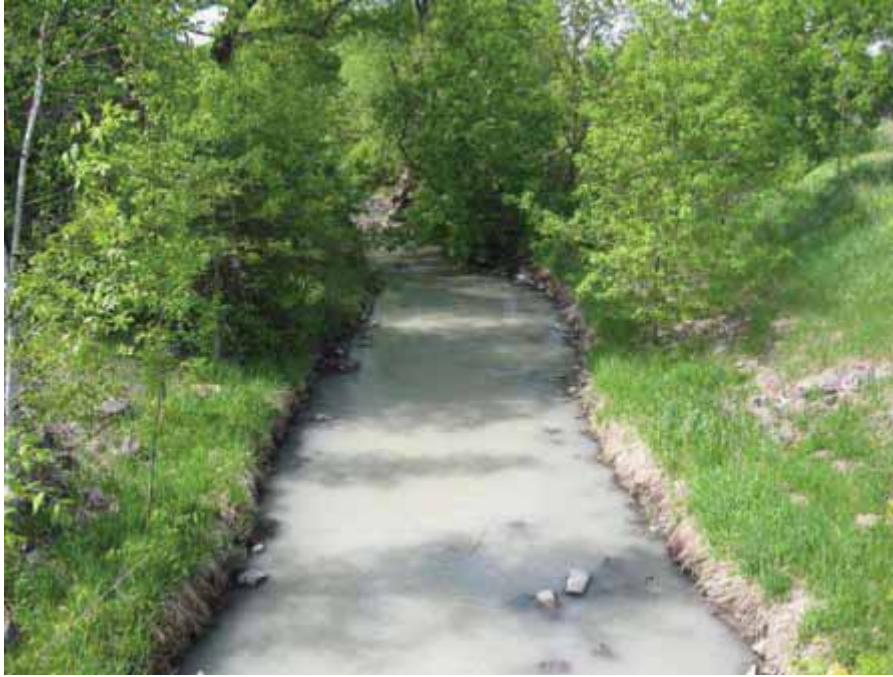
Figure 29. Photograph taken looking downstream of the pedestrian bridge over Graham creek at the general channel characteristics through the residential and commercial lands.
