Ottawa Cycling Safety Study Report

A report summarizing the findings from a safety evaluation of ten cycling facility sites selected by the City, and the presentation of candidate safety countermeasures that attempt to address the safety risks at each site.

May 2011

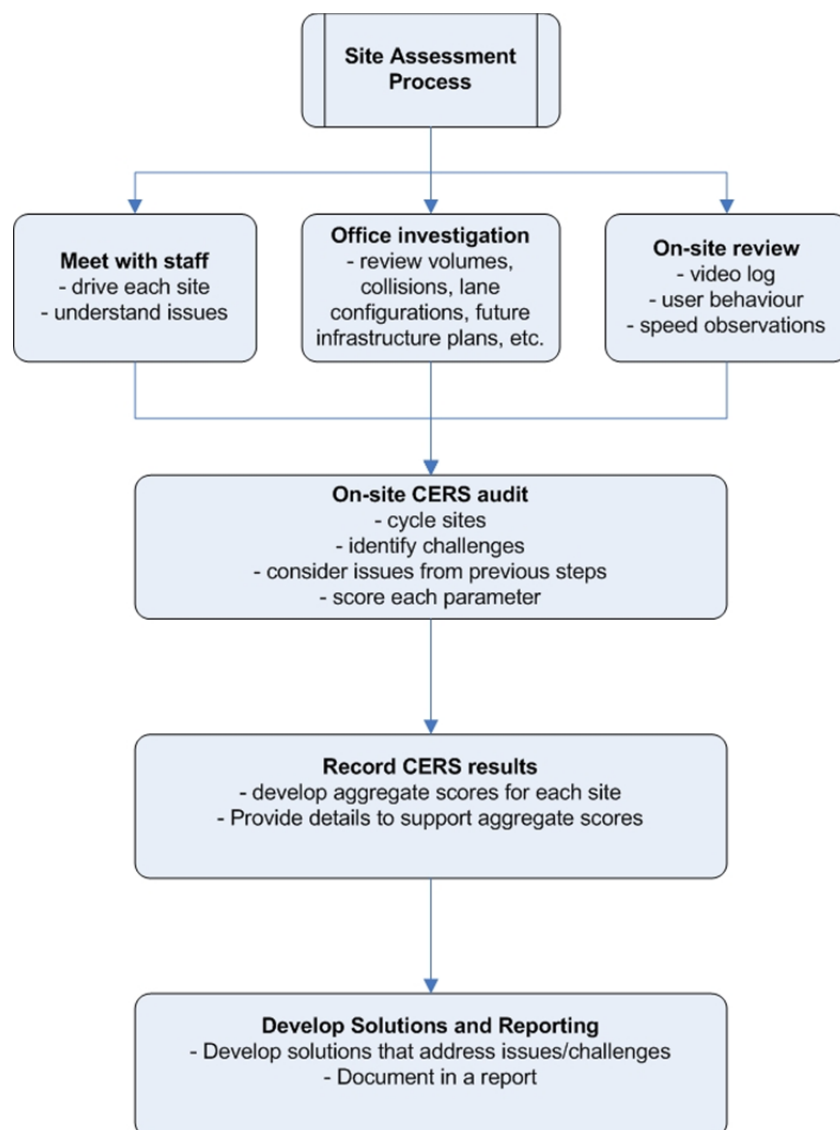
Figure 3: The site-specific safety assessment process

The Figure below illustrates the site-specific safety assessment process.

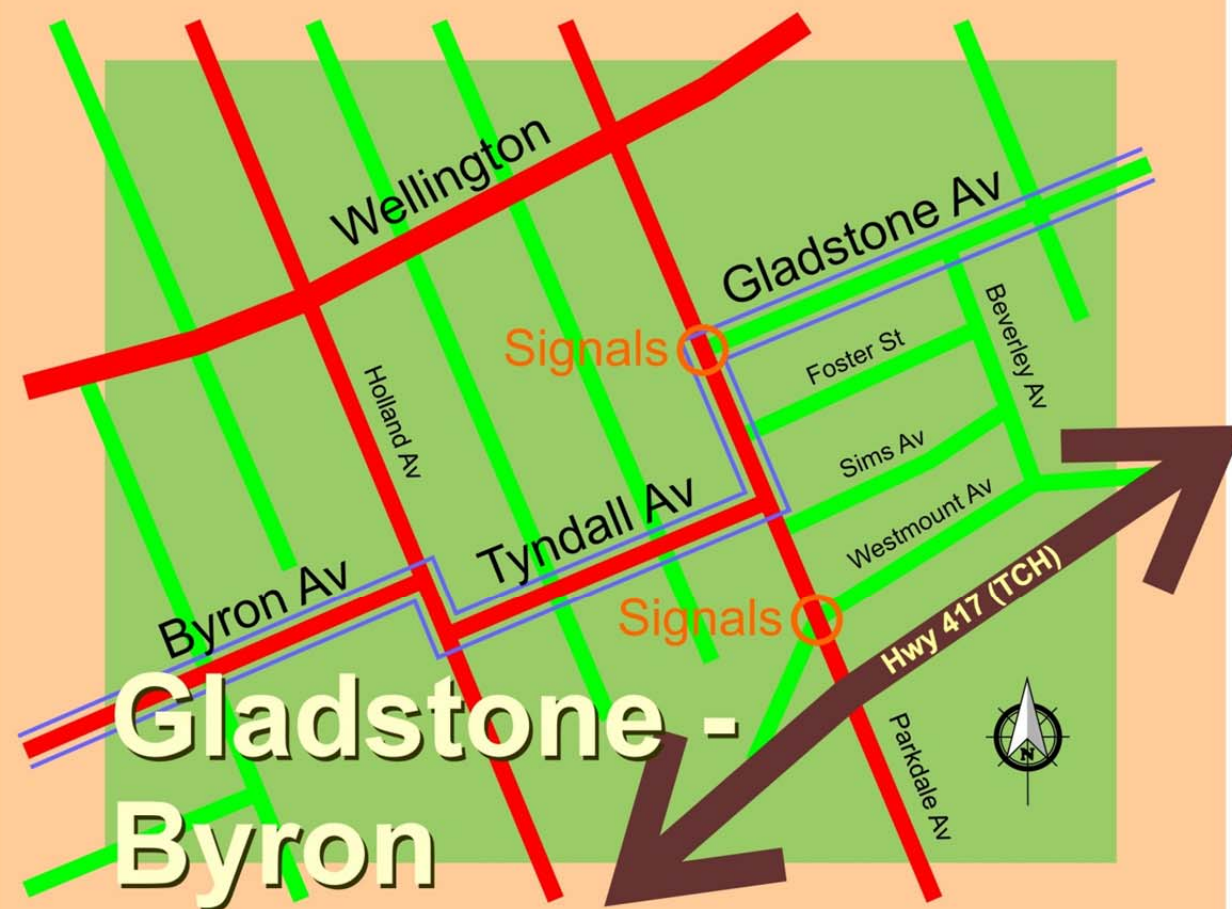
- Poor sightlines and long delays at intersections (especially eastbound)
- Traffic signals on Parkdale do not provide sufficient gaps for turning cyclists
- Congestion on Parkdale and Holland during peaks
- Short weaving movement required on Holland Avenue
