**Fitzroy Harbour – Carp River  
Erosion Control Class  
Environmental Assessment**

FINAL ENVIRONMENTAL  
ASSESSMENT STUDY REPORT

**Prepared for:**  
City of Ottawa

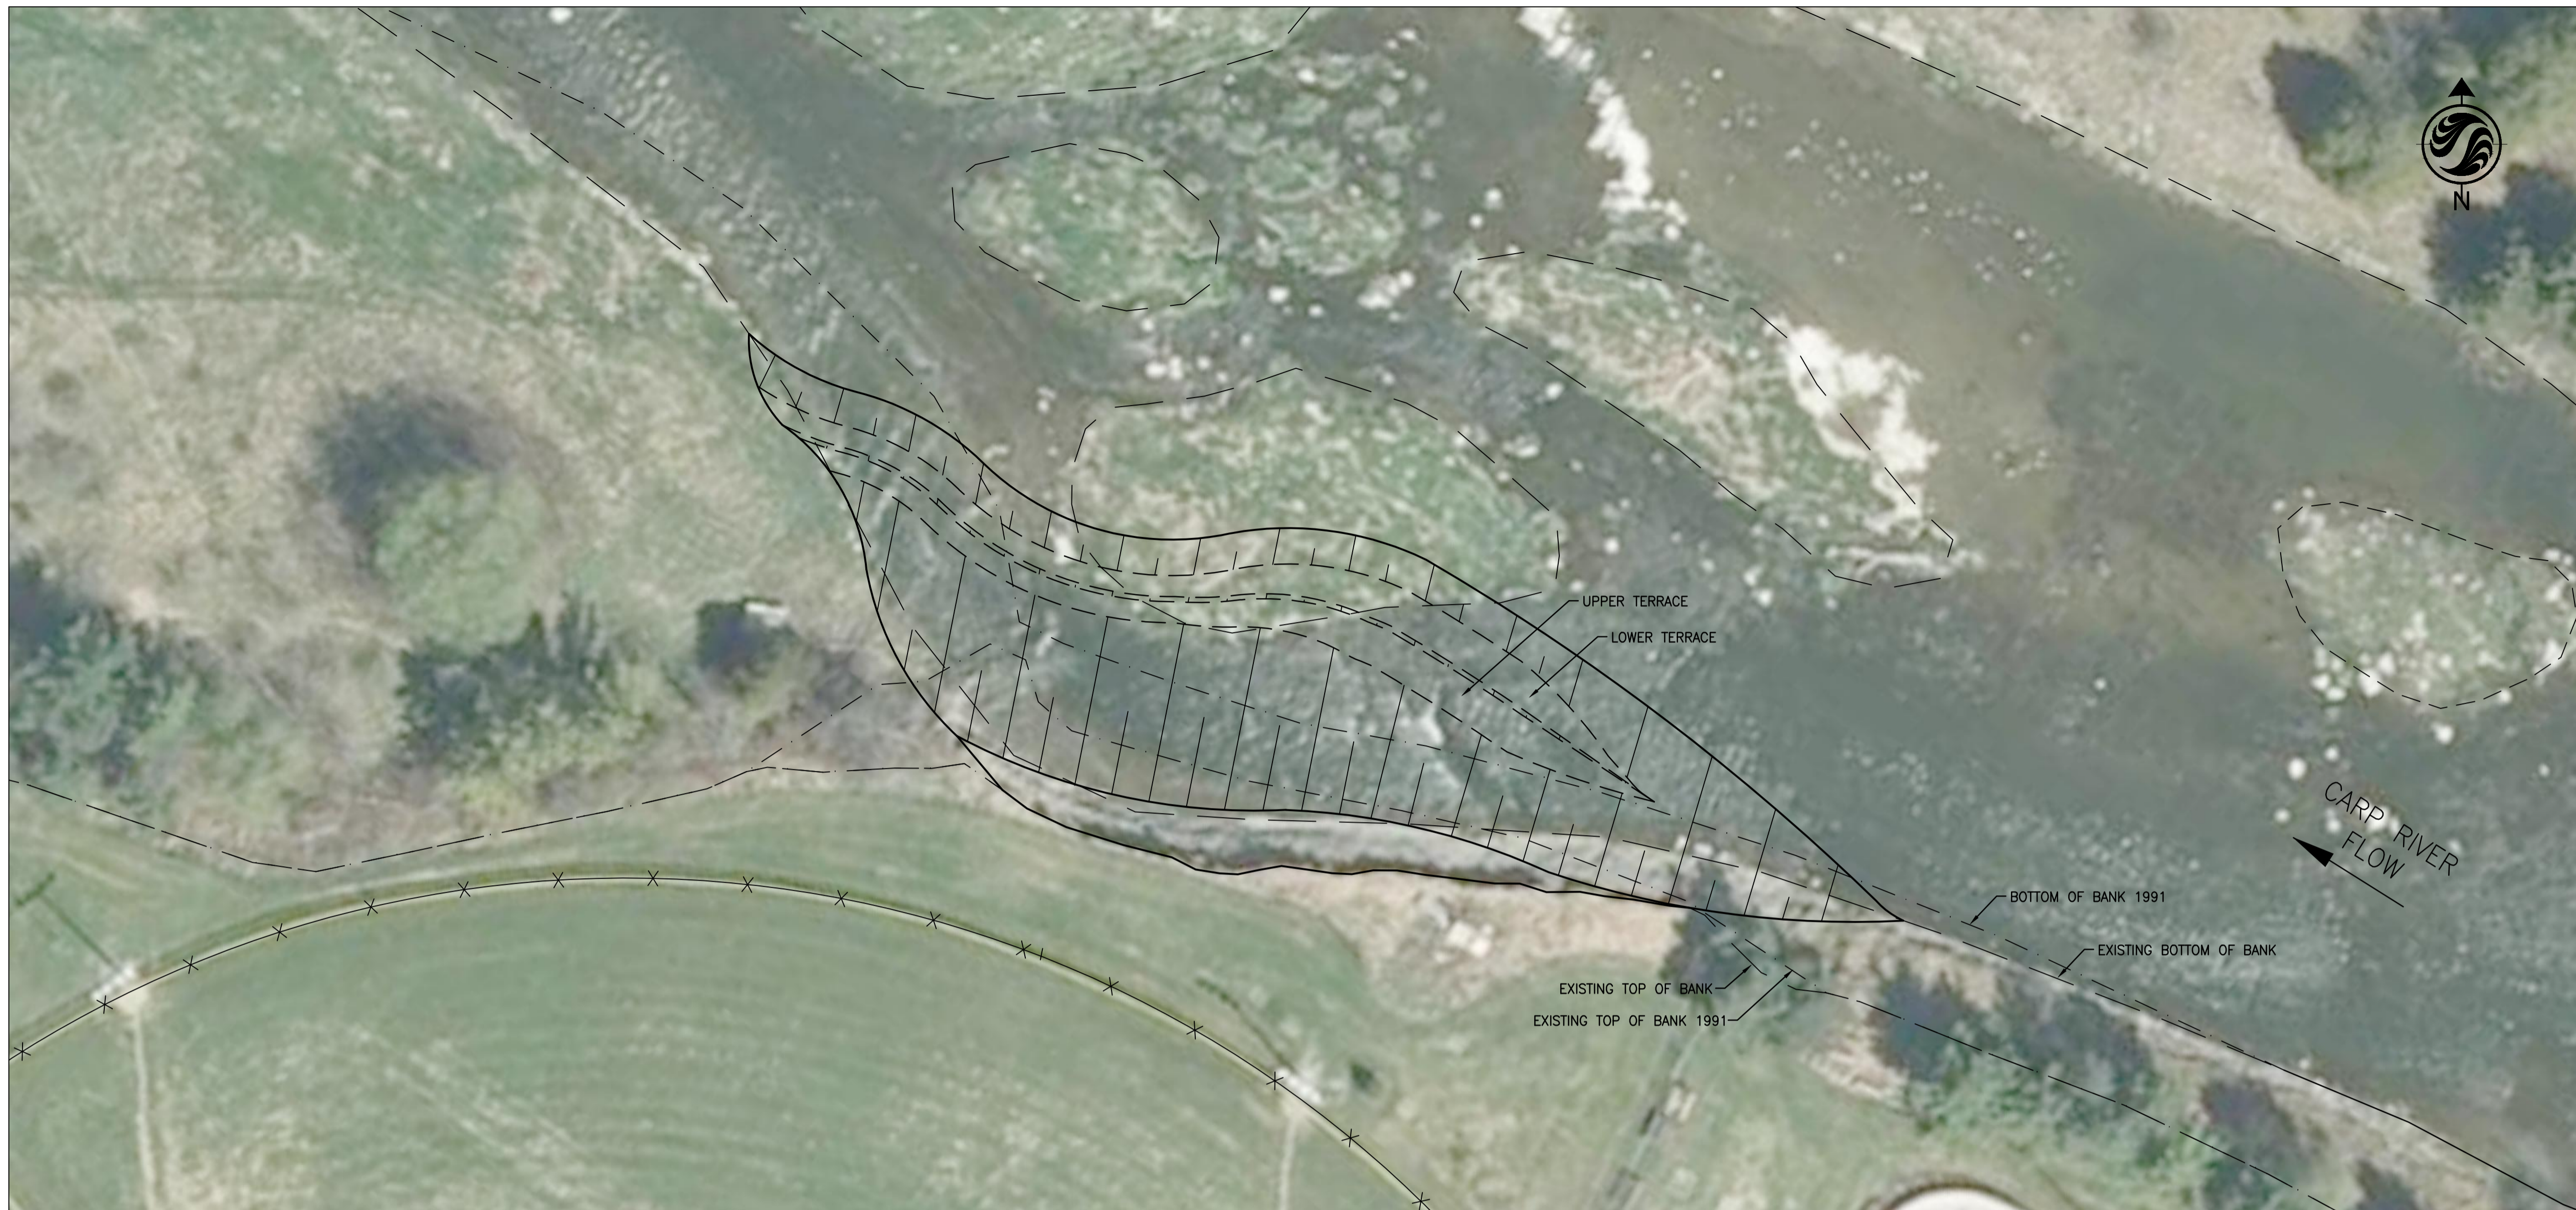
PLAN VIEW  
 N.T.S.

TYPICAL SECTION  
 N.T.S.

Based on the preceding evaluation of alternatives, and as summarized in **Table 5-9**, the recommended solution for the primary erosion area is the re-establishment of the general form of the river to previous (1991) patterns through Alternative 6: Partial River Channel Retraining. While this alternative is among the most expensive to implement, it is considered to be a longer lasting and therefore more sustainable solution. This solution will reverse the local tendency of

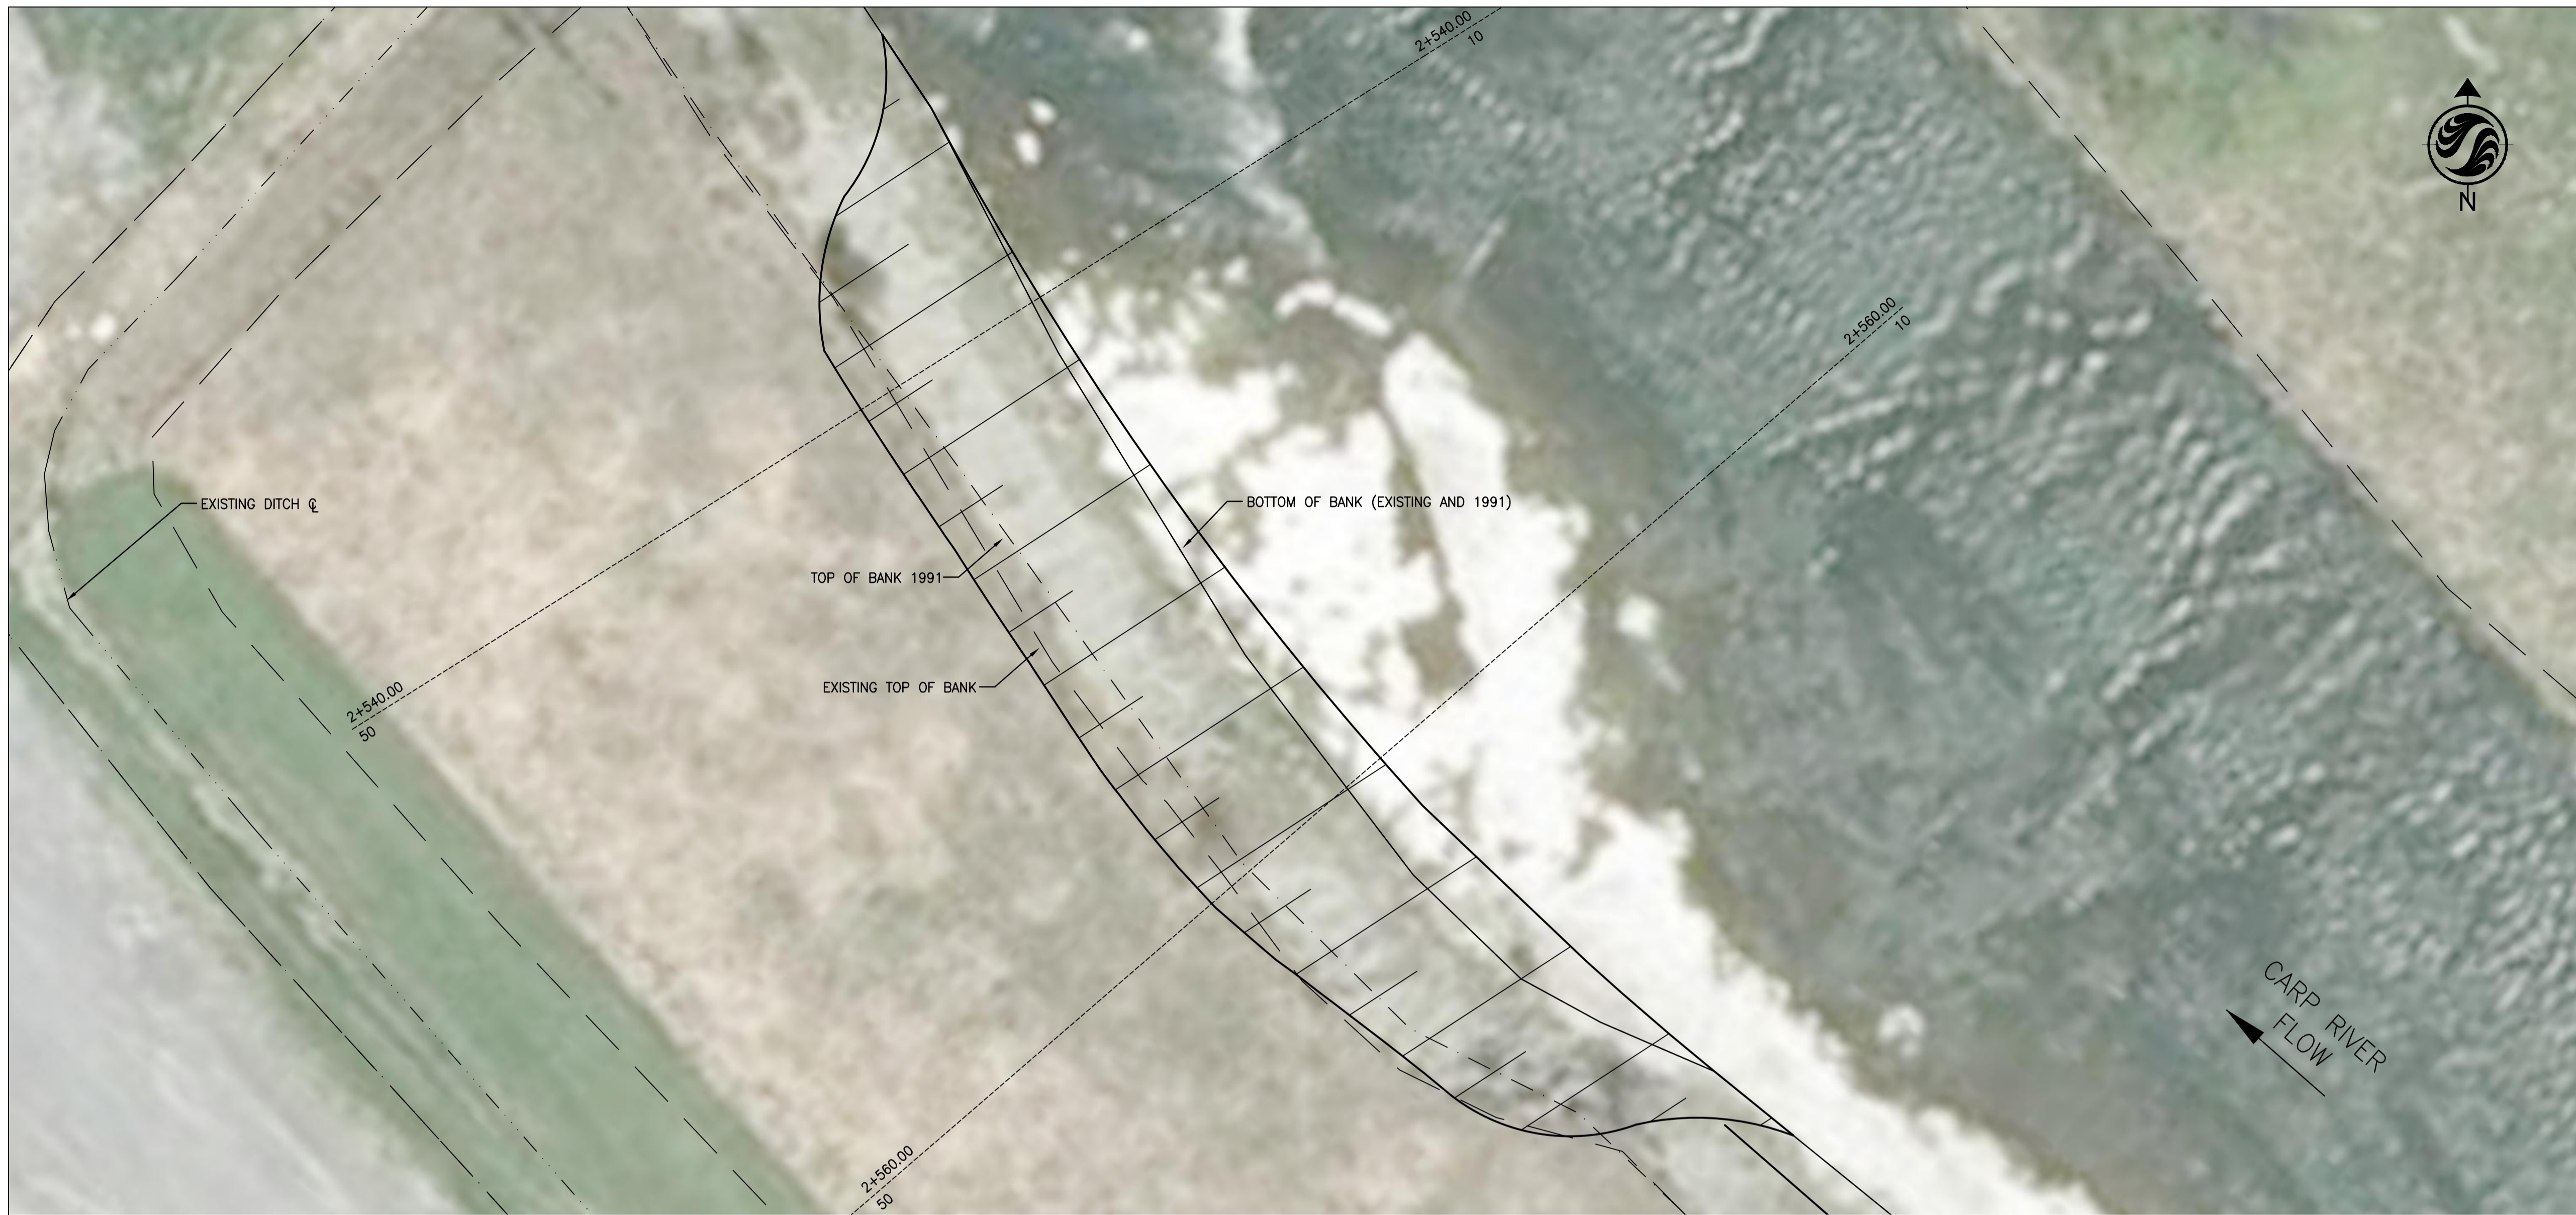
PLAN VIEW  
 N.T.S.

TYPICAL SECTION  
 N.T.S.

As for the secondary erosion site, the recommended prescription involves the simple re-grading of the over-steepened slope (minimum 2 horizontal to 1 vertical) with the need for little to no imported fill material. The base of the re-graded slope would be armoured with either riprap or bioengineering techniques such as brush layering to prevent erosion and the upper slope would be re-vegetated.

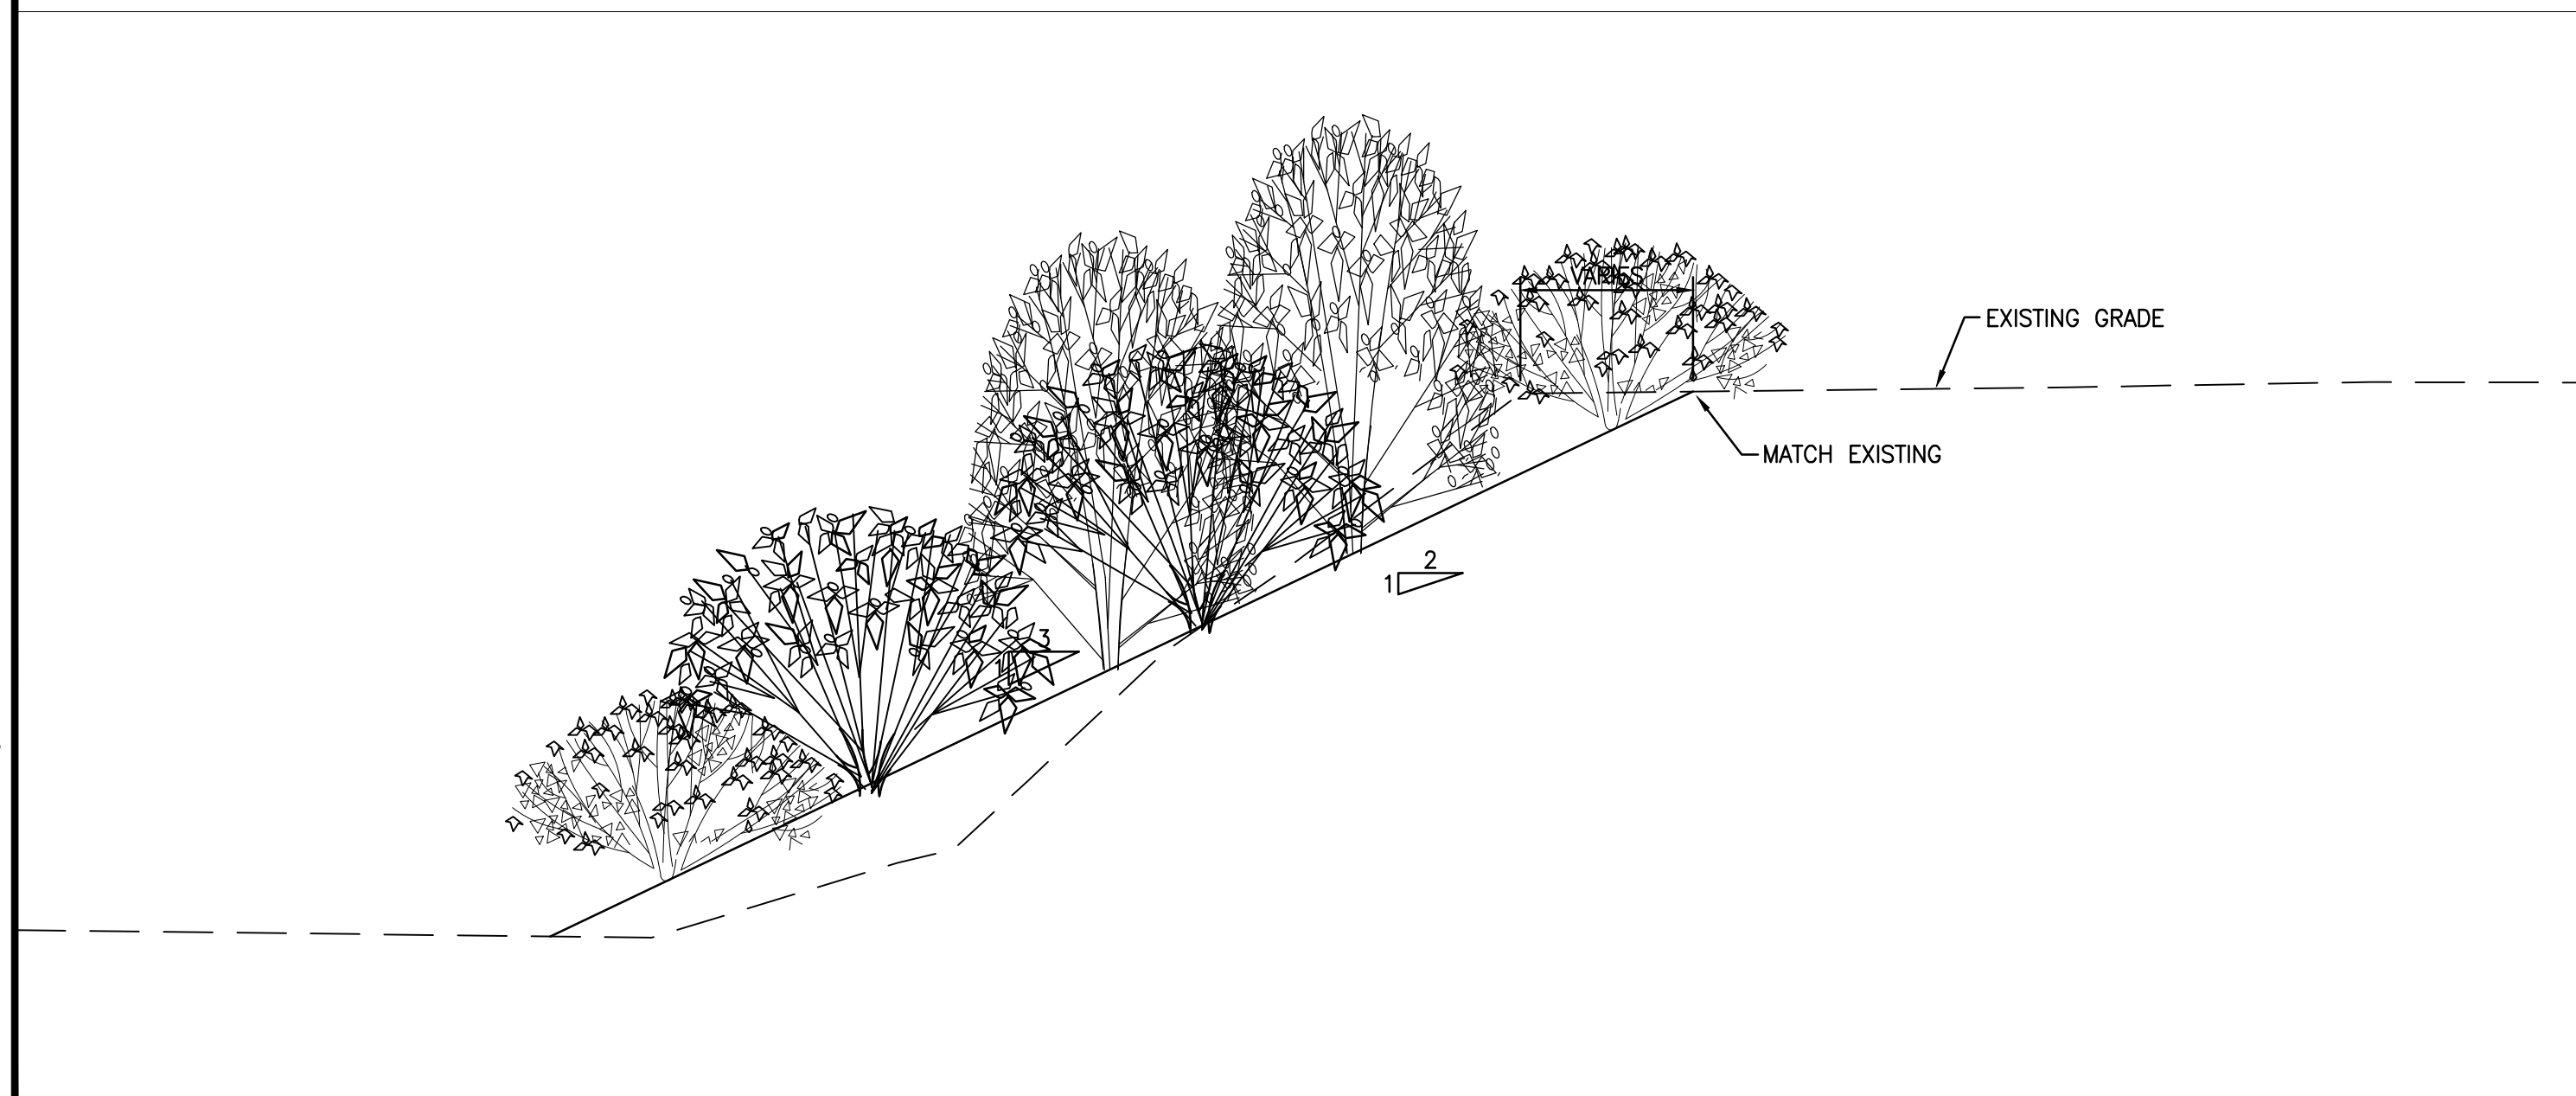
1 PLAN VIEW— SECONDARY SITE  
SCALE 1:250

2 SECTION— SECONDARY SITE (STATION 2+560)  
SCALE 1:50

<b>FITZROY HARBOUR SLOPE STABILITY</b>				
<b>PLAN VIEW AND TYPICAL SECTION SECONDARY SITE</b>		Contract No. <b>000</b>	Dwg. No. <b>000</b>	
		Sheet <b>—</b> of <b>—</b>		
		Asset No. <b>00</b>		
		Asset Group <b>00</b>		
Manager - Division <b>—</b>	Project Manager <b>—</b>	Des. <b>00</b>	Chk'd. <b>00</b>	
		Dwn. E.C. <b>00</b>	Chk'd. <b>00</b>	
		Utility Crc. No. <b>00</b>	Index No. <b>00</b>	
		Const. Inspector <b>00</b>		
		Scale: AS SHOWN		
<p><b>NOTE:</b> The location of utilities is approximate only, the exact location should be determined by consulting the municipal authorities and utility companies concerned. The contractor shall prove the location of utilities and shall be responsible for adequate protection from damage.</p>				
		Stantec Consulting Ltd. 1565 Lapeere Avenue Ottawa ON Canada K1Z 7T1 Tel. 613.722.4420 Fax. 613.722.2799 www.stantec.com		
REVISIONS	No.	Description	By	Date (dd/mm/yyyy)

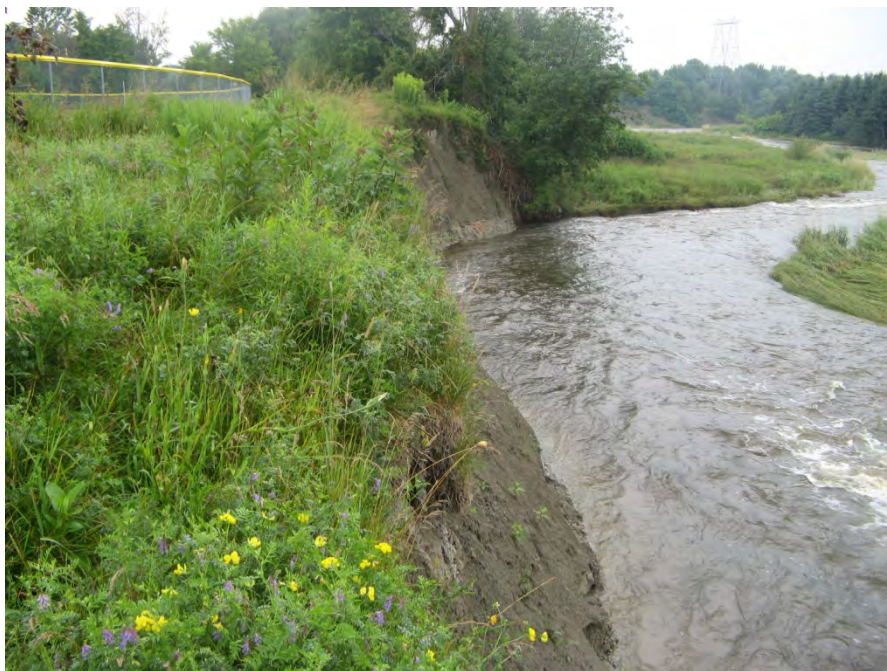
Photo Plate 1: View looking downstream at flow in contact with eroding bank under moderate flow conditions.

addition, it appears that the bedrock outcrop dips slightly in the direction of the eroding bank, further pushing flow in that direction.

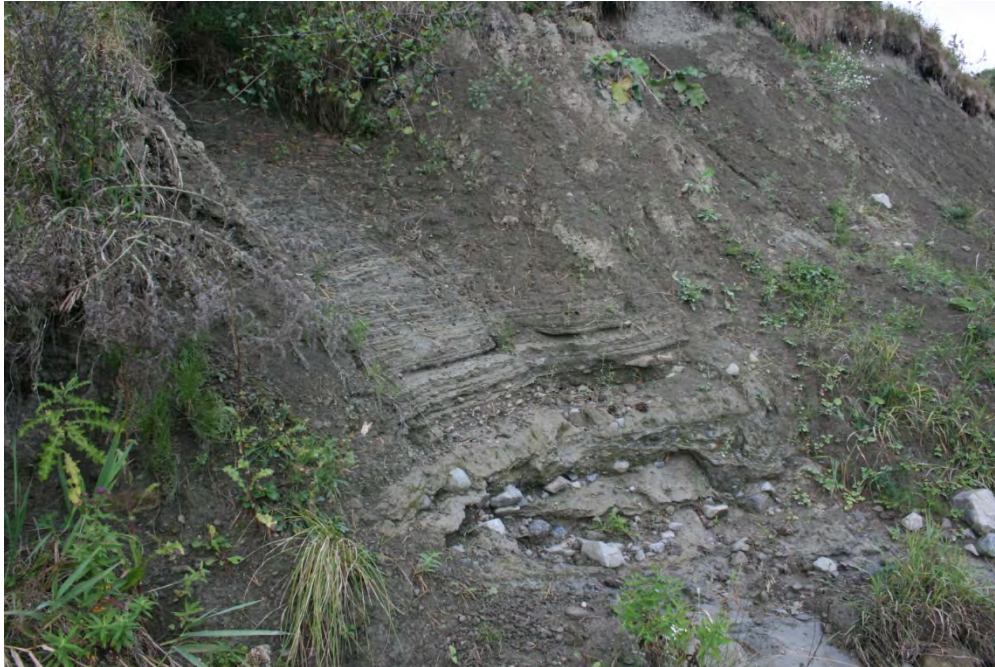
*Photo Plate 2: View of the base of the bank showing horizontal bedding planes in the varved clay.*

The bank material is also a factor in the rate of recession of the bank. Banks along the lower Carp River have a layer of varved clay (deposited during the recession of the Wisconsin Glaciation 8000-10000 YBP. As this area was under water as part of Lake Champlain, settling of clay particles at the bottom of the lake created bedding planes which are points of weakness in the clay matrix. Photo Plate 2 shows the varves (horizontal layering) within the clay at the base of the eroding slope.

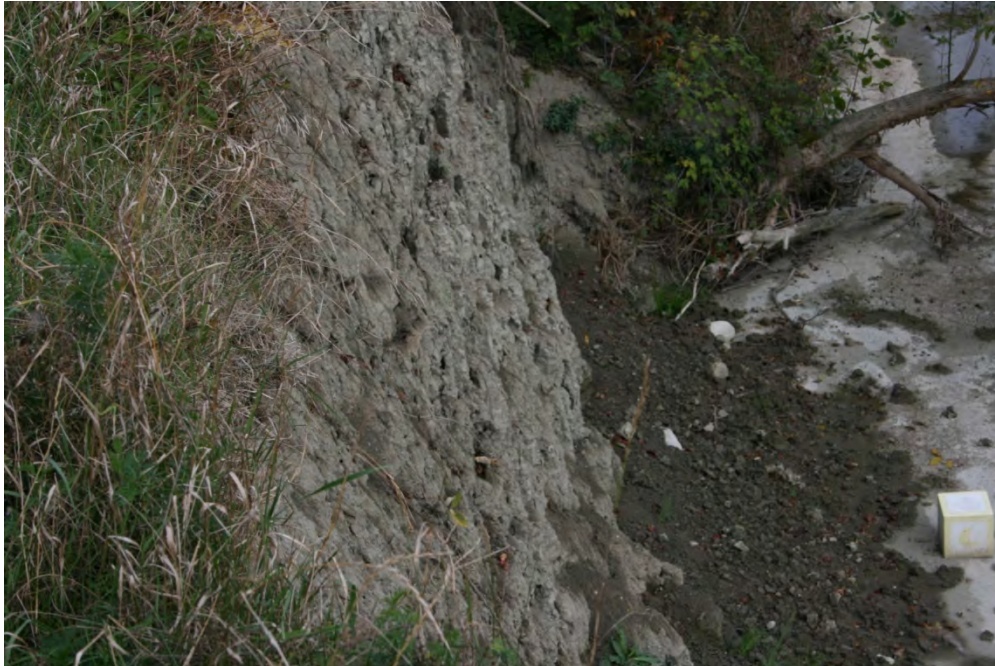
*Photo Plate 3: View showing desiccation of the clay surface and bulk erosion collecting at the toe of the slope.*

During drying periods the banks suffer from desiccation of the clay materials, which leaves small fractures which are acted upon by water action. This allows for clump erosion as these small blocks of clay are worn away as bulk units. Photo Plate 3 shows a close up of the desiccation and fractures in the clay at the time of the stream assessment.

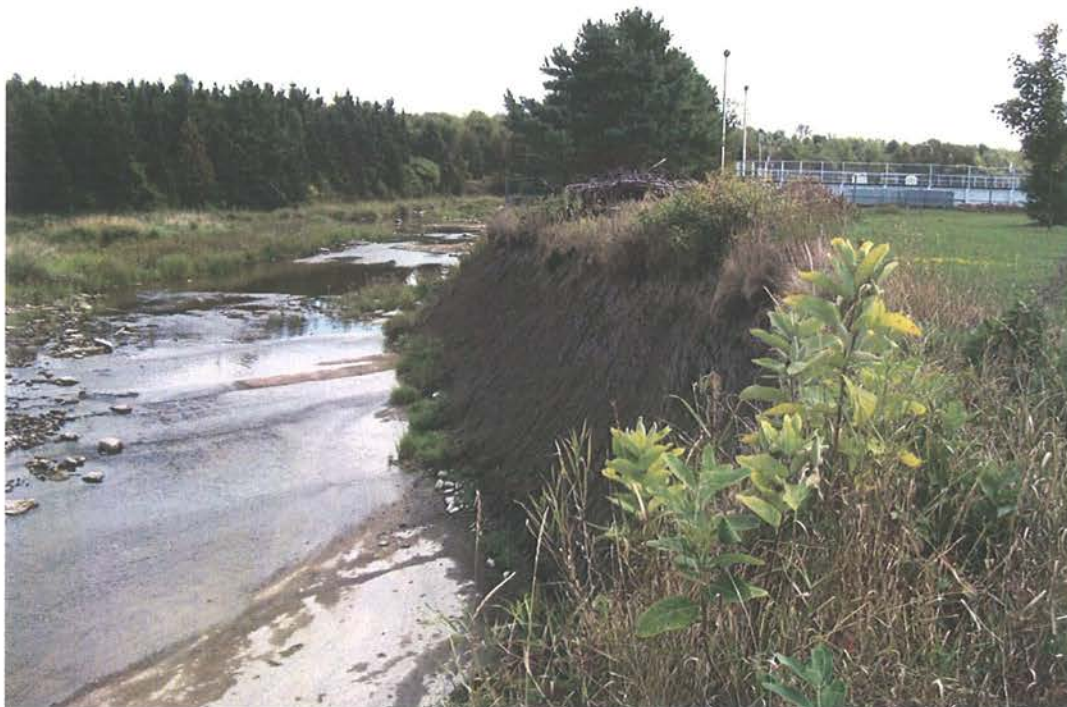
**Photo No. 1: Critical slope surface (east side)**

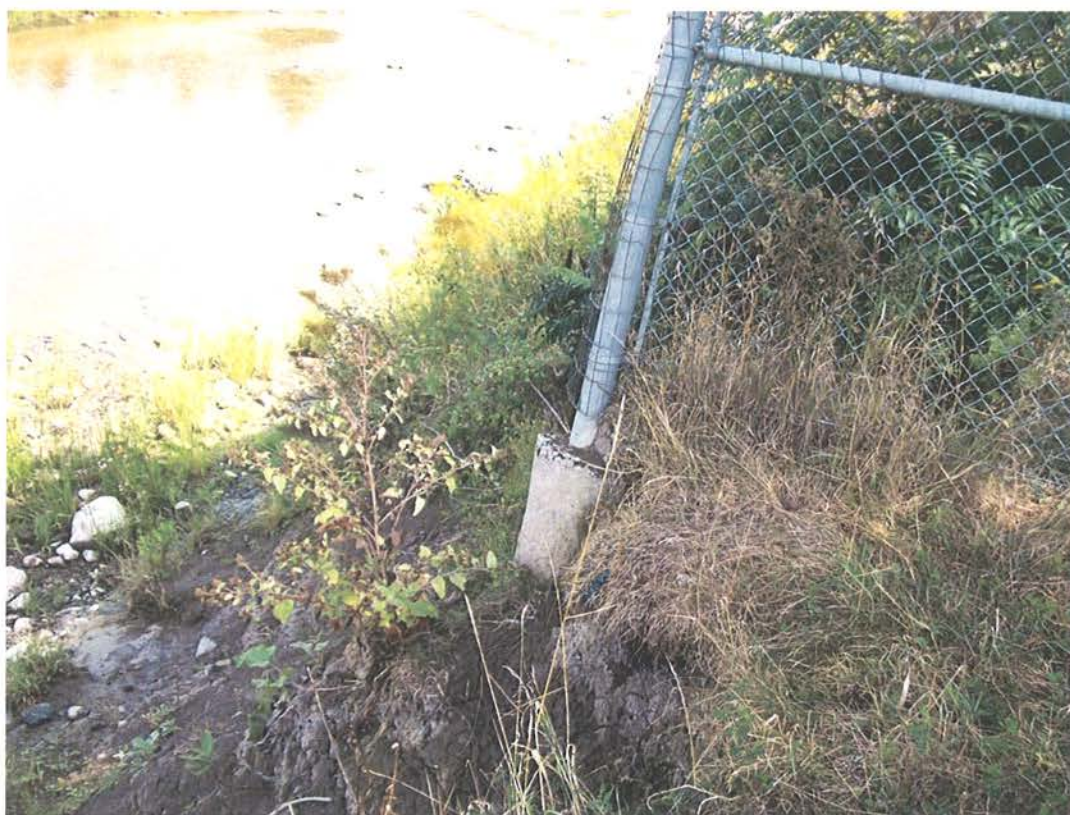
**Photo No. 2: Exposed fence post foundation at east end of critical slope**

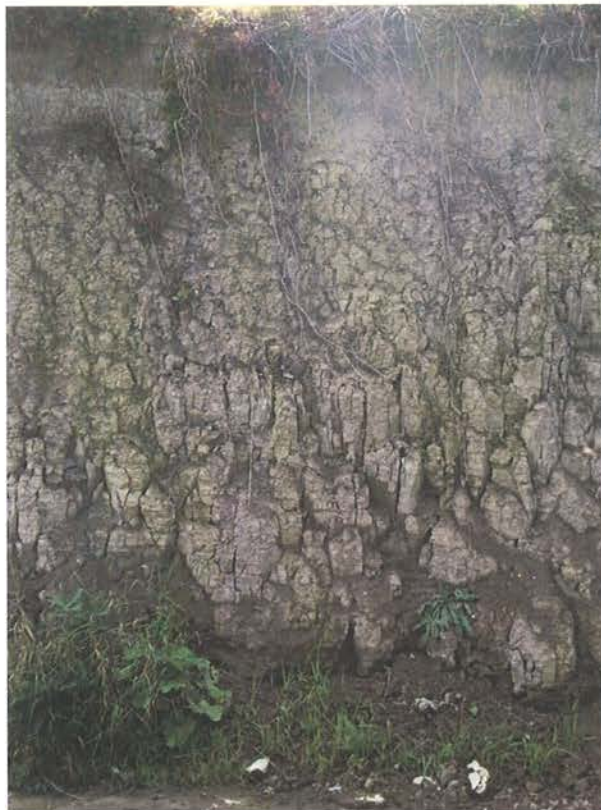
**Photo No. 4: Desiccated and blocky clay on vertical slope face (west end).**

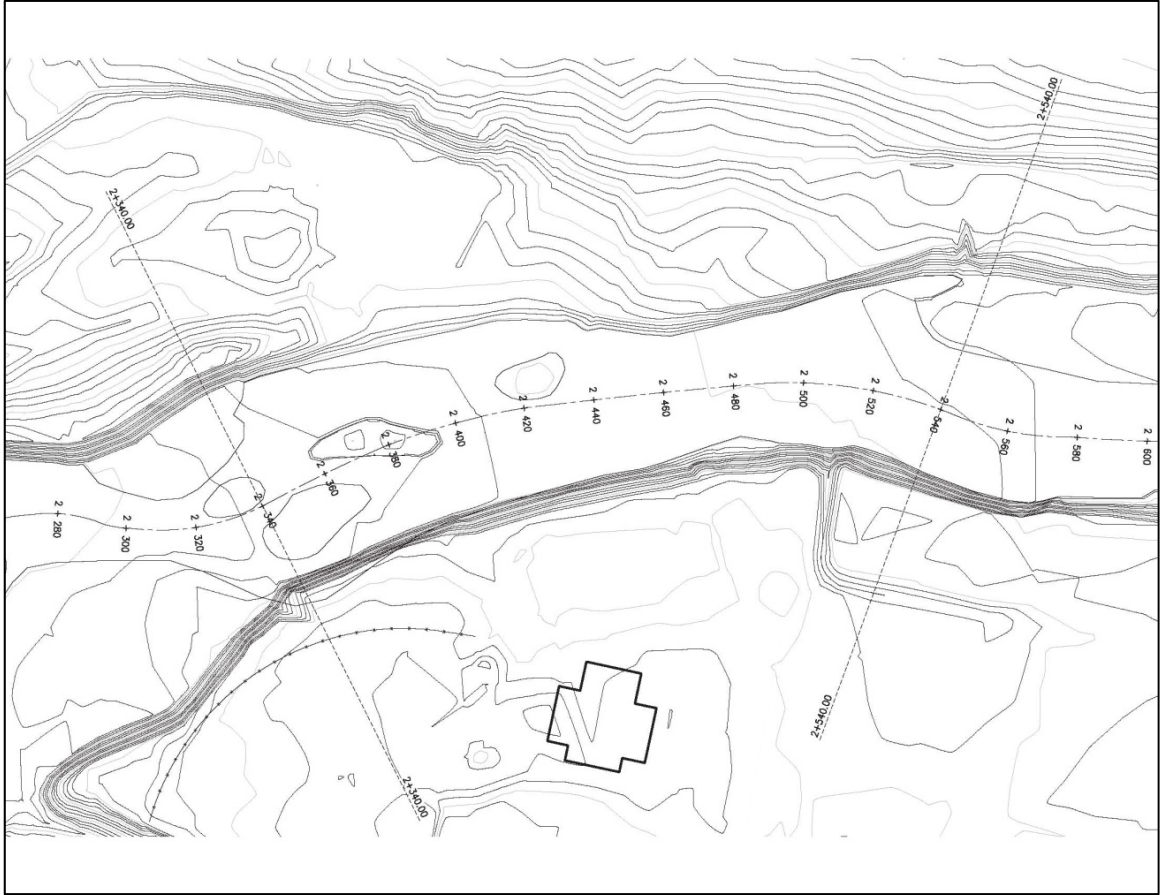
**Figure 1. Sections of Interest.****SIMULATED FLOWS**

The expected impact on the average flow velocities of the implementation of the preferred alternative will vary from a decrease of 0.31m/s (seen at Section 2+400) to an increase of 0.55m/s (seen at Section 2+360). The average velocities under both the existing and the preferred alternative conditions ranged from 1.76m/s to 3.13m/s under the 1:100 year conditions.

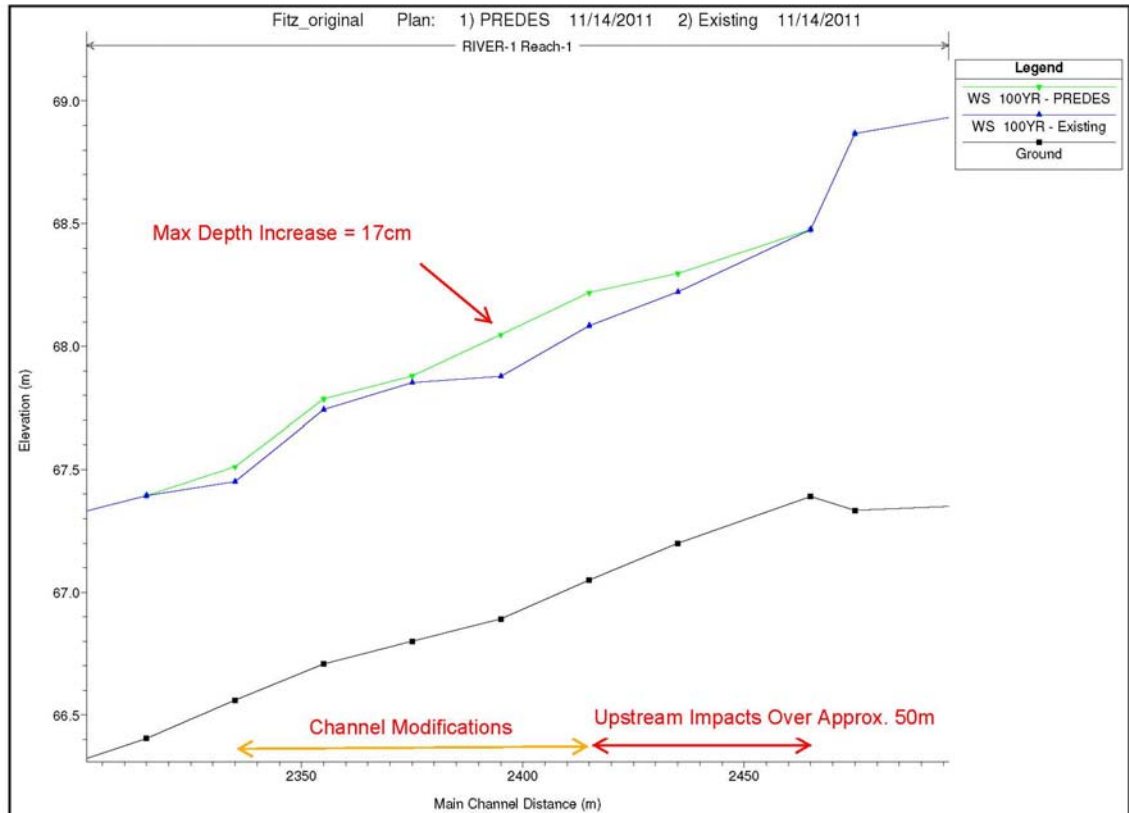
Figure 1. Results - Hydraulic Grade Line Comparison.

Additionally, the maximum difference in depths between the preferred solution and existing conditions is approximately 17cm under the 1:100 year flood conditions. This
